## Collapse analysis of a venlo greenhouse by heavy snow hazard

**Keywords:** venlo greenhouse, heavy snow hazard, collapse, structural identification

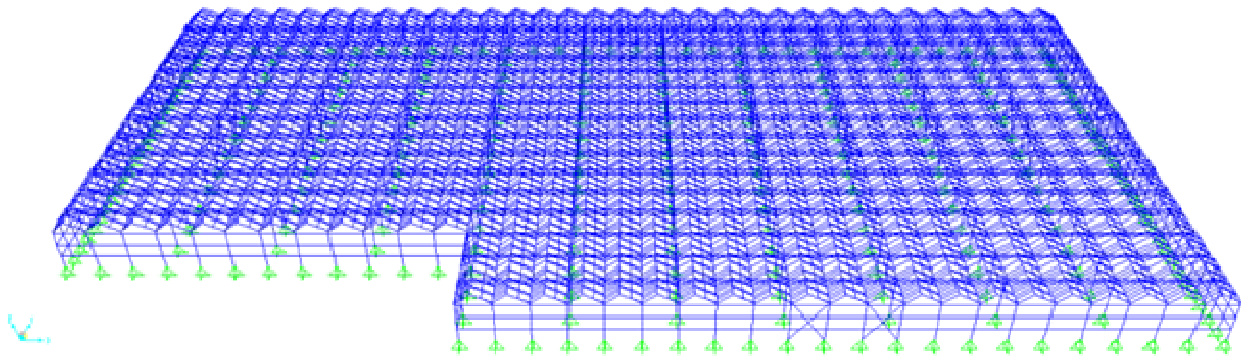
**Figure1. finite element mode**

Modeling of the Venlo style greenhouse is analyzed via SAP2000 V14.2.4 finite element software. Glass and solar panels on the roof are simplified into uniform load simulation, interior wall pipes of heating system, sprinkling pipe system of the roof, windmills are installed at the models' nodes through concentrated force load. Other components all adopt elastic beam element to model strictly in accordance with section size and designed length. On-site test reveals that the connection of the column fixed by two anchor bolts is weak on the basis of hinged support simulation. Materials for struts between columns, supporting trusses of the roof, coupling beams between walls and columns are namely Q235, Q345 and 6063A-T5 for roof purlins, ridges and gutters. During the process of structural recheck by virtue of finite unit, group structural dead load, live load, snow load, wind load, temperature load effect by virtue of bearing capacity and common usage limit stage in accordance with load code for the design of building structure [3], and Greenhouse structure design load [4]. And then check and compute the most disadvantageous load effect with possible design situation concerned.
