# Analysis of corrosion perforation of a gas gathering carbon steel pipeline in a western oilfield in China

**Abstract.** In the west of China, corrosion perforation and scaling of pipelines occur frequently in the ground gathering system in oil and gas field, and cause serious safety and environmental problems. In the present work, the corrosion perforation of a carbon steel pipeline with a grade of 20 in a western oil field in China was investigated. Optical metallographic microscopy, scanning electron microscopy (SEM), energy dispersive spectroscopy (EDS), and X-ray diffraction were used to determine the most probable causes of the corrosion perforation. The results showed that the internal corrosion of the studied carbon steel pipe was ascribed to the corrosive CO<sub>2</sub> gas and the high content of formation water in the internal transporting medium. The formation of loose and porous iron carbonate layer and the scaling layer with poor adhesion could not protect the carbon steel effectively, so that the high concentration of chloride ions in the formation water caused the initiation of localized corrosion possibly by changing the solubility of iron carbonate, and then the

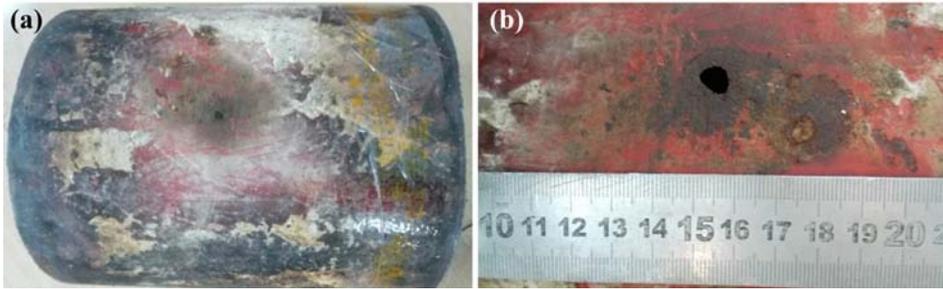
Figure 1 shows the outer appearance of the perforated carbon steel pipe. On the outside surface of the pipe, the red anticorrosive paint and white insulation layer can be observed. In addition, a corrosion pore with a diameter of  $\sim 8$  mm can be seen in Figure 1. Near the corrosion pore, the red anticorrosive paint dropped locally and slight corrosion can be seen.

**Figure 1.** The outside appearance of the corroded carbon steel pipe

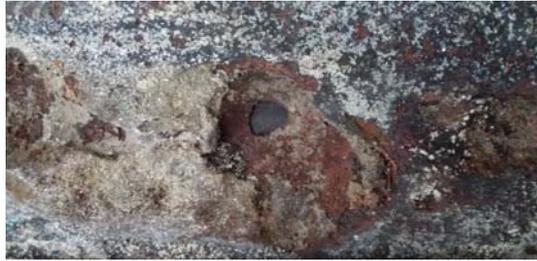
Figure 2 presents the internal appearance of the perforated carbon steel pipe. There are several characteristic features. First, a wide-range area of corrosion thinning can be seen around the corrosion pore. The largest size of the corrosion pits is  $120 \text{ mm} \times 40 \text{ mm}$ . Second, significant exfoliation of corrosion products can be seen. Figure 3 shows the appearance of the spalled corrosion layer.

**Figure 2.** The internal appearance of the corroded carbon steel pipe

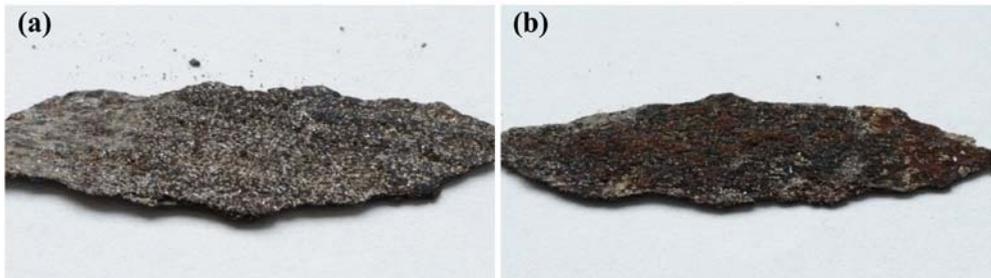
**Figure 3.** Macro appearances of the corrosion layer: (a) the outer surface, and (b) the inner surface

Fourth, the localized corrosion may be related to the failure of iron carbonate layer and/or scaling deposit layer. The scale deposit layer seems be detached from the outer surface layer by layer as mentioned in Figure 3. In the formation water, the high concentration of chloride ions ( $\sim 111$  g/L)

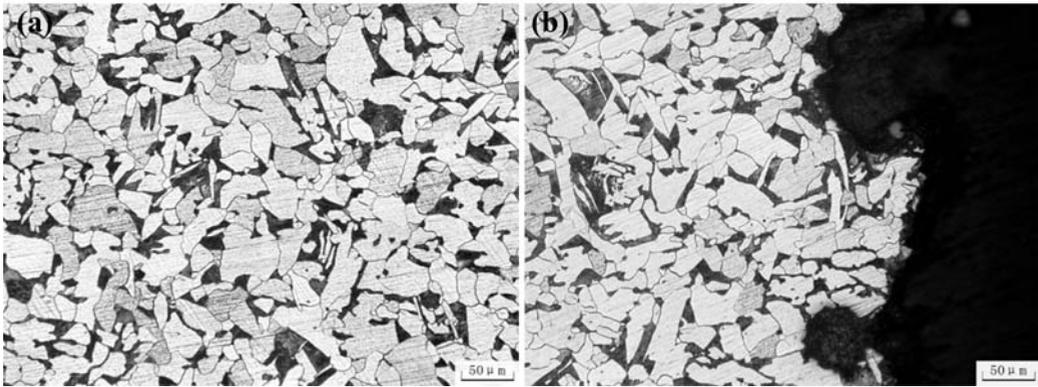
Table 2 lists the results of metallographic microstructure, grain size and non metal inclusions of the perforated carbon steel pipe. It indicates that the metallographic structure of the carbon steel pipe is ferrite (shown in Figure 4a), the grain grade is 6.0, and the inclusions are A0.5, B0.5, D1.5, and D0.5e. For the specimen containing the corrosion perforation, its metallographic structure is ferrite with no

significant deformation, while some corrosion products is visible in the corrosion pore as shown in Figure 4b.

**Figure 4.** Microstructures of the (a) NF specimen and (b) CP specimen

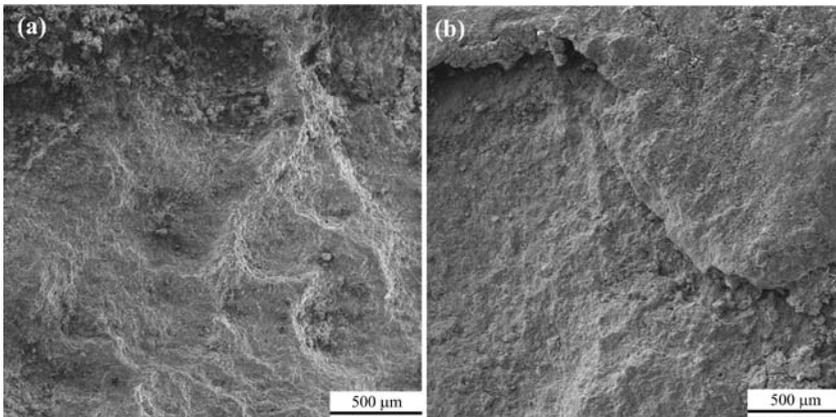
Figure 5 presents the surface morphologies of the No. 1 specimen. On the bottom of the corrosion pit, several small pits make the surface rough enough (Figure 5a), and EDS analysis indicates the high content of C, O, Fe, as well as some content of S and Cl. In the region outside of the corrosion pit, evident exfoliation can be seen in Figure 5b. EDS analysis indicates that the chemical compositions are similar to those in the bottom of the corrosion pit.

**Figure 5.** Surface morphologies of the No.1 specimen in the region of (a) the bottom of the corrosion pit and (b) the flat area near to the corrosion pit

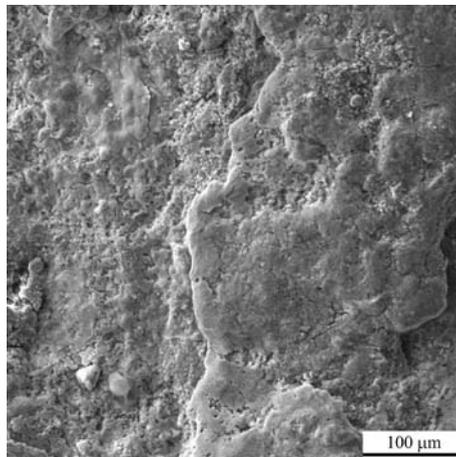
Figure 6 shows the surface morphologies of the No.2 specimen. Far away from the corrosion pit, the corrosion products seem dense, however, exfoliation is still evident. EDS analysis indicates that the similar chemical compositions as above.

**Figure 6.** Surface morphology of the No.2 specimen

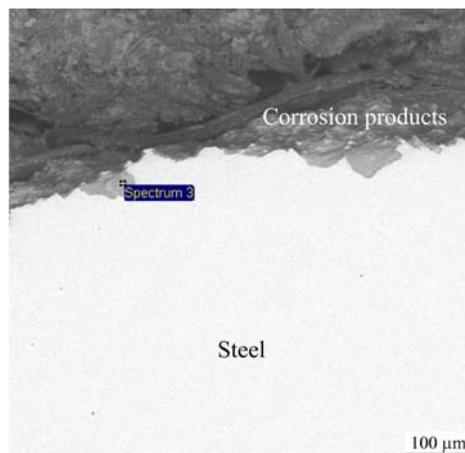
Figure 7 presents the cross section morphology of corrosion pit. Several small pits can be observed, which is in accordance with the observation from surface morphology as shown in Figure 5a. EDS analysis implies that the chemical compositions are similar to the corrosion products in others, except for the small content of Ca.

**Figure 7.** Cross section morphology of the corrosion pit (No. 3 specimen)

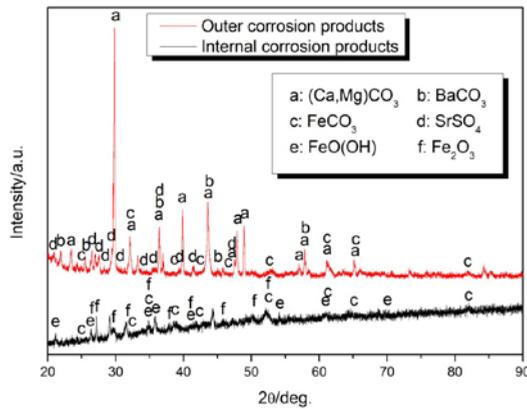
Figure 8 shows the XRD spectrum diagrams of the corrosion products, where the outer corrosion products were made from the exfoliated corrosion layers as shown in Figure 3 and the internal corrosion products were taken from the region where surface products spalled. It can be seen that the outer corrosion products are composed of  $(\text{Ca},\text{Mg})\text{CO}_3$ ,  $\text{BaCO}_3$ ,  $\text{FeCO}_3$  and  $\text{SrSO}_4$ , and the internal corrosion products consists of  $\text{FeCO}_3$ ,  $\text{FeO}(\text{OH})$  and  $\text{Fe}_2\text{O}_3$ . The formation of insoluble salts such as  $(\text{Ca},\text{Mg})\text{CO}_3$ ,  $\text{BaCO}_3$  and  $\text{SrSO}_4$  in the outer corrosion products is generally ascribed to the high scaling sensitivity of the formation water which containing high concentrations of  $\text{Ca}^{2+}$ ,  $\text{Mg}^{2+}$  and  $\text{Sr}^{2+}$  (shown in Table 3). The formation of iron oxides in the internal corrosion products is usually related to the corrosion during the later transporting process where the wet internal surface was exposed to air and formed iron oxides.

**Figure 8.** XRD spectrum diagrams of the corrosion products
