Analysis on cracking of repaired tubing used in surface gas injection pipeline in a western oilfield in China

Abstract. According to the cracking accident of repaired tubing used in surface gas injection pipeline in a western oilfield in China, the cause of the failure tubing was analysed by means of macroscopic analysis, non-destructive testing, chemical analysis, mechanical testing, metallographic examination, macro and micro fracture analysis. Combined with the working environment of the repaired tubing, conclusions were made that the failure cause of the tubing was sulfide stress corrosion cracking (SSCC) and the crack originated from the clamp area of make-and-break test in the outside surface of the tubing. Finally, suggestions and measures for prevention congener failure were put forward.

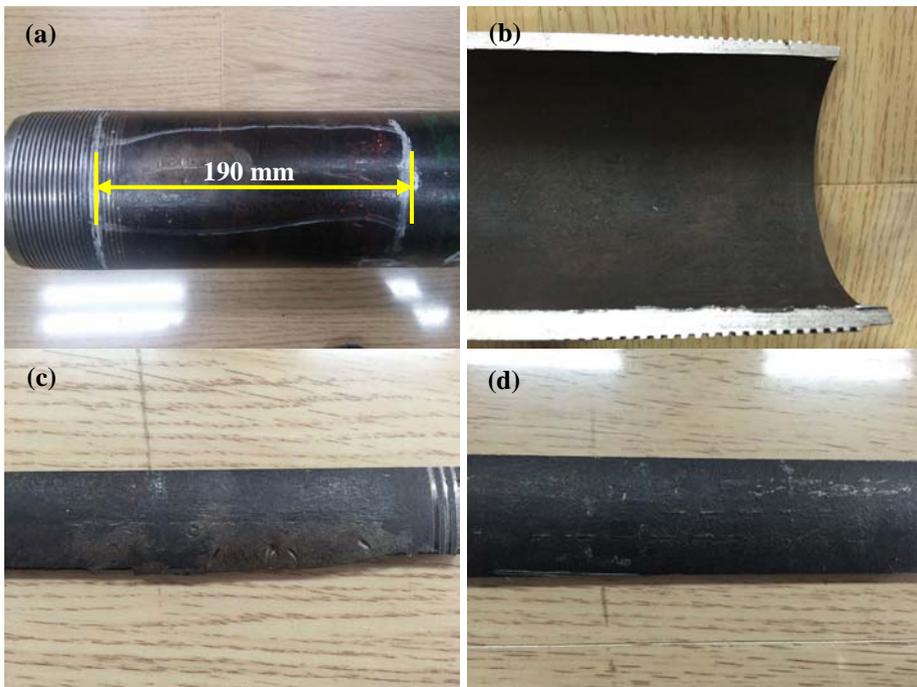
Figure 1. Macroscopic photos of the failure tubing

Figure 1 shows macroscopic photos of the failure tubing. The outer wall of the tubing has a length of about 190 mm of the longitudinal crack extending to the disappearance of the external thread. The internal and external walls of it don't have obvious corrosion (Figure 1a and Figure 1b), while the external wall in the vicinity of the crack has a relatively shallow clamp printing (Figure 1c). Moreover, the deep clamp printing can also be seen in the region to the other parts of the ring (Figure 1d), and the surface of the external thread was no damage and intact appearance.

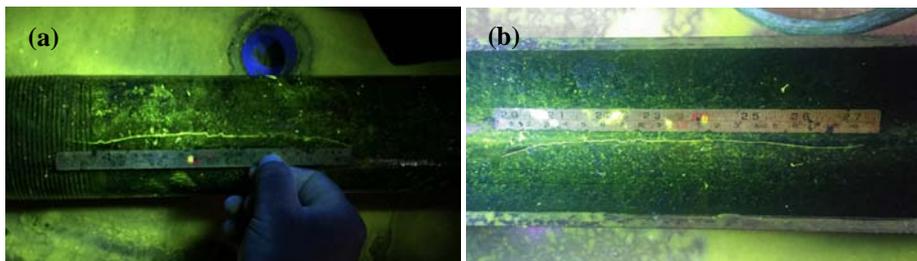
Figure 2. The results of magnetic particle testing of internal and external surface of the failure tubing: (a) external surface and (b) internal surface

The failure tubing was subjected to ultrasonic detection and the inside and outside surface of the magnetic particle testing. Results show that the body of the tubing produces a length of about 190 mm longitudinal penetrating crack extended to the external thread disappear. Magnetic particle testing results are shown in Figure 2.

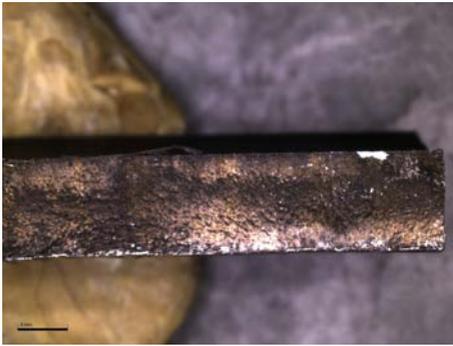
Figure 3. The macro morphology of fracture

After the crack was opened by mechanical means, the macroscopic fracture with cleared by cellulose acetate was observed by optical microscope as shown in Figure 3. It shows a smooth and blackened fracture with the radial pattern obviously, which converges to the outer wall of the tubing body. Those belong to characteristics of brittle fracture. Figure 4 the longitudinal position of the crack source of the fracture. From Figure 4, we can see that the distance between the source of the fracture surface and the disappearance of the external thread is 40 mm. According to the make-and-break experience and macroscopic observation, it can be found this place is the clamp area of make-and-break test of tubing exactly and clamp marks are remarkable.

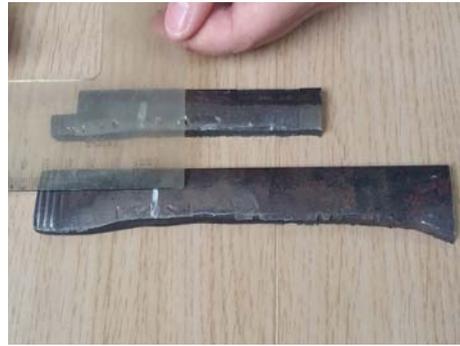
Figure 4. The location of crack source

(2) The failure cause of the tubing is SSCC and the crack originates from the clamp area of make – and-break test in the outside surface of the tubing.

(5) To develop a new make-break process, reduce or eliminate residual clamp printings on the outer surface of the tubing, so as to improve the surface quality of a pipe body to prevent similar incidents from happening again.

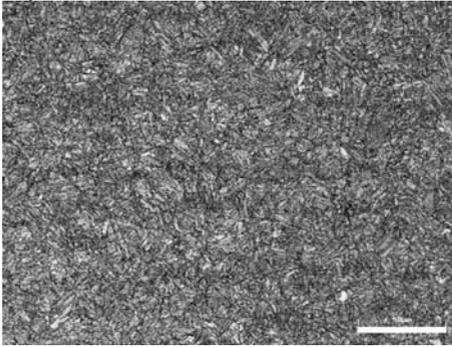
Figure 5. The body tissue of the tubing

The samples were cut from the body of the tubing and the vicinity of the crack of the tubing. Results of metallographic observation are as shown in Figure 5 to 7. It can be seen from the figures that body tissue of the tubing is tempered sorbite, Grain size is 9.0 grade and non-metallic inclusions is A0.5, B0.5 and D0.5 (Figure 5). The tissue near the crack has no abnormalities (Figure 6), the crack of the tubing body is extended from the external surface to the inner surface (Figure 7).

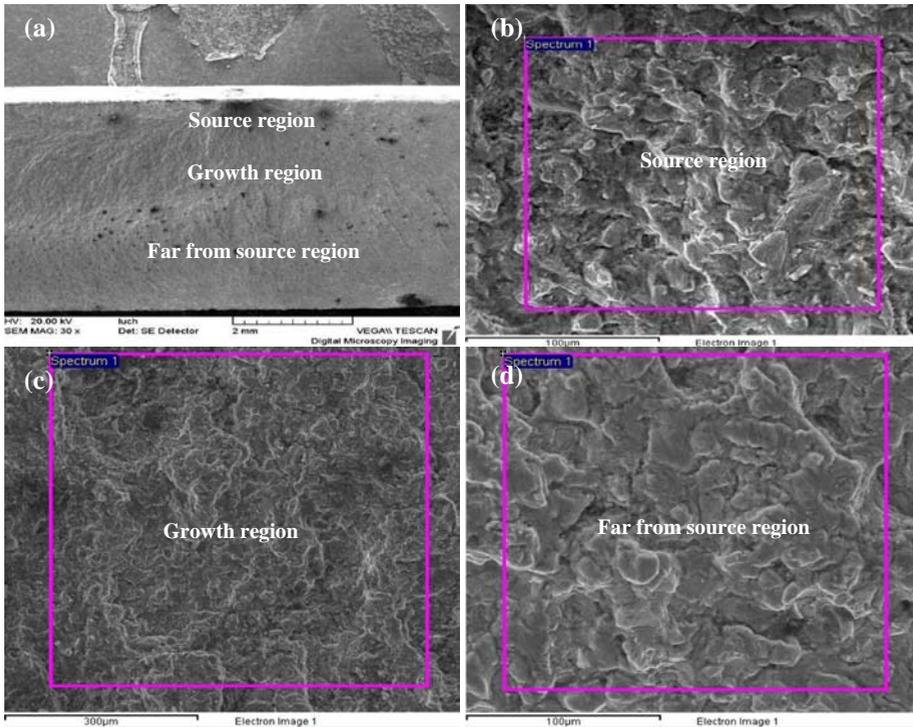
Figure 8. Microscopic morphology of the fracture

Figure 8 shows microscopic morphology of the fracture. As can be seen from the diagram, the fracture at the side of the outer wall has obvious radial pattern and its convergence is for the crack source. It shows a flat fracture with no obvious plastic deformation (Figure 8a). Intergranular traces exist in the source region and the growth region. Moreover, intergranular secondary cracks are in the cross-section of the fracture (Figure 8b and 8c). EDS analysis of the fracture surface shows the content of element S is relatively high, as shown in Table 4.

The observation of the macro morphology of longitudinal cracking of the tubing shows that the fracture is flat with no obvious plastic deformation. Meanwhile, macroscopic fracture with cleared by cellulose acetate is blackened and has the radial pattern obviously, which converges to the outer wall of the tubing body. Those belong to characteristics of brittle fracture, which meet macro fracture characteristics of sulfide stress corrosion cracking (SSCC). The micro morphology analysis of the fracture surface can be known that the characteristic of intergranular traces exists, and intergranular secondary cracks are in the cross-section of the fracture, which is in accordance with the micro fracture characteristic of SSCC [6]. In addition, EDS analysis of the cross-section of the fracture also shows some element S. By the macroscopic and microscopic characteristics of the above section, it can be determined that the failure tubing is a typical SSCC, and the crack originates from the outside surface of the tubing.
