Emergency Repair of Xushui River Bridge in the Expressway around Zhengzhou

Abstract—An safety accident of Xushui River bridge in the southwest expressway around Zhengzhou city occurred in July 2014. Due to the accumulation of building waste materials near the bridge, one of pier columns was broken up by accidental horizontal load. Key technology for emergency repair construction of the bridge was concerned in this paper. Firstly, the repair plan and difficulty was carried out. Then the main construction steps were described in detail. In the end, main characteristics of the emergency project were summarized based on the whole repair process.

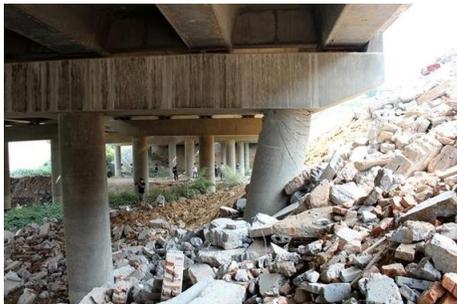
As shown in Fig.3, the bridge safety accident was unfortunately occurred in July 7, 2014. A large number of building waste materials were deliberately dumped on the west side of the bridge, and the vertical height of the waste was 5m higher than the bridge deck. Along with the accumulation of building waste materials, one of the pier columns of the bridge (No.p6-1#) was obviously inclined and cracked (Fig.3). Without supporting, the main girders had large vertical deflection, which seriously affected the traffic safety. The observation results showed that the cap beam, the middle pier (No.p6-2#) and several main girders were damaged, and the bearing cavity also appeared.

Figure 3. Accident photo

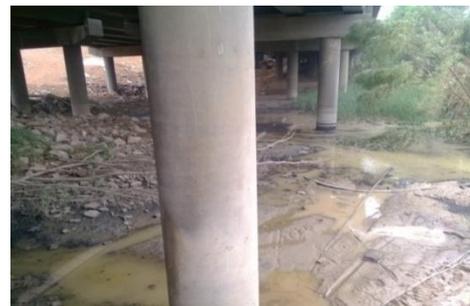
(1) The damaged p6-1# pier was located in the lowest area of the river. The detection result indicated that there was a lot of silt under the bridge, and the depth of the silt was about 5-7m. Therefore, the work of removing the silt would be the first difficulty in the whole repair period.

Figure 5. Original silt situation under the bridge
