Failure Analysis of Steam Pipe Flange Gasket

Abstract. Flange at the end of steam line in the Co coking joint unit became invalid in a normal operation at a petrochemical corporation. The failure mechanism was fatigue fracture failure by means of gasket macro analysis, chemical composition analysis, metallographic analysis, fracture analysis and energy spectrum analysis. The reason was that residual stress existed in serrated gasket. The improving measure was put forward to prevent the failure in serrated gasket.

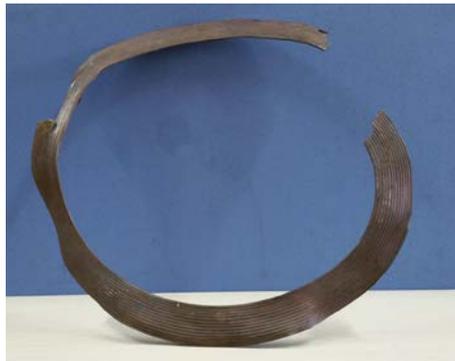
Fig. 1 Failure flange gasket

After the failure of the flange open, found that the blind side of the plate gasket cracking, figure 2 showed the cracked flange gasket macro photo, it can be seen that the failure gasket has been broken, and the deformation of the gasket has occurred, and the crack of the gasket is extended along the circumferential direction as well as the crack extending along the radial direction. The other side of the blind flange gasket is basically intact, no deformation and cracking. There is no obvious plastic deformation at the fracture surface, which shows the characteristics of macro brittle fracture.

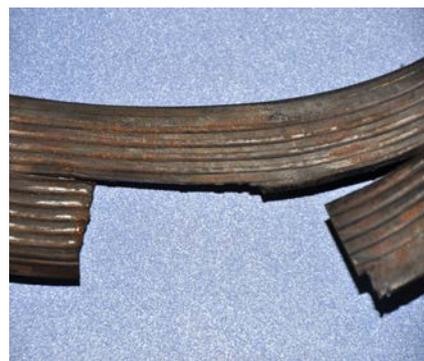
Fig. 2 Circumferential crack

Further observation, it is found that the crack location of radial and circumferential cracks is located at the sixth grooves of the inner diameter of the gasket, as shown in Figure 3. The radial crack extends along the circumferential direction, also extends along the radial direction, and then through the entire gasket in radial direction. At the same time it can be seen that the failure gasket at the convex ring of the fracture site has been severely crushed, the inner diameter parts almost flattened, showing the plastic deformation is greater than that of other parts. It indicates that gasket of this part is subjected to higher pressure from the flange body. It can be speculated that the bolt pretension is not uniform in the pre tightening process of the flange bolt.

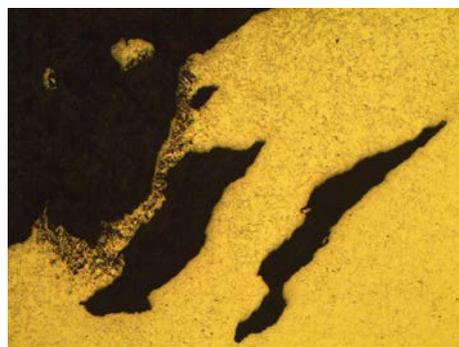
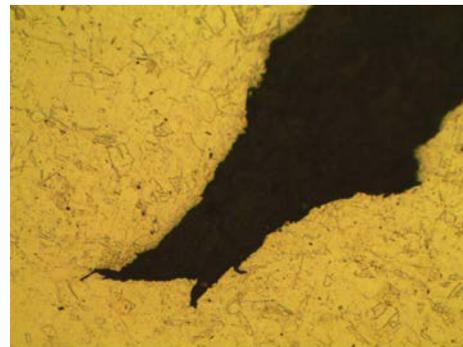
Fig. 3 Crack at fracture

Sampling of the radial cracking occurred on the gasket and metallographic examination. Figure 4(A and B were respectively the magnification of 50 and 200 times) was the crack at the metallographic photos. The material is austenite, and a lot of grains can be seen in the grains. From the macroscopic analysis, the main crack presents the transgranular expansion along the radial direction^[1], and the crack has a slight bifurcation in the expansion process, and the crack tip is blunt.

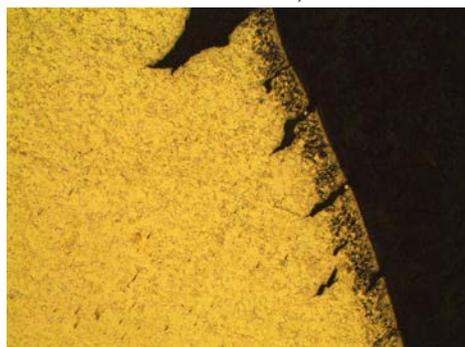
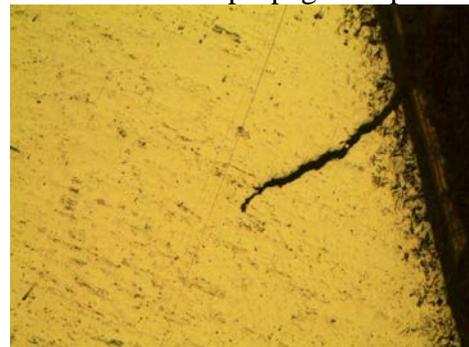
Fig. 4 Micro-crack near fracture

Figure 5(A and B were respectively the magnification of 50 and 100 times) was the micro crack near the fracture. It can be seen that there are many micro cracks in the microstructure, some of which are vertical to the main crack, and some are still in the crack propagation period.

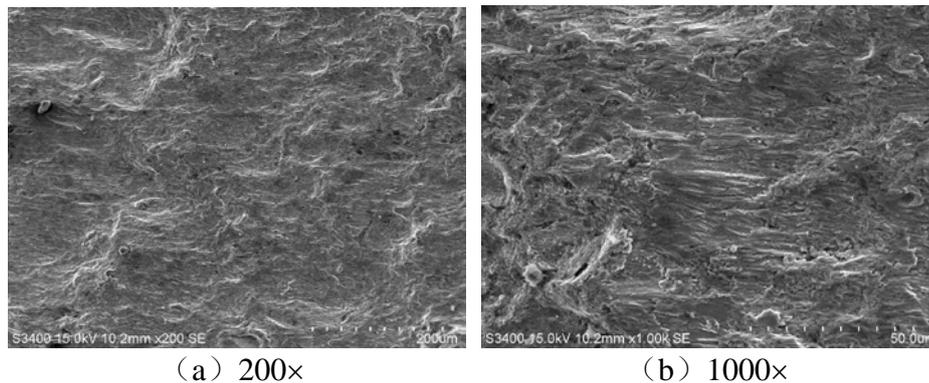
Fig. 5 SEM at fracture

Scanning electron microscopy can be modulated imaging by physical signals which is excited by the scanning electron beam on the sample surface, the intensity and distribution of the obtained information are related to the surface morphology and surface state of the samples. The microscopic morphology of the samples can be characterized by observing the information received by SEM^[2]. The fracture surface was sampled and cleaned by ultrasonic acetone, and the fracture surface was observed by SEM, as shown in figure 6(A and B were respectively the magnification of 200 and 1000 times). It can be seen that the whole fracture is characterized by brittle fracture, and there is almost no typical dimple. In the magnification of 1000 times, it can be seen that there is fatigue striations, which indicates that the fracture is fatigue.

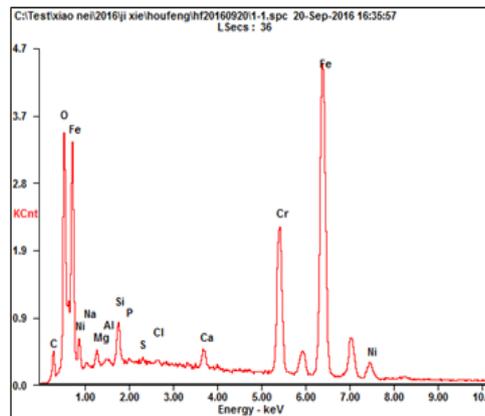
(a) Energy spectrum (b) Element percentage
Fig. 6 Results of energy spectrum analysis at fracture

Energy spectrum analysis of fracture surface, the results are shown in figure 7, it can be seen that there are a small amount of Cl, S, Ca, Na, Mg and other elements in the fracture surface, indicating that there is corrosion in the fracture surface. These components are likely to come from the steam.
