Analysis and Repair of the Fault of Electric Power Special Optical Cable

Keywords: electric power special optical cable; ADSS; OPGW; operation and maintenance; fault treatment

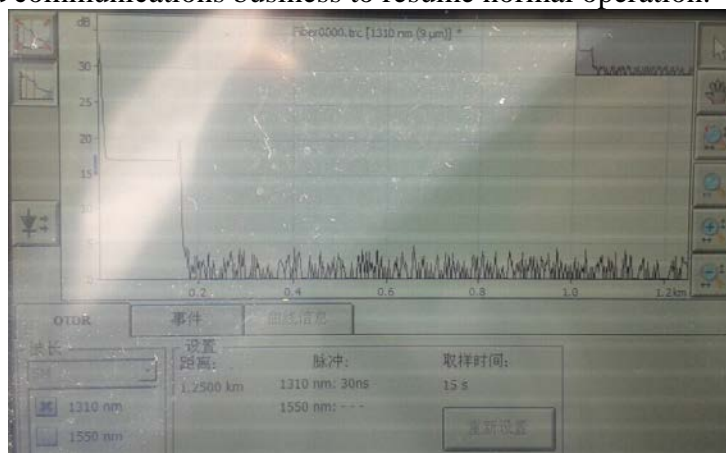
Fig. 1 OTDR waveform

May 12, 2014 morning. On duty officer found that there is a serious communication transmission network management alarm. The warning message is that the transmission communication network is interrupted. The alarm information involves two substations, 66kV Xin Bin substation, 66kV North Siping substation. The communications professional transport inspection officers immediately rushed to the Xinbin substation, carried out on the 66kVOPGW overhead optical cable survey. In the substation station, OTDR (optical time domain reflector, a device that can obtain the useful information of the optical fiber cable line [5]) can be used to test the fiber optic cable channel failure, the waveform is shown in figure 1. According to the graph analysis, the location is about 190 meters, the optical path is interrupted. Maintenance personnel along the fiber cable path to carry out the line inspection. Found serious tilt phenomenon in fourth power tower. A careful view found that the outer sheath of the optical fiber cable is damaged.

Based on traces, maintenance personnel to determine the cable break cause of the malfunction is caused by lifting machinery. Damaged optical fiber cable segment is re replaced, optical path recovery, the affected communications business to resume normal operation.

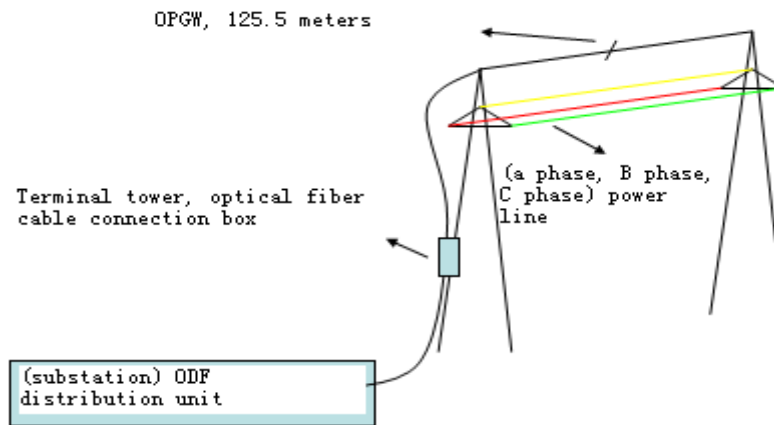
Fig. 2 Schematic diagram of failure optical fiber cable

In March 12, 2013, in the 66kV Kuang Zi substation, communication engineering construction site. After the fiber optic cable is laid, the communication professionals will be ready to debug the fiber channel. Commissioning work is related to the two substation terminal, 66kV Kuang Zi substation, 220kV Qian Wu substation. 2 groups of people were using handheld optical power meter and hand-held light source equipment, to complete the debugging work of the fiber channel. After passing through the channel one by one after the test did not succeed. At the same time, the construction staff also confirmed that the optical fiber cable connection and the terminal ODF (fiber optic distribution unit) welding are no quality problems. Then use the OTDR device to test the fiber cable, the results show that there is an interruption at a distance of 125.5 meters. Field personnel according to the actual conditions of the survey analysis, optical cable connector box in the terminal tower, distance communication room is about 60 meters, optical interrupt does not occur in the optical fiber cable connector box. Preliminary determination, location in the two towers, but did not find significant problems (visual judgment). OPGW cable was put down by the construction staff. After careful examination found that in the OPGW cable 125.5 meters or so, aluminum alloy wire (AA) has a slight extrusion damage. The schematic diagram of the fault optical cable is shown in Figure 2.

Optical fiber cable fault reason is as follows, in the course of the cable laying, the construction personnel cable traction is not correct, resulting in OPGW cable bending extrusion damage caused by internal optical fiber broken. Damaged fiber cable is replaced, the business channel debugging work completed successfully.
