Fault Analysis of Wall Bushing Dielectric Loss and Capacitance of 66kV Exceed the Standard

Keywords: Wall Bushing; Insertion Loss; Capacitance; Fault Analysis

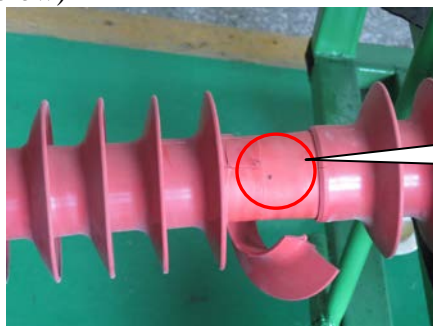
Test and maintenance personnel will be immediately removed to check the casing without exception, remove the umbrella skirt and found traces of discharge occurs between the indoor terminals sixth, seventh fixed flange lateral direction skirt below sixth umbrella skirt found a hole. (as shown below)

The discharge point was found after the umbrella skirt was removed.

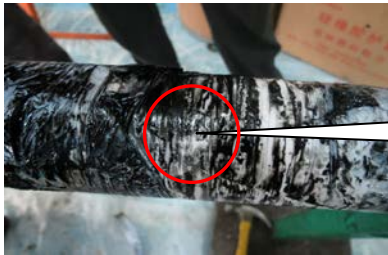
The casing through the return to factory inspection, remove the heat shrinkable insulation jacket was found, sixth and twelfth along the wall bushing along the outer winding capacitance screen are

affected by the presence of force deformation, a first layer capacitance screen can be seen directly. (as shown below)

Twelfth the internal winding along the umbrella skirt is uneven.

The outer insulation deformation phenomenon discovered by disintegration, preliminary analysis of the production process due to the outer insulation winding uneven, fastening degree insufficient, at the same time in the process of extrusion force by packing and transportation, resulting in deformation of outer insulation. The operation of the electric power in the casing vibration and the effect of thermal expansion and contraction, the uneven distribution of electric field strength of casing, easily lead to insulation breakdown, in the long time accumulation effect caused by outer insulation breakdown and discharge.

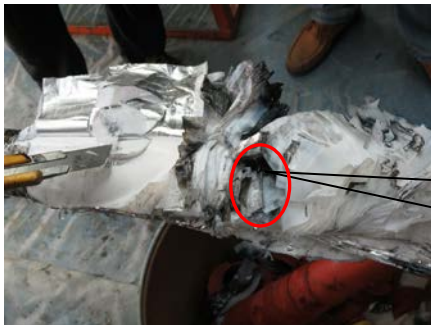
The disintegration of layers of dig inspection found sixth small holes along the wall bushing, Ninth edge from the outside to the inside of the three layer capacitive discharge, sixth, ninth and twelfth along the 90 degree angle from the outside to the inside of the two layer capacitive discharge. (as shown below)

Sixth along the umbrella skirt from the outside of the three layer capacitor screen discharge
