Inspection Case and Its Failure Cause Analysis of Leaked Storage Tank

Hazardous Chemical Substance Equipment Division, China Special Equipment Inspection and Research Institute, Beijing, P. R. China

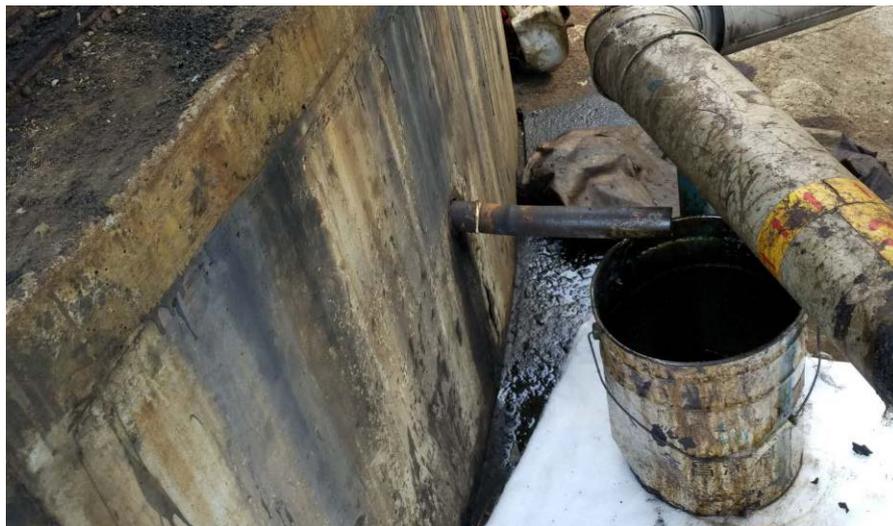
Afterwards, due to the process adjustment, the base oil of another storage tank was transported to the tank in Aug., 2014. It’s found that the heat exchange tube bundle of the storage tank was leaked in Sep., 2014, but it was put into use again after replacement. Due to insufficient thermal load of heat exchanger, the upstream process device process was changed and the oil was input into the tank again in Dec., 2015. Until Aug., 2016, the device was overhauled and normal process was restored. However, the leakage occurred in Sep., 2016. The field situation is as shown in the Fig. 1.

Fig. 1 Leakage scene of the storage tank

Organization of the Text As described by the device manager, the leakage of the storage tank was the oil leakage of the leakage detection hole in foundation at all directions. Due to the high oil liquid level stored at that time, it’s too late to unload the oil. Thus, there were enormous leaked substances deposited on the foundation. Afterwards, the oil was leaked outwards from between the baseboard and foundation of the storage tank.

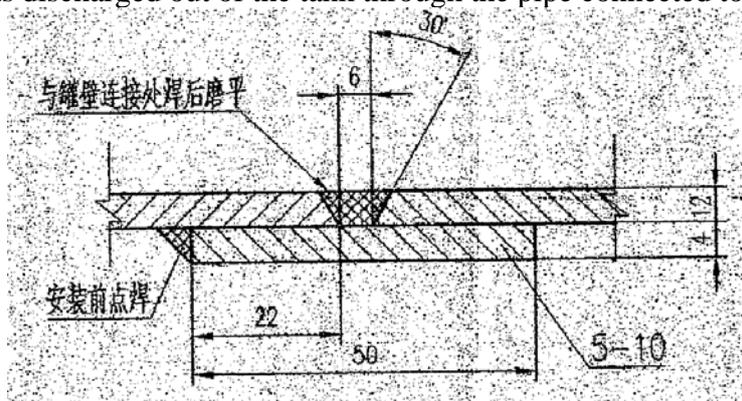
Butt Weld of Baseboard. Butt welding was adopted for the baseboard of the tank, as shown in the Fig. 2. Through this welding method, the baseboard was firstly welded to a piece of cushion board through spot welding and then to another piece through butt welding. However, the welding stress might be caused through two times' welding. Thus, stress concentration would be caused to the last welded joint and the failure would be caused.

Fig. 2 Baseboard welding manner of the storage tank

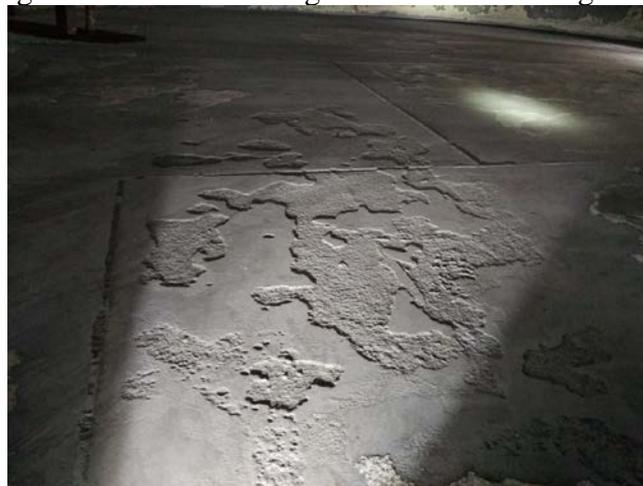
Fig. 3 Corrosion of baseboard of the storage tank

In late Sep., 2016, the tank was cleared and internal sand blasting of the tank was conducted according to the inspection requirement, which met test conditions. Firstly, macroscopic inspection was performed. Due to the thick anti-corrosion layer inside the tank, the sand was not completely removed. However, it's found that there was large area of partial corrosion on the surface of naked bottom of the tank, as shown in the Fig. 3.

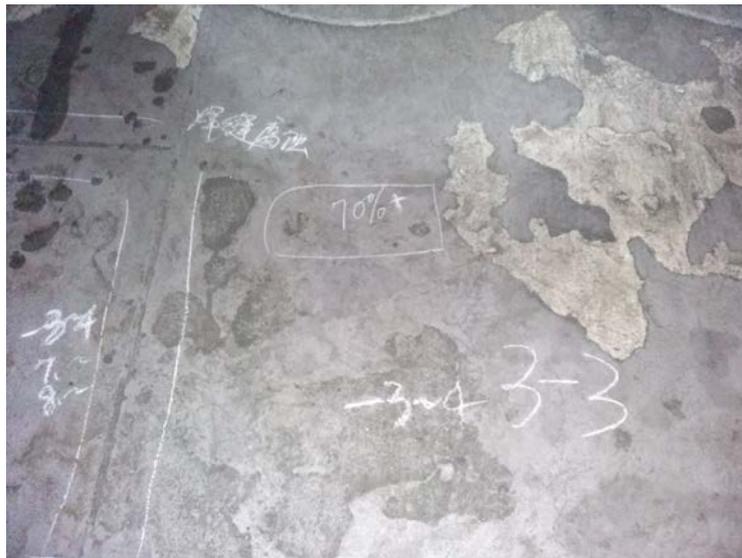
Through thickness measuring spot check, it's found that the corrosion part was reduced by 3-4mm. Besides, the butt weld was severely corroded. The deepest part was 4mm, as shown in the Fig. 4.

Fig. 4 Corrosion depth of baseboard of the storage tank

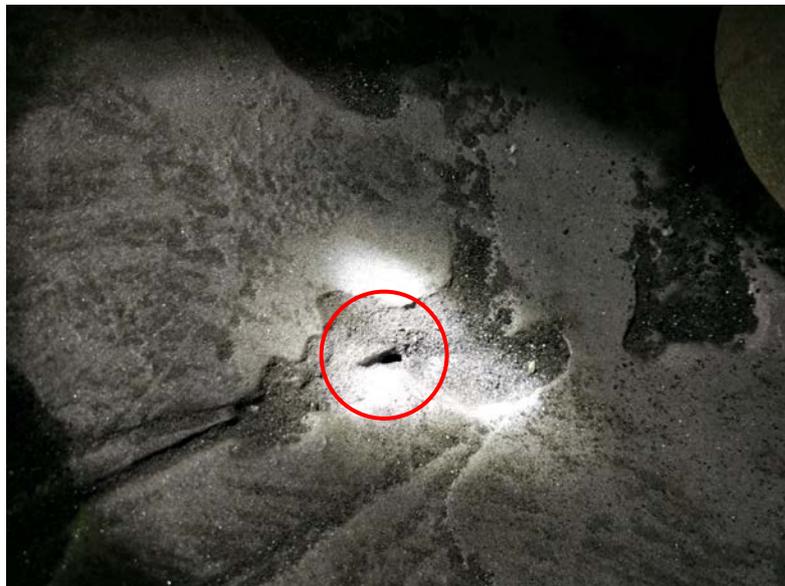
Fig. 5 Corrosion perforation of drainage channel

Through macroscopic inspection of drainage channel, it's found that the partial corrosion was serious and there was one leak point, whose dimension was about 30×10mm, as shown in the Fig. 5.

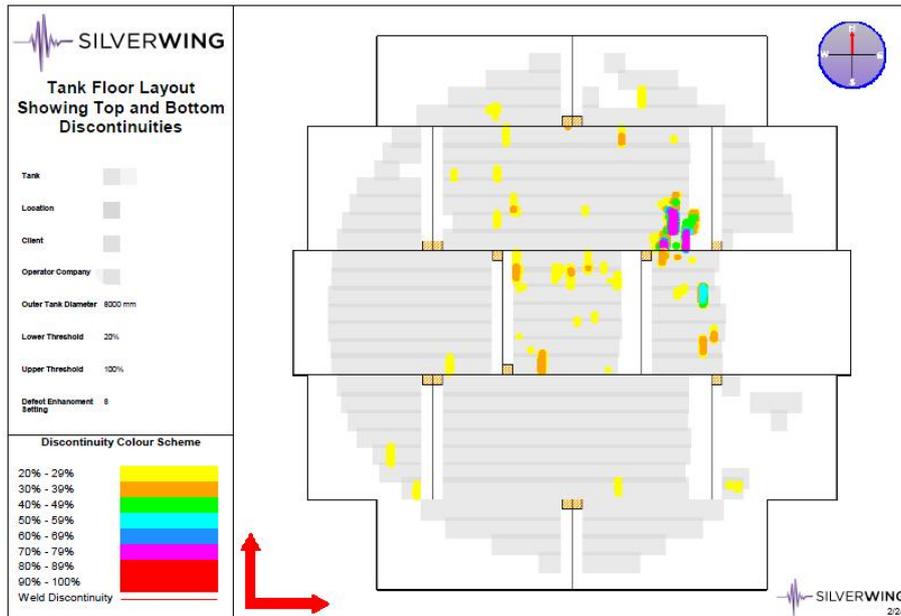
Fig. 6 Magnetic flux leakage scanning result of the baseboard and equivalent depth of corrosion

According to the magnetic flux scanning result, it revealed that the equivalent corrosion depth reached 70% and there was corrosion on the upper and lower surface to a varying degree and the corrosion on the terrain of the storage tank was more serious.

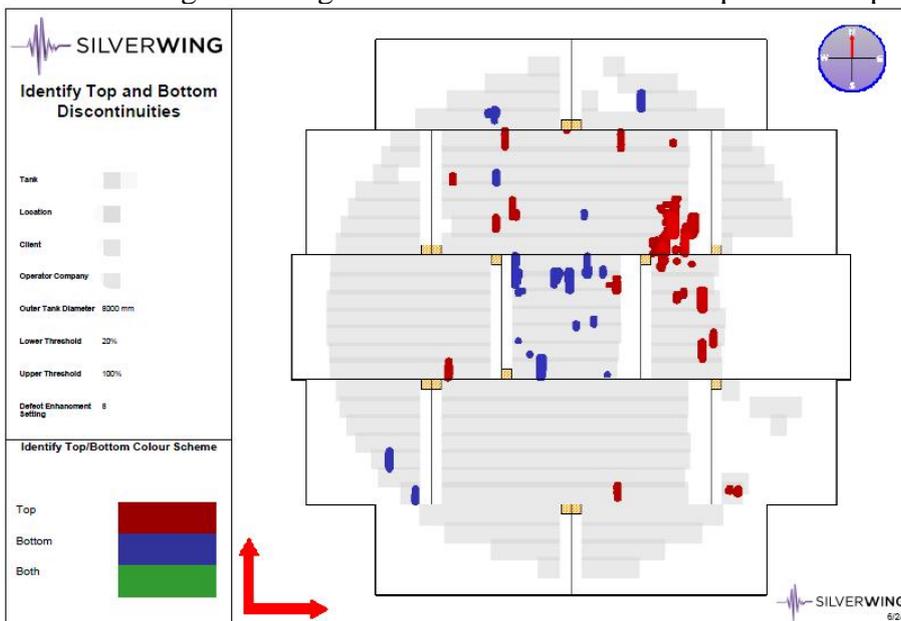
Fig. 7 Magnetic flux leakage scanning result of the baseboard and upper and lower surface
