# Analysis and Prevention of Tubeburst in Rear Platen Superheater of Boiler

**Keywords:** Boiler; Water blocking; Rear platen superheater

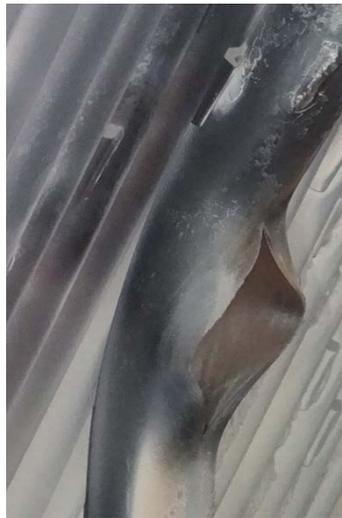
Fig. 3 Explosion shape

After stopping the boiler and checking, it was found that the No. 12 tube in the north of the second panel of B side of the rear panel superheater exploded and the explosion shape was shown in Figure 3. The explosion mouth was 1.5 m from the elbow with a shape of the trumpet. The edge was sharp and the diameter of the tube near the mouth was increased. The surface was gray-black. The shape of the mouth is consistent with the characteristics of the explosion mouth shape caused by the short-time overheating, so the initial reason was determined to be the short-term overheating.

No oxide skin or other foreign matter was found after the further inspection of the rear panel tube. There was a lot of liquid water in the tube when the damaged tube was cut. The specific situation was as shown in Table 1, Table 2 (the water height in the tube is its distance from the elbow). The layout of the B-side rear panel superheater was shown in Figure 2. The heating tubes were named from north to south as the first, the second, .... The No. 1 elbows in the north of No. 41, 42, 43 rows in the east of the final superheater were found to have no water stored, and the wall thickness was normal.

From Table 1 and Table 2, it can be known that there was more water in the Panel 4 (East 1-4) near the explosion mouth, with the highest being nearly 2.0m. There was a small amount of water in the holding tube in the west side and there was no water in the elbow. Under normal circumstances, when the unit was shut down, there will be some condensed water in the platen superheater, but it is abnormal that there is such a large amount of condensed water. It can be seen from Figure 1 that, the rear panel superheater is not directly connected with the primary desuperheating water, so the primary desuperheating water cannot reach the rear panel by going across the platen superheater. The secondary desuperheating water can only be leaked to the final superheater. So the possibility that the leakage of the desuperheating water causes the accumulated water can be excluded.

Combined with the operation, it can be seen that, the unit has an emergency stop at 11:40 due to the large bearing vibration. At 12:30, it was reignited. At 22: 10, the furnace pressure alarmed and the tube exploded. It took 50 min from the emergency stop due to the vibration in the first ignition to the second ignition. During the emergency stop, there was a large amount of condensed water in the superheater tube. During the second ignition of the unit, the drain valve at the inlet and outlet header didn't discharge the condensed water in the rear panel superheater tube, resulting in the water plug. In the heating process, the water plug cannot be completely discharged, resulting in the tube explosion.

Through the several water plug tube explosions in this plant, it can be known that it is necessary to open the atmospheric relief valve and the drain valve of the superheater during the starting and stopping of the boiler in time. Drain the condensed water in the superheater so as to avoid the water plug tube explosions. In addition, the leakage of the desuperheating water is also an important cause to the water plug tube explosion of the superheater. When the superheater behind the desuperheating water valve explodes due to the water plug, it's essential to check whether the desuperheating water control valve is tight or not first.
