Comprehensive Detection Technology In The Application Of Transformer Insulation Diagnosis

The power generation company has the 500 kV main transformer that is single-phase and rated capacity is 210 MVA, with which two high-voltage and low-voltage windings, high rated voltage is 530 kV and low voltage is 20 kV. The transformer was put into operation successfully in November 1991 .

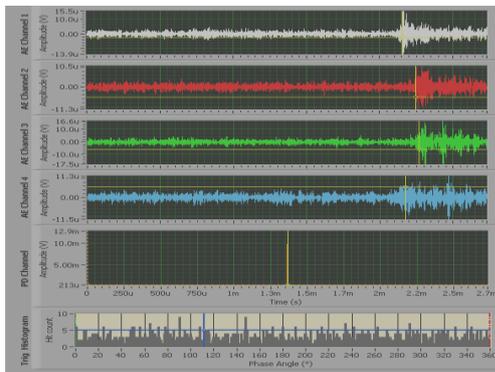
Figure 2: Transformer ultrasound partial discharge test pattern

Conduct induction withstanding voltage test and partial discharge test, when high-winding side test voltage up to 412 kV ($1.3U_m/\sqrt{3}$), of which discharge magnitude is about 450pC. When high side voltage continued to rise to 444 kV ($1.4U_m/\sqrt{3}$), significant partial discharge signals have been detected, of which discharge magnitude is about 2000pC. 5 min after, when continue to rise to 476 kV voltage ($1.5U_m/\sqrt{3}$), of which discharge magnitude is about 5600 PC. Through partial discharge pattern analysis shows that the transformer was internal discharge, when using ultrasonic location, after a lot of moving ultrasonic sensor position^[8-11], that found near the bottom of the high voltage wire end obvious discharge signals are detected, as shown in Figure 2.

Test voltage/kV	Magnitude of partial discharge/pC		Ultrasonic positioning	
	before	after	before	after
412	450	60	Find obvious discharge signals on above 35 cm at the bottom of the device.	none
476	5600	60	Find obvious discharge signals on above 35 cm at the bottom of the device.	none

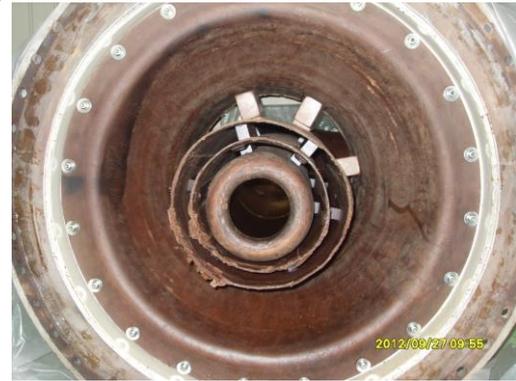
Figure 3: High voltage outlet device

Through the strip inspection in the transformer factory, in addition to the high voltage outlet device, other parts were not found abnormalities. The High voltage outlet device inspection found that the two support blocks of equalizing tube were shift that led to insulation cylinder deformation, as shown in Figure3. Corresponding corrugated plate to the black marks that is about 12 cm long and 5 cm wide. In addition, the corrugated plate surface had many black

stripes, however, support blocks had not been found discharge traces .

- Through the above analysis, the black mark of corrugated plate due to discharge of high voltage outlet device that insulation performance had seriously decline. Combined with the previous test, doubt that characteristics gas produced from high voltage outlet device. In order to further confirm whether the growth of characteristics gas caused by high voltage outlet device or not, replace high voltage outlet device and carry on comparative analysis of induction withstanding voltage test and partial discharge test.

High voltage outlet device to produce C_2H_2 , that is caused by the region insulated electric field distortion for a long time because of support blocks of high voltage outlet device were shift. It is understood that the company had switched the brake operation in August 2012, operating overvoltage caused by induced the equalizing tube discharge to corrugated plate, which burned the surface material of corrugated plate, and produced C_2H_2 in oil. When operating overvoltage was stopped, discharge also immediately stopped, and C_2H_2 content wasn't grow, however, due to the area of outlet had undertaken higher electric field for a long time, which further accelerated insulation aging.

Transformer replaced the high voltage outlet device (other parts not replaced) and the factory test are all qualified. Focus on the induction withstanding voltage test and partial discharge test. The data of partial discharge test before and after the replacement of high voltage outlet device were shown in table 3:
