Seismic response of a stock of social housings in Italy with R.C. and masonry materials.

Abstract. The paper is based on a survey activity on a subset of 48 buildings for social housings. The structural materials are R.C. and Masonry. They are representative of about 9000 social flats on the district of Leghorn (Italy), built from early '900 up to 1981, date of adoption of seismic norms. The subset is divided into 15 masonry structures and 33 r.c. frames. Two different methods are adopted to classify the stock from seismic point of view. The stock has been classified in terms of Iv (Vulnerability Index) through GNDT 2° level forms and PGA (Peak Ground Acceleration) from operation and collapse limit states (SLO and SLC), calculated by SAVE procedure. An example of classification, to establish priorities for further seismic investigations, is furnished. Main recurrent vulnerable details are highlighted, together with perspectives for more detailed seismic analysis.

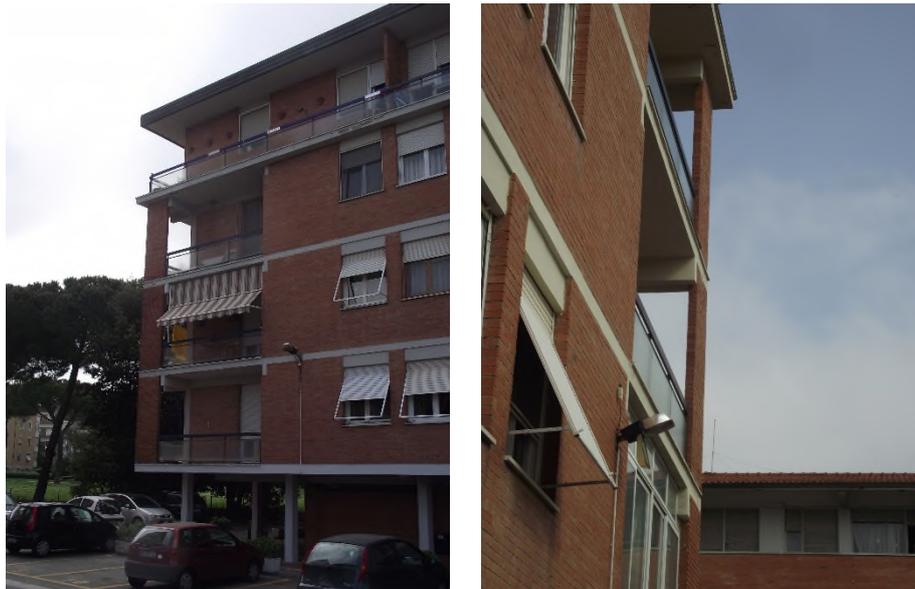
Both procedures do not cover some relevant aspect of the seismic protection, related to structural and non structural elements. A first significant cause of seismic risk is given by rocking collapses of masonry walls or analogous vertical components (Fig. 5). The phenomenon is relevant from seismic point of view [2-4], but it could be activated also by extreme climatic scenarios [5, 6]. It can be reduced by temporary preventive steel rods [7] and evaluating the density of energy dissipated [8]. Another factor of risk are the inefficient constructive joints (Fig. 5). The negative effect of mutual impacts along the joints could be avoided by introducing specific dissipative elements, i.e. RCW [9] on vertical surfaces, moreover acting favorable biaxial states of stress [10]. Another negative aspect of the examined stock is the presence of non loadbearing cavity walls infilling r.c. frames.

Figure 5. Example of vulnerable rocking walls.

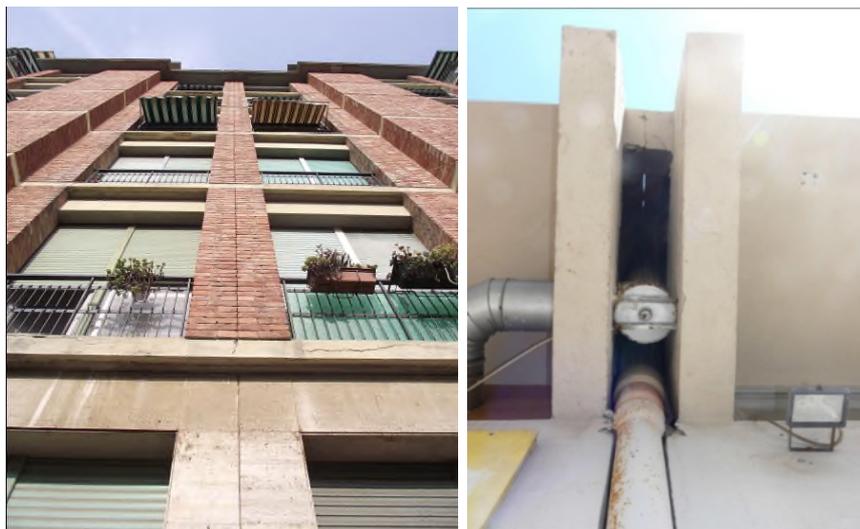
Fig. 6 Example of technical joints with inefficiency or improper use.

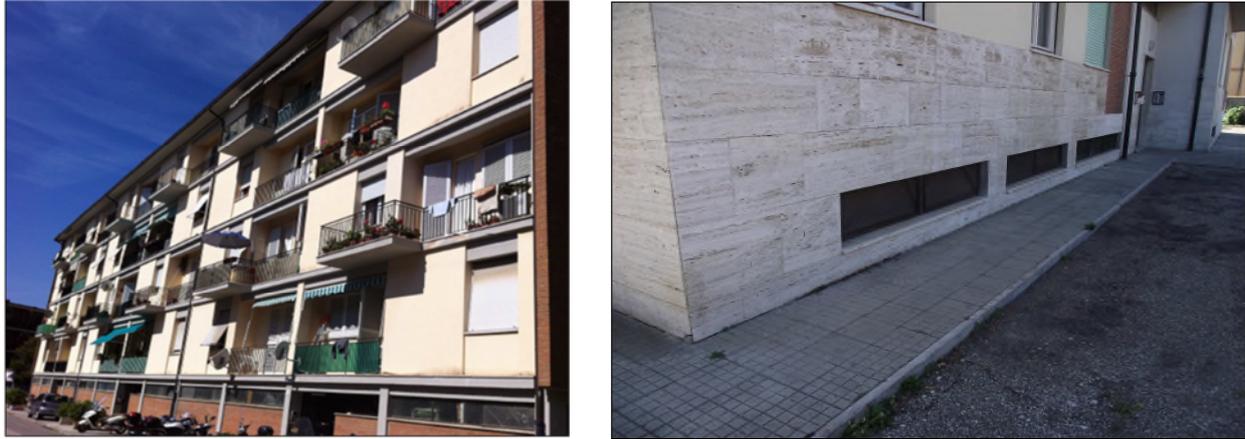
The replacement of the internal layers with lightweight and natural non loadbearing elements can join seismic protection with more sustainability, environmental friendly solutions and saving thermal energy [11]. The negative geometrical conditions of the ground level (Fig. 7), weakened by horizontal openings, hanging extremities of façades or undefended flexible columns are well known in literature and can be easily solved by external frameworks or shear walls [12-14].

Fig. 7 Openings on the ground floor causing brittle collapse.

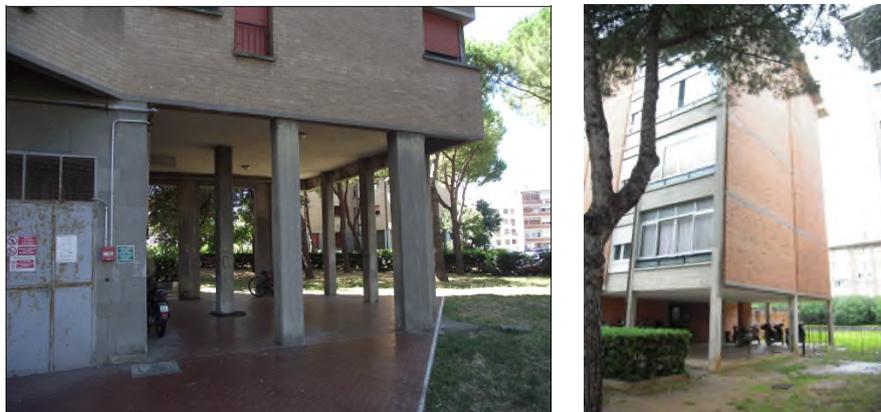
Fig. 8 Vulnerable extremities of façades and flexible ground floor.
