Crack Analysis of W6Mo5Cr4V2 Thread Rolling Roll

Keywords: W6Mo5Cr4V2; Thread rolling roll; Crack analysis

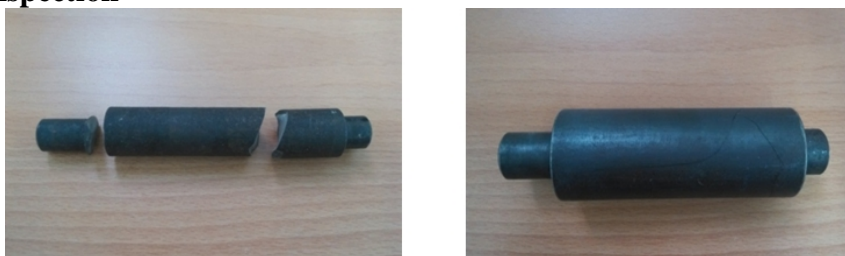
Fig.1 Appearance of the two samples

The $\Phi 23\text{mm}$ and $\Phi 40\text{mm}$ samples were named by S1 and S2 respectively. Fig.1 showed two failure samples. For the S1 it was broken into three parts caused by external stress, forming two matching

fracture. S2 cracked spread the whole roll, with random direction. There was no plastic deformation around the fracture and the crack. So all the cracks were typical brittle fracture.

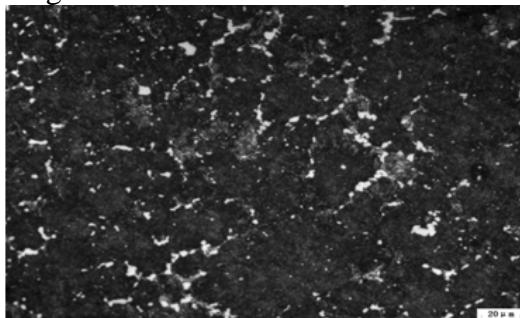
Both of the samples were composed of tempered martensite and carbides microstructure. Fig.2 and Fig.3 of the S1 sample could be clearly observed serious carbide network, angular carbide and other overheated structures. Fig.4 and Fig.5 of the S2 sample was shown the carbide had high dispersion degree, and some carbide networks were be found in the partial area caused of overheating.

Fig.2 Microstructure of S1 (50X)

According to metallographic examination, the microstructure of the two samples were tempered martensite plus carbides. However, partially there are serious carbide network, angular carbide and other eutectic structure caused by overheated. Therefore, it can be concluded that there is a case of overheating during the heat treatment process. Crack formed under the action of thermal stress, W6Mo5Cr4V2 thread rolling rolls finally result in brittle fracture. They extend under the action of thermal stress and finally. S1 broken into three parts caused by external stress.

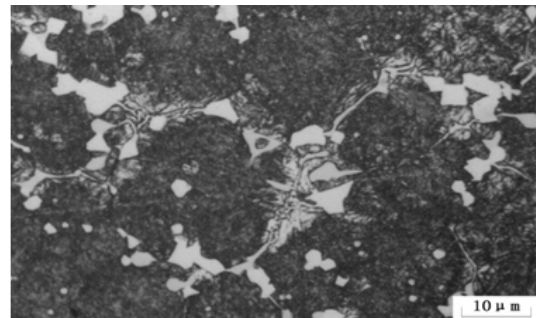
Fig.3 Microstructure of S1 (100X)

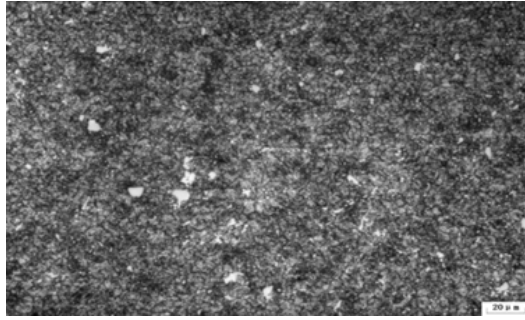
Fig.4 Microstructure of S2 (50X)

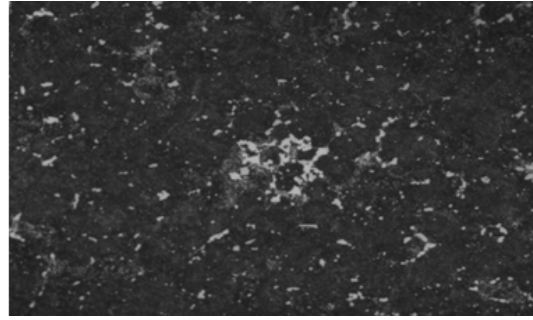
Fig.5 Microstructure of S2 (100X)

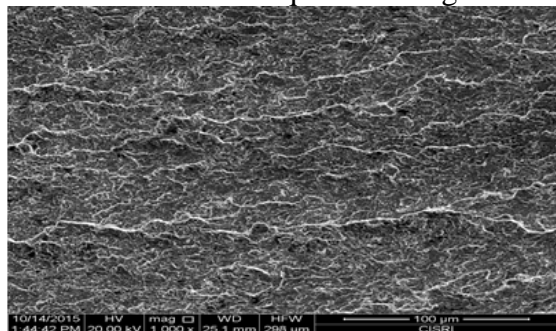
Scanning electron microscopy (SEM) analysis was carried out on the fracture surface of S1 and S2, as shown in Fig.6 and Fig.7. According to the microscopic fracture analysis, we could see the fracture characteristics were quasi-cleavage-like fracture characteristic.

Fig.6 SEM of S1 fracture surface

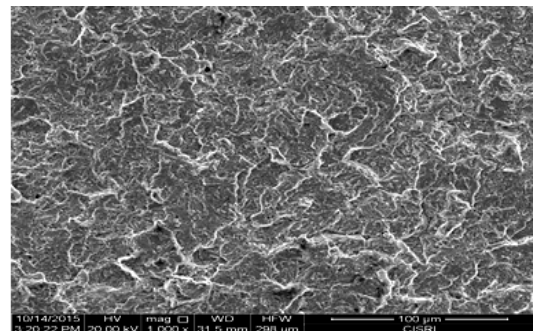
Fig.7 SEM of S2 fracture surface

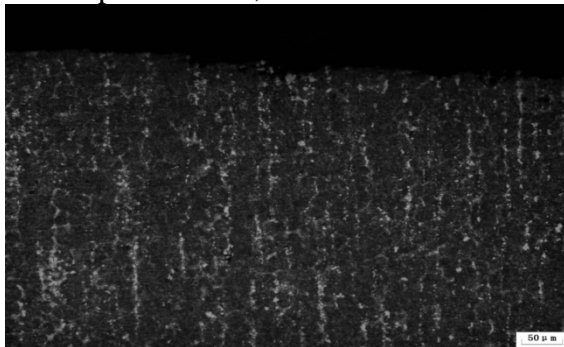
Taking the fracture adjacent areas of S1 and S2 to do the metallographic structure observation, as shown in fig.8 and fig.9. The results showed that both fracture section organization were tempered martensite plus carbide, the same with the matrix, and no other abnormal defects were found.

Fig.8 Microstructure of S1 fracture surface(20X)

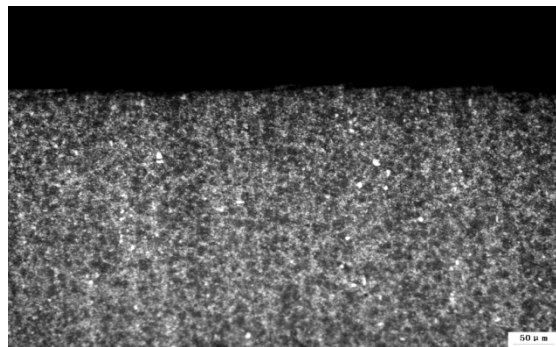
Fig.9 Microstructure of S2 fracture surface (20X)

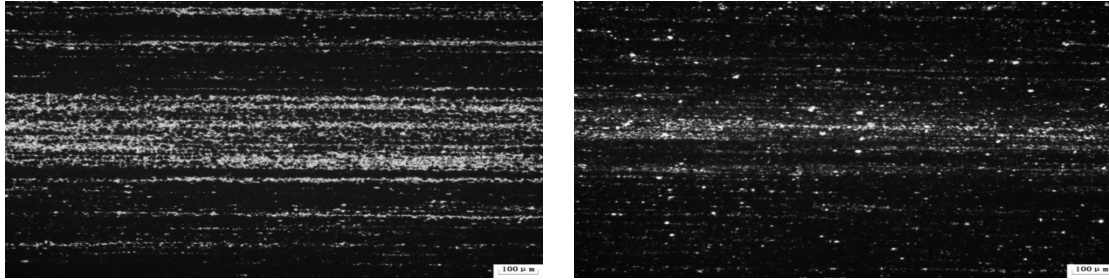
According to GB/T 14979-1994, the longitudinal section of the S1 and S2 samples were taken to evaluate the inhomogeneity of carbide. Carbide analysis results were shown in table 3, Fig. 10 and Fig.11. Carbide inhomogeneity of the two samples did not meet the requirement of GB/T 9943-9943, and the carbide inhomogeneity level was higher than 3 grade.

Fig.10 Inhomogeneity of carbides of S1 (10X) Fig.11 Inhomogeneity of carbides of S2 (10X)

The results of carbide inhomogeneity analysis shows that carbide inhomogeneity of two W6Mo5Cr4V2 thread rolling rolls are not meet the standard. So it can be concluded that melting process quality is poor.
