## Failure Analysis of the Screw Connection Rod of A Hoisting Machine

**Abstract.** The screw connecting rod of a hoisting machine suddenly breaks during the service at temperatures below 20 °C. In this article, the fracture surface, material, heat treatment process and mechanical properties of the connecting rod are analyzed. We find the low temperature brittle fracture of the screw is mainly caused by too large unbalanced load due to improper operation. The incorrect heat treatment process of the screw is one of the reasons for its fracture.

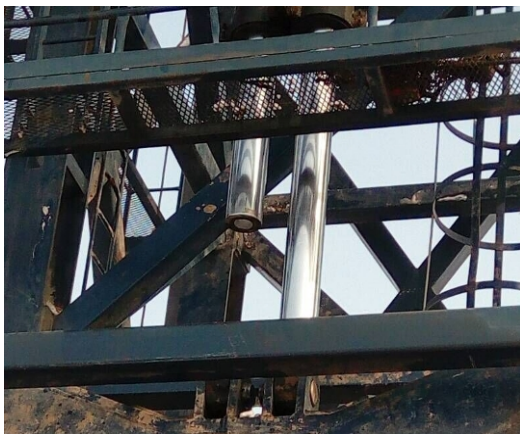
Fig 1. The connecting rod of the hoisting machine

**Fracture failure analysis of connector.** The connecting rod of the hoisting machine was shown in Fig 1. Macro morphology of fracture of the connecting rod was shown in Fig 2. We will make a preliminary analysis of the reasons for the fracture of the connecting rod by analyzing the feature surface.

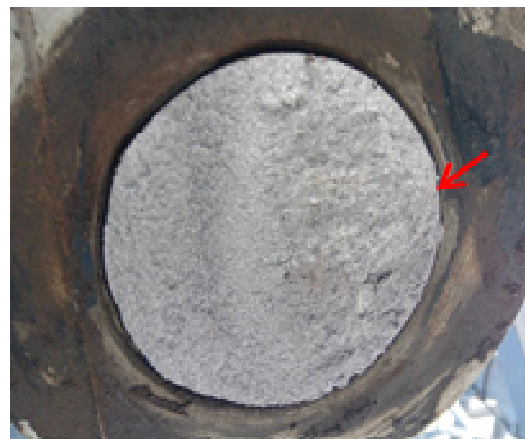
Fig 2. Fracture of the connecting rod

**Analysis of fracture surface of the connecting rod.** According to Fig 2, the whole fracture was fresh and bright, and no rusty spots were found. This shows that the whole section is a new fracture. There is no old crack, which precludes the possibility of crack defects before the fracture of the connecting rod. At the same time, no shell like fatigue crack pattern was found to eliminate the possibility of fatigue fracture.

According to the radial pattern on the left side of the fracture, we determine the position of the crack source in the arrow as shown in Fig 2. Through further observation of the fracture characteristics of the sample, it is found that there are small, bright and clean cleavage cross section, and the cross section shrinkage is less than 5%, which shows that the material is brittle cleavage fracture. Cleavage fracture is a transgranular fracture of a metallic material at a very rapid rate along a certain crystallographic plane when the normal stress of the external force reaches a certain value. The cleavage plane is generally the lowest index or the lowest surface energy. Generally, cleavage fracture is always brittle fracture, but brittle fracture is not necessarily cleavage fracture. Cleavage fracture is a typical brittle fracture. Although it is brittle fracture, there is also a crack initiation and propagation process before fracture. Cleavage fracture is a kind of low energy fracture, and the size of stress and size of grain affect cleavage fracture[1-4].

In addition, when the material is brittle under uniaxial tension or compressive stress, the cross section should be in the 45 degree angle to the axial tension and compression stress. However, the fracture of the screw joint is relatively flat, and the angle is 90 degrees into the axial direction. From Fig 2, it is known that the fracture source is at the edge of the screw joint rather than the center of the screw. From this we can infer that the screw is subjected to greater bending stress during the operation of the hoist, which results in overload. The material breaks from the maximum tensile stress at the outside of the rod under the bending stress state, and then occurs at a very rapid rate of cleavage propagation fracture, forming a radial crack propagation texture.

In a word, the low temperature brittle fracture of the screw is mainly caused by too large unbalanced load due to improper operation. The incorrect heat treatment process of the screw is one of the reasons for its fracture. It is suggested to strengthen the operation management of crane construction and strictly prohibit illegal operation.

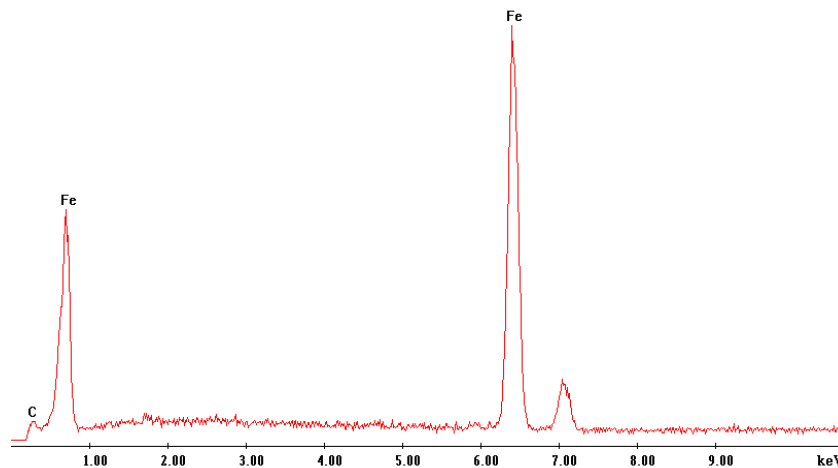
Fig 3. Sample alloy element energy spectrum

**Material analysis.** Scanning electron microscopy (SEM) was used to observe the metallographic spectrum of the samples. The results of SEM were shown in Fig 3. No other alloy elements are found in the sample except Fe and C elements shown in Fig 3, indicating that the joint is carbon steel. Carbon and sulfur analysis showed that carbon content (mass fraction) was 0.456% and sulfur content was 0.011%. Therefore, the material used for determining the connecting piece is ordinary carbon 45 steel, and the impurity element content is normal.

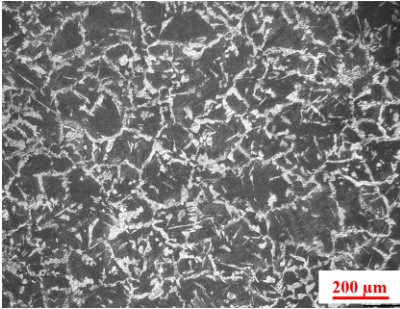
Fig 4. Metallographic structure of sample

**Analysis of heat treatment process for materials.** Sampling is carried out on the connecting rod, followed by sanding, polishing, and etching. As shown in Fig 4, we found that the microstructure of the specimen is coarse Widmanstatten structure. The grain size in the sample is about 100-300 microns and the grain size is 0-2. The grain of the connecting material is too large and the microstructure is poor, so the steel used for connecting parts may not be normalized and quenched and tempered. So far, the formation mechanism of Widmanstatten structure has not yet reached full consensus, but the research work has been to continue[5-6]. The Widmanstatten structure is a kind of overheating defect structure steels, which reduces the ductile brittle transition temperature of the steel,

so fragile in the use of low temperature environment will be greatly enhanced. Experimental results show that the coarse austenite grain is more easy to produce Widmanstatten structure and fine austenite grain is not easy to produce Widmanstatten structure[7-9].

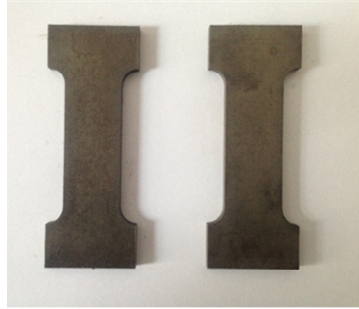
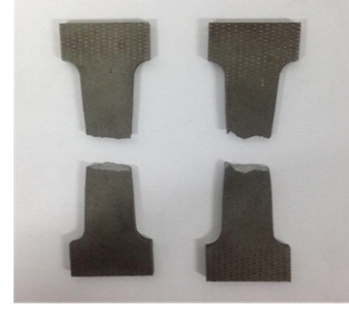
**Mechanical properties of materials.** Axial tensile tests of two specimens were carried out at 10 °C. The sample is stretched before and after drawing as shown in Fig 5, Fig 6. It is found that the fracture of the joint material is grey and dark at the 10 °C static tensile condition, and there is obvious necking at the fracture. It shows a plastic fracture feature. But it should be pointed out that one of the two specimens has the characteristic of brittle fracture, so it is brittle.

Fig 5. Sample before tension

Fig 6. Sample after tension

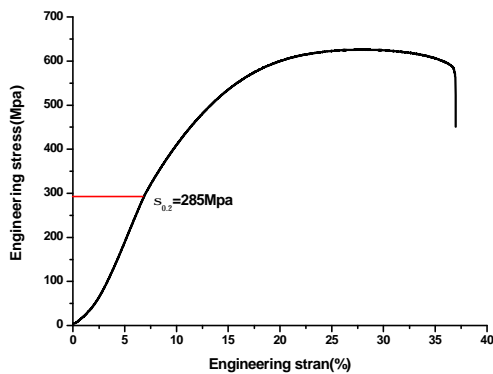
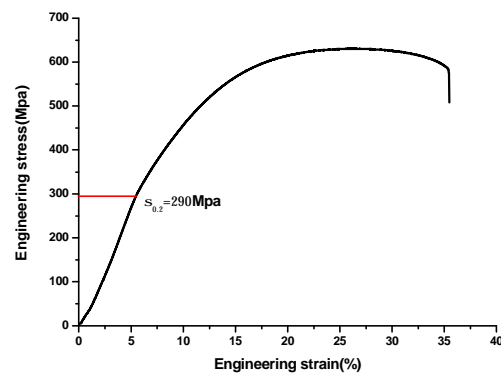
Fig 7. Tensile curves of sample A

Fig 8. Tensile curves of sample B

The stress and strain curves of the two specimens have no obvious yielding platform as shown in Fig 7, Fig 8. According to the GB/T 699-2015 standard[10], the yield strength is determined by  $\sigma_{0.2}$ . The mechanical properties of the two specimens are shown in Tab 1.

According to the GB/T 699-2015 standard, the basic mechanical properties of 45 steel should satisfy: tensile strength is more than 600MPa, the yield strength is above 355MPa, the elongation is more than 16%, more than 40% section shrinkage and delivery hardness more than 229HB. It is found that the fracture connection, the screw yield strength, the cross section shrinkage and hardness are all lower by comparison. The main reason is that the heat treatment is not correct. The microstructure of the specimen is coarse Widmanstatten. which results in low number of its mechanical properties. The screw parts are not one of the important factors to produce brittle fracture at low temperature without proper heat treatment.
