Failure Analysis on Input Gear of a Gearbox

Abstract. A tooth of the input helical gear of an intermediate gearbox in a helicopter fractured during testing. In order to find out the failure mode and cause, macro and micro observation, hardness and carburized depth testing, microstructure examination, surface roughness and round angle testing were carried out. The results show that the failure mode of the gear is fatigue failure. The crack initiated from the round angle of the tooth root at the working-face side. The round angle radius is smaller than the required value, leading to the increase of stress concentration, which is the main cause for the fatigue fracture of the tooth. The machining process of the round angles should be concisely controlled so that such failure can be avoided.

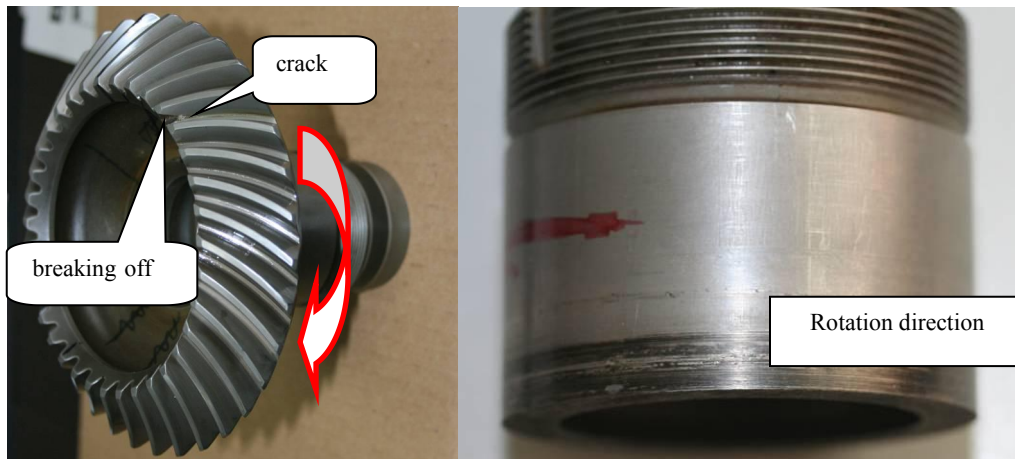
The appearance of the failed gear is shown in Fig.1. A crack with the length of about 50mm was found at the round angle of a tooth root, and near the small end, a block had broken off. Obvious circumferential wear trace can be seen at the axle journal, and the wear trace is near assembly region between bearing and axle journal, as shown in Fig.2. Because the fit between bearing and axle journal is interference fit, it can be inferred that the circumferential wear trace resulted from inching wear. The macro appearance of the crack fracture surface is shown in Fig.3. The crack initiated from the working face at the round angle. The source is a small linear source. The macro appearance of the breaking-off block is shown in Fig.4. The source is a big linear source.

Fig.1 Macro appearance of the failed gear

Fig.2 Macro appearance of the fractured tooth

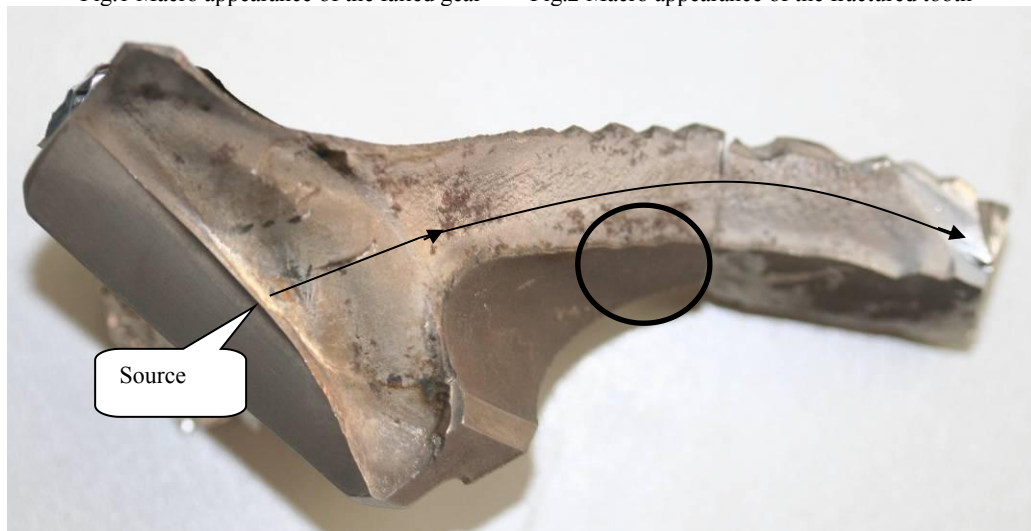
Fig.3 Macro appearance of fracture surface of the round-angle crack

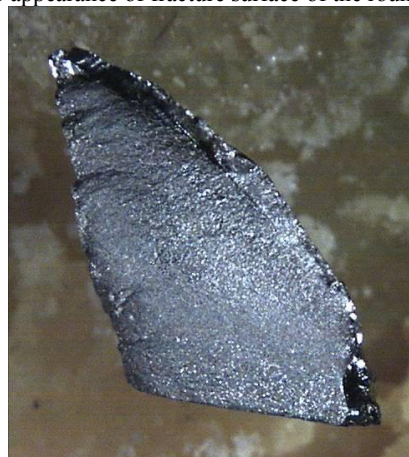
Fig. 4 Macro appearance of fracture surface of break-off block

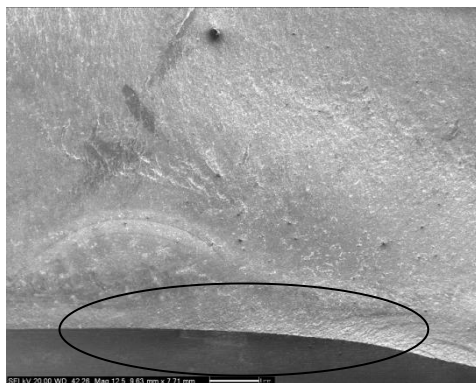
The low-magnification appearance of the source region of the crack fracture surface is shown in Fig.5. The source is at a small line source and there are no obvious metallurgical defects at the source region. Machining trace can be found at the lateral face near the source, shown in Fig.6. The depth of the machining trace is about $1.5\mu\text{m}$ and the width is about $4.0\mu\text{m}$. Fatigue striations can be seen at the propagation region, shown in Fig.7. The man-made fracture region presents the characteristic of dimples, shown in Fig.8.

Fig.5 Low-magnification appearance of the source region of the crack fracture surface

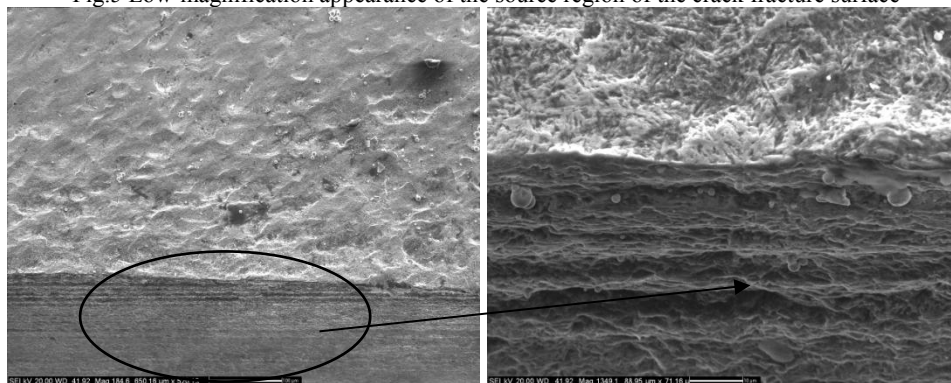
Fig.6 Machining trace near the source

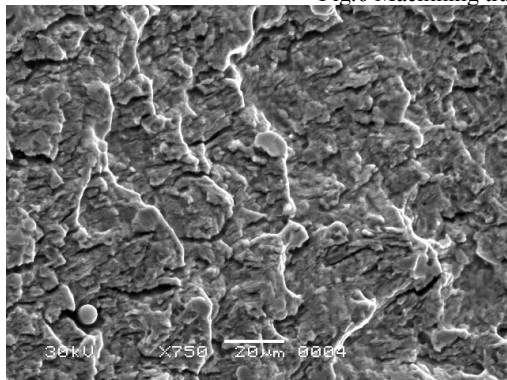
Fig.7 Fatigue striations at the propagation region

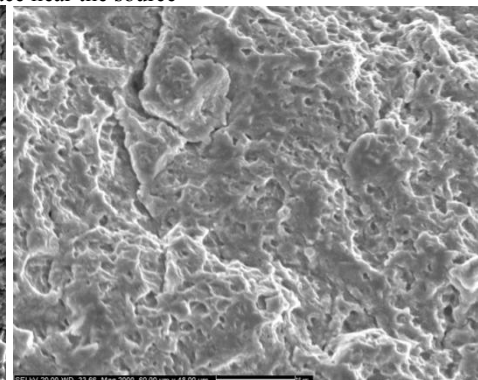
Fig.8 Dimples at the man-made fracture region

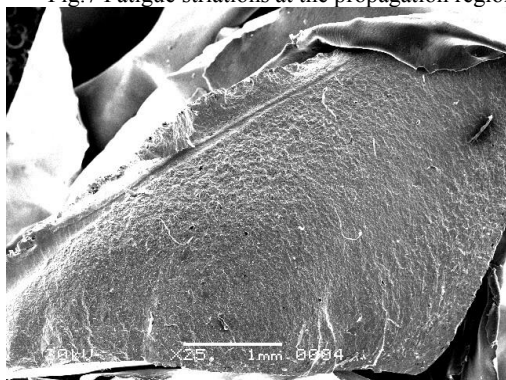
The black regions at the working face of other teeth present shelling-off feature due to serious wear, shown in Fig.9. EDS analysis results show that the oxygen content of these regions is about 4.7%. At the working face near the top and at the top of some teeth, parallel wear trace can be seen, shown in

Fig.9 Low-magnification appearance of fracture surface of the breaking-off block

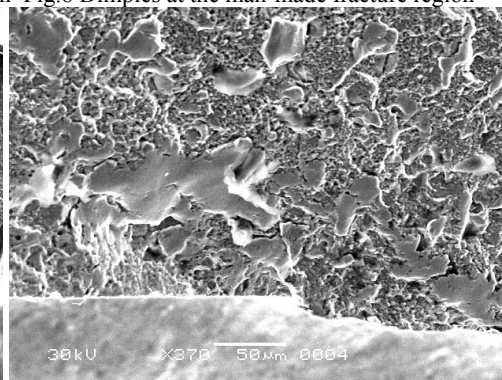
Fig.10. During normal service, the top of the teeth of the output gear wouldn't be in contact with the bottom of the teeth of input gear. According to the parallel wear trace at the top of teeth, it can be assumed that axial float had happened to the gear. The parallel wear trace is shallow, short, and parallel, so it can be assumed that they formed a short time ago. Namely, they occurred after the tooth fractured. The direction of the working face wear trace of the teeth is the same as that of the top wear of the teeth, so it can also be assumed that they are also related to the axial float.

Fig.10 High-magnification appearance of the source

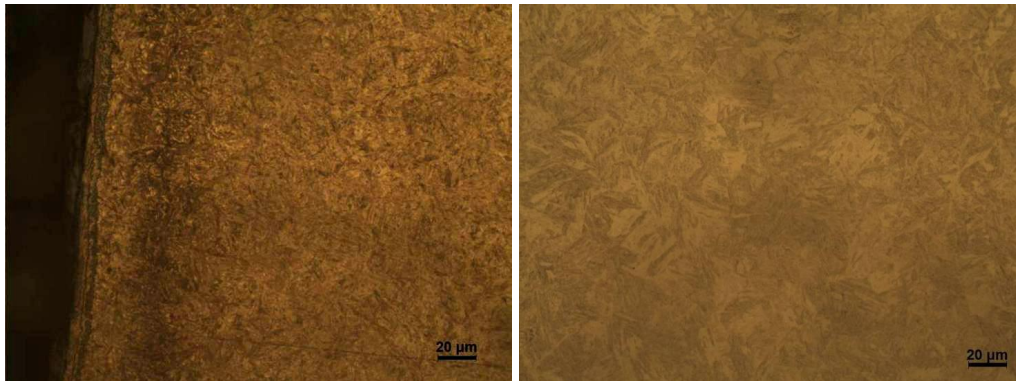
Metallographic specimens perpendicular to the burn tooth face were cut down from the teeth near the fractured tooth. A burn surface layer can be seen, composed of sorbite(Fig.11). The core region is composed of lath-shaped martensite and residual austenite, shown in Fig.12. And there are only a small number of inclusions in the matrix, shown in Fig. 13.

Fig.11 High-magnification burn structure near the surface Fig.12 Microstructure of core region of gear tooth

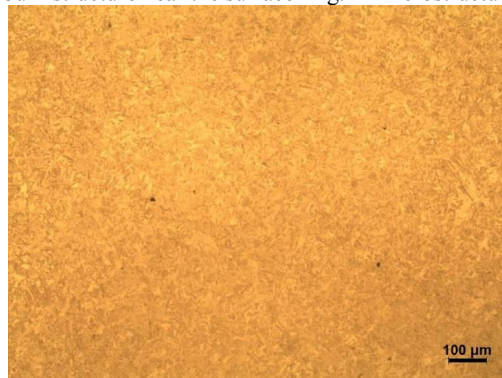
Fig.13 Inclusions in gear tooth
