A Fault Finding Analysis of Transformer Internal Defects

Keywords: transformer, lead wire diversion, Insulation oil, chromatographic analysis

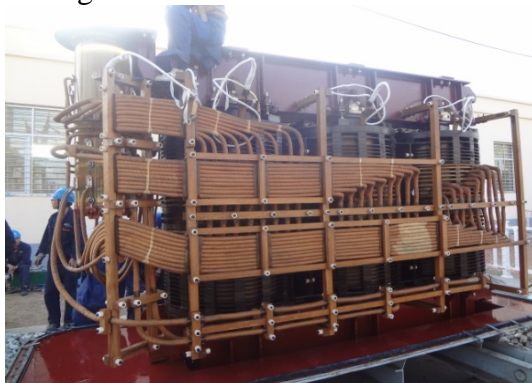
Fig.1

The core inspection was performed on the transformer after confirming the fault location. C phase lead cable of the transformer high-voltage side was found to have obvious signs of overheating and discharge due to contact with the root of the inner wall of the copper pipe of the high voltage casing, external insulation damage, and partial exposed wires. This is consistent with the results of our previous trial judgments. This is the lead wire diversion fault that is the closed loop formed at the contact point between the inner wall of the copper pipe of the casing and the lead cable, and generates heat and discharge when the load current flows. The actual scene is shown in figure 1 and figure 2.
