The Rectification Measures on High Fault of 10kV High Voltage Isolation Switch

Keywords: high voltage isolating switch, failure rate, wiring terminal, pile head

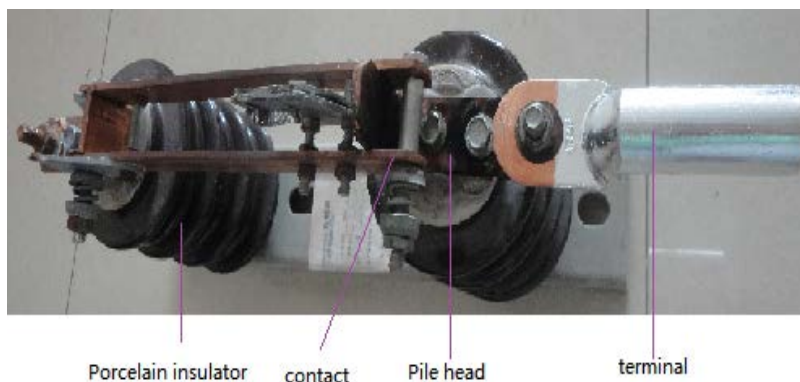
Fig.1. Part name of the isolating switch.

Analysis results: From table 4, during 110 times line tripping caused by the failures of isolating switch in 2017, "the damaged pile head " and "the damaged terminal" is 84 times, that is 76.3% of the total tripping rate, it is the main reason to influence high failure rate of 10kV high voltage isolating switch.

Terminals and pile head interface pressure is small, it is not for examination and using excessive copper and aluminum terminals and terminal blocks have not reached the national standard, screw isn't tighten, environment and humidity exceed certain limits. The assembly point isn't mastered, the load current is large, terminal and pile head contact area is small, and size is small. Therefore, there are reformed main problems: 1. The effective contact area between the terminals and pile tip is small; 2. The contact surface pressure between terminal and pile is small.

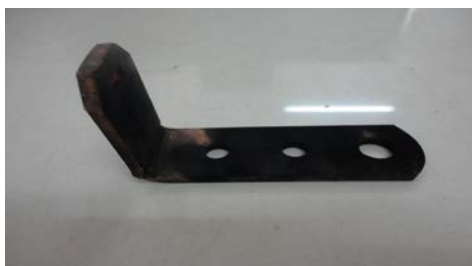
Fig.2. The terminal before improvement

3.1 The Effective Contact Area Between the Terminals and Pile Tip is Small

In order to increase the effective contact area between the isolation switch and the terminal, according to the field measurement of the isolation switch, the pile head should be extended to 83mm, 46 mm width and 5 mm thick. According to the design process, it is shown in figure.2 and figure.3.
