Analysis of Large-area Blackouts Caused by Errors in Rainfall Bombs

1. Dandong Power Supply Company, Liaoning Electric Power Company Limited, State Grid, China

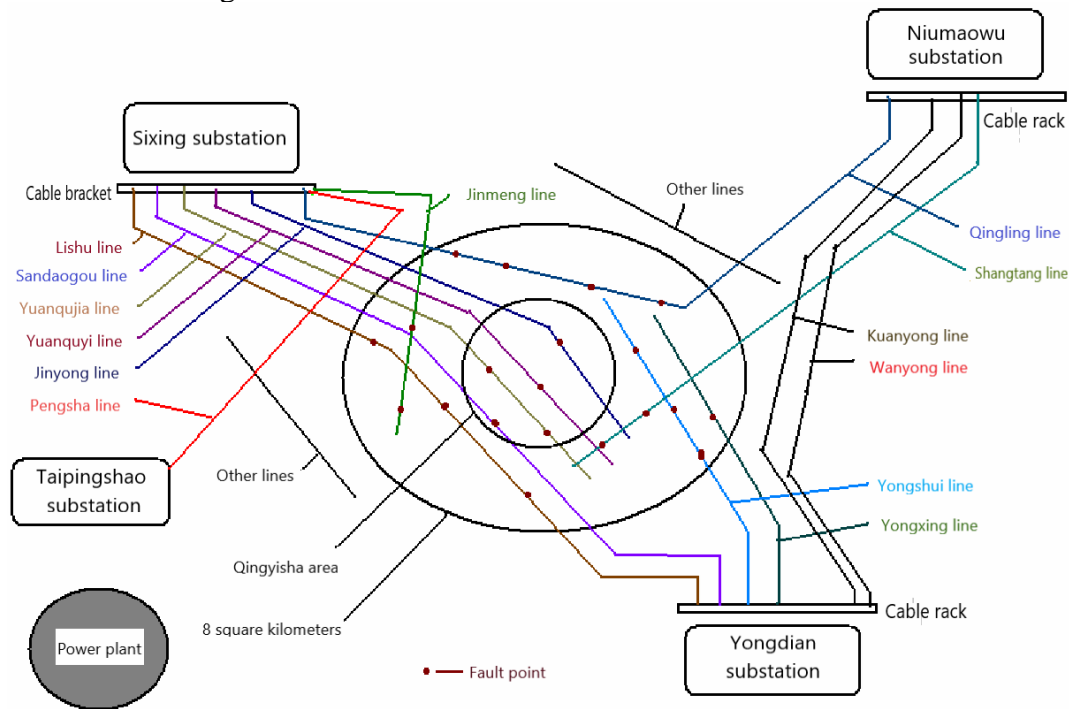
Fig. 1. Image map of accident area

switch, isolation switch and so on is the reduction of surface insulation resistance, most of the drop switch fixed iron hoops are burned, the circuit breaker falls off directly (there are three things like this), the failure of lead wire (the main line leads are 240 square millimeter insulation lines) is mostly caused by two phase or three phase collapse or interruption, wire and upper rod head or transverse load disruptive discharge. And the scope of the accident is spread around the Qingyishan area. After statistics, 10 lines and 34 fault points are concentrated in the area of 8 square kilometers. The figure is shown in Figure 1

It can be clearly seen from Figure 1 that the failure point of the accident is very concentrated and has never happened before. It is difficult to determine the cause of the accident for a time. Usually, there are 3 main reasons for large area blackout accident.

4.2.1. The insulation of the equipment is aging. In Figure 1. Multiple lines with regional concentration and different conditions, multiple points, and multiple equipment had similar faults at the same time, while the proximate Kuanyong line and Pengsha line which were more old and old could run safely, proving that the insulation aging was not caused by the internal insulation of the equipment.

4.2.2. Overvoltage has occurred. There was no thunder on that day, and lightning overvoltage could be excluded. If it was caused by resonance or overvoltage, it should be a single circuit or associated circuit. It could be clearly seen from Figure 1 that there was no correlation between fault lines and no lightning arrester was damaged, so it was not caused by overvoltage.
