Analysis on A Case of Marine Hydraulic Steering Gear Failure

Abstract: The hydraulic steering gear is an important equipment of the ship and its failure could contribute to navigation unsafely. With regard to the failure of a certain hydraulic steering gear and inspection of the steering mechanism, this article specifies reasons for the failure of the steering gear and puts forward methods including control to the design, selection and manufacture and enhancement to the watch-keeping and ship-repairing so that the similar accidents could be avoided. In this case, the analysis and treatment to the failure of the marine hydraulic steering gear could result in the prevention and elimination to the failure.

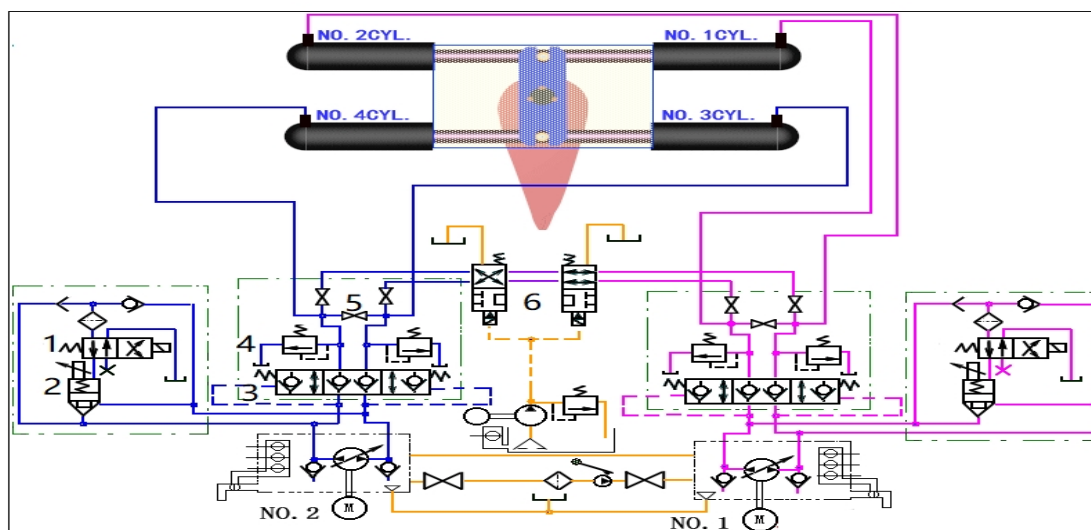
Fig.1 Hydraulic System of Steering Gear

According to the above analysis of the hydraulic system, the reasons why the steering gear cannot rotate effectively may be as follows:

(1) Unloading valve fails and logic valve 2 still opens so that hydraulic oil flows directly back to the tank instead of to the working cylinder.

(2) Storm valve still opens which results in hydraulic fluid flows back to the tank. In that case, the oil pressure is insufficient to drive the steering mechanism.

(3) Failure of the main or auxiliary oil pump results in insufficient oil pressure to drive the steering gear.

(4) Leakage of the cylinder is seriously so that the oil pressure could not be built up.

With regard to the above analysis, the chief engineer checks the working conditions of the steering gear hydraulic system in the steering gear room after the failure. He finds that the hydraulic system functions normally and the steering gear operates normally as well. As a result, electrical faults and hydraulic system failures can be eliminated, and the underwater part of the steering mechanism should be taken into account.

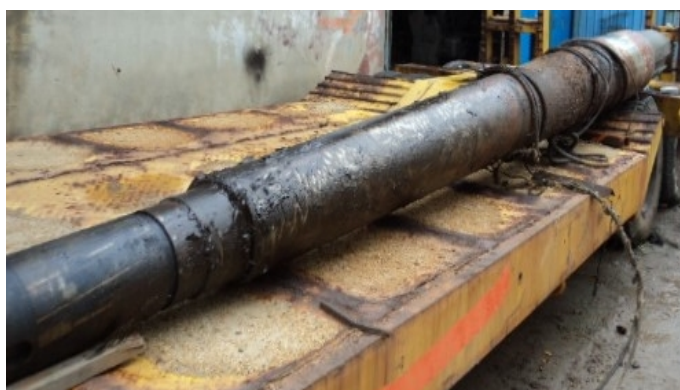
Fig. 2 Rudder Stock

(1) Inspection to the rudder stock: The length overall of the rudder stock is 5925mm, diameter 430mm, and the surface is in good condition. There is no wear, strain or deformation. The keyway is approximately normal, which is shown in Figure 2.

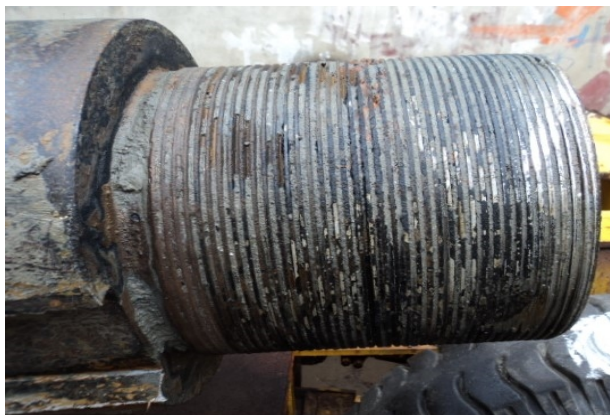
Fig.3 Rudder Stock Screw

(2) Inspection to the fixed parts of the rudder stock: The tightening nut on the rudder blade is M260*6 and the height is 210mm. No tightening nut is found during the inspection; the crest of the screw part of the rudder stock is damaged, and the bottom of the rudder stock is flat. As shown in Figure 3 and Figure 4.

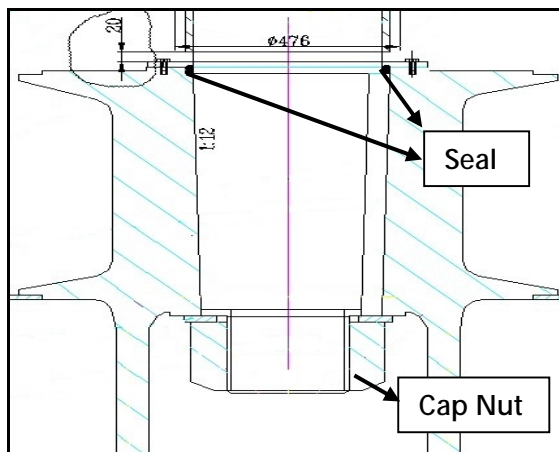
Fig.6 Sealing and Tightening of Rudder Blade

In accordance with referring to the drawings of the rudder blade, it is found that no interlock device fitted between the blade and the tightening nut of the stock. Only one $\phi 440 \times \phi 270 \times 16 \text{mm}$

shim made from No. 35 steel is shown in the design drawing. If there is a problem with the gasket, the pre-tightening force of the rudder stock nut may be insufficient and loose consequently. As a result of its own weight, relative motion could happen among the rudder post, blade and the nut (Figure 6).

According to the investigation to the corrosion on the cone surface of the rudder blade as well as drawings and analysis to the repair during special survey, we could suspect that leakage into the lower chamber along the keyway and “trachoma” which is caused by the bad sealing effect between rudder stock and rudder blade (sealing device shown in Figure 6) or inferior sealing quality of the cover plate during welding operation. Both of rudder stocks and gaskets are made of 35 steel and the hardness is HB150~185. Once leaked into the seawater, the gasket will be corroded firstly. As the shim continues to corrode, the pre-tightening force of the rudder stock nut decreases; meanwhile, the break of rudder stock nut and threads also corrode to different extent. Because the nut safety device is welded on the rudder blade leading to the breaking effect of the rudder nut safety device reduced, the nut is subject to great variable friction as the rudder blade rotates to port side and starboard side. When the rudder blade rotates to port side, the rudder stock nut is forced to disengage and the rudder stock nut cannot be tightened when rotating to the starboard side, so the lock nut loosens gradually. When the rudder stock lock nut is retracted to a certain position, the nut is damaged instantaneously by 7 to 8 tons gravity force of rudder blade, resulting in drooping-off of the rudder blade. In a word, the cause leading to loss of the rudder blade is more complex and involves various aspects: the rudder stock nut is lack of breaking device at the design stage; sealing effect of the unit deteriorates or welding quality of the cover plate is inferior; meanwhile, seawater may flow into the nut chamber to lead to corrosion as this part is below the waterline permanently, so the pre-tightening force of the nut could decrease. As various factors exist together, the nut loses fastening effect correspondingly, which is the main cause of this incident.

(1) During the process of design, site selection and manufacturing, the steering gear should be paid attention thoroughly by professional and technical personnel. The fix between nut and gasket should be thickened, and the nut breaking device be fitted as well. Meanwhile, the installed rudder blade should be tested for defection or sealing if applicable.
