Force loading of wagon during interaction of truck and bodywork in curves paths

Abstract— This article examines the reasons for gatherings of mountain areas; the relationship of malfunctions of the technical systems of the wagon; proposals for the detection and elimination of the causes of their formation

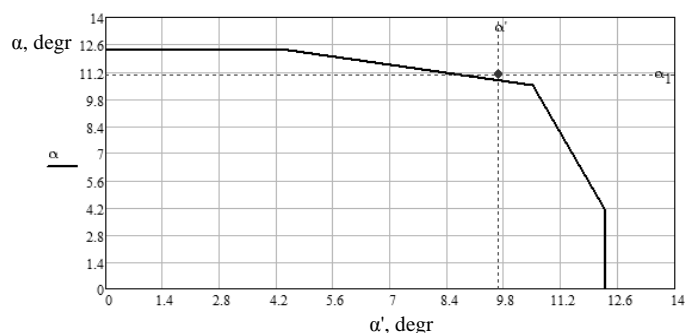
Fig. 6. The position of the point of the passage linking cars with a gathering on a stretch of Kedrovaya-Tankhoy

If the point lies within the circuit, passage of wagons on the curved sections is provided [8]. If the outline of the point is the need to adjust the calculation, let us checkup serviceability of the coupler casing and stop UP1.

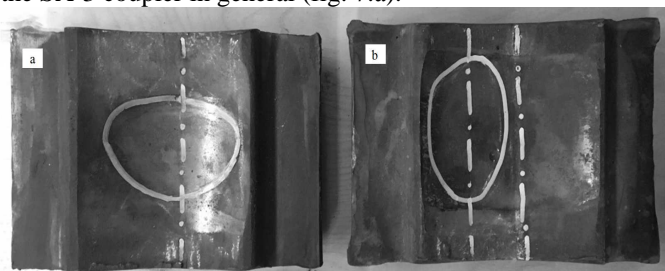
Mirroring the stain from the contact surfaces on the radial thrust plate must be arranged strictly according to the axis of symmetry. Such coupling surfaces confirm proper operation of the SA-3 coupler in general (fig. 7.a).

Fig. 7. Contact patches on a hard plate: (a) symmetrical; (b) with the shift to the left

If the contact patch on the hard plate has an offset from the axis of symmetry (right-left, fig. 7.b), one must check for smooth rotation between corps SA-3 shock window outlets (as far as it will go in vertical facets window UP1) (fig.8).

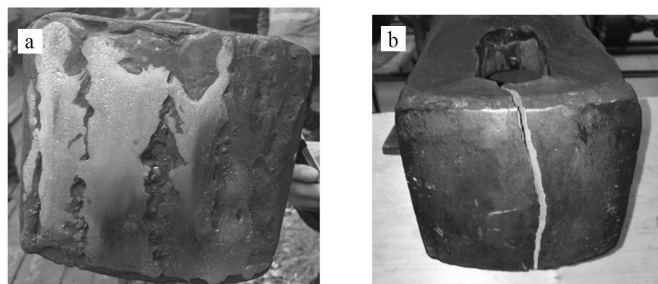
It is possible that the contact surfaces (R150 and R130) become nonoperative and have defects that restrict the mobility of the coupling in the horizontal plane (poor surface condition after repair of the shank).

Fig. 9. Coupler shank: (a) shank coupler housings with vanishing; (b) shank, renovation

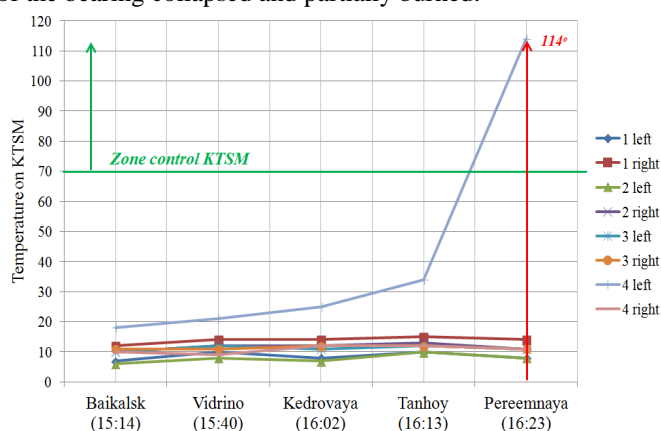
During the movement of the left wheel comes with dual temperature increases throughout the route, and the temperature rise during the last minutes of the 15-20 movement, going on to surge of 114 degrees and complete axle by jamming the site. Inspection showed that the inner ring of the bearing collapsed and partially burned.

Fig. 12. Temperature rise in the axle box

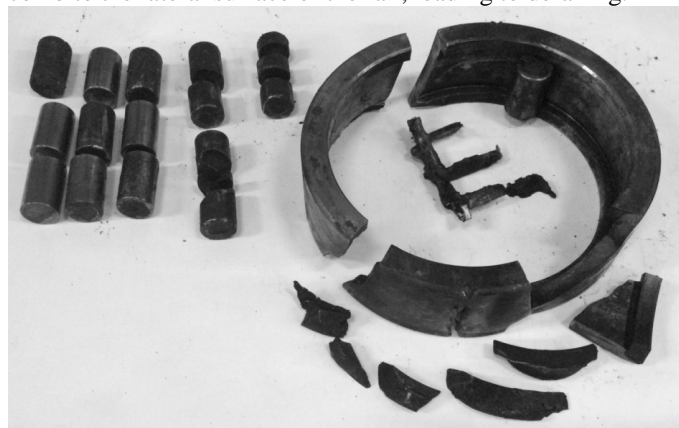
Cracks, ruptures of internal and external rings appear mostly in operation when the wagon is operated primarily on difficult sections of mountainous terrains (fig.12).

Causes of appearance defects and destruction in the axle-box may be: lozengeing of bogie side frames (18-100 to 30 mm), the crooked wheel pair axle;

- offset to another (UP1) in the extreme corner position of shell shank SA-3 on the hard plate (up to 13° to the right or left);

- distortions of a series of rollers in the front and rear, radial bearings due to the fact that the axis of symmetry of wheel pair "aims to" take some angular deviation;

Fig. 13. Elements of a destroyed bearing
