## Research on the Fire Evidence Identification Method of Electric Water Heater

**Abstract.** With the presentation of a fire accident caused by the improper use of electric water heater, this paper introduces how to use the metallographic method to judge the state of the electric water heater before the fire broke out. This method is simple, reliable and efficient, which can not only help fire investigators improve the accuracy of the fire cause identification, but also provide the necessary help and support.

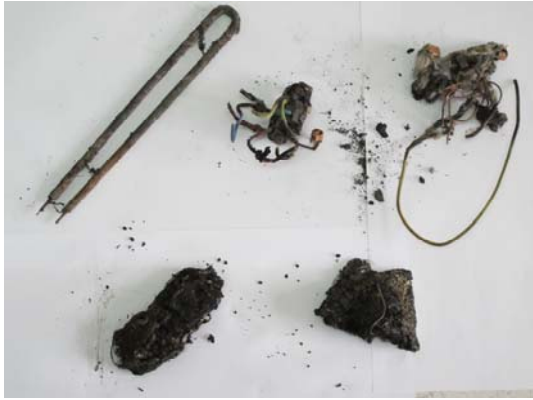
Figure 3. Appearance of fire scene residues

Because there were apparent location features of traces in fire scene, so after fire site ascertained, the evidence exacted contained debris of electric heating pipe, the cord of power plug seat and debris of plug seat, as shown in Figure 3. By inspection, there are no metal melted traces for technical identification on all evidence extracted. By means of dismantling, the heating wire in casing maintains integrity, no fusing, which brings great difficulties to the identification of fire cause.

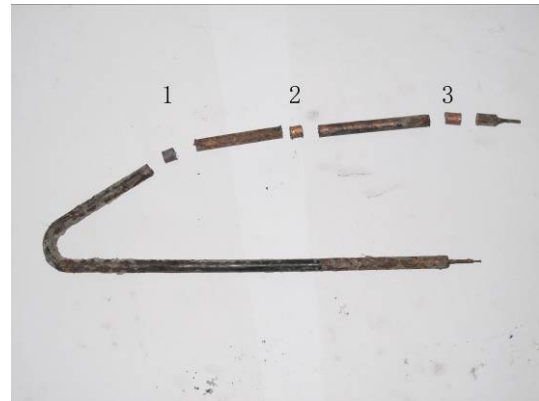
Figure 4. Sampling on the different positions of the electric water heater casing

In order to validate whether the electric water heater was in power-up state, the different positions of casing of the electric water heater were selected for metallographic analysis, specific selected positions were shown in Figure 4. Position 1 located in lower of the heating casing, which had heating wire inside; position 2 was in the center of heating casing with heating wire as well; position 3 was in the bottom of the heating casing, there was the terminal inside, and no heating wire.

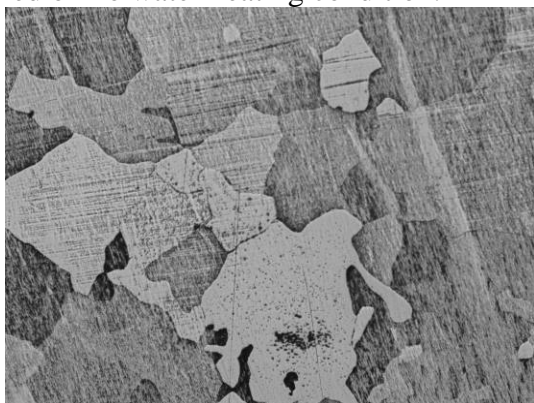
Figure 5 Microstructure of traces in position 1 and 2

In the same magnification of metallurgical microscope, the significant differences are observed between the organization characteristics of traces in position 3 and the organizational characteristics of traces in position 1, 2. More specifically, the microstructures of traces in position 1, 2 present huge, massive equiaxial crystals, as shown in Figure 5, and 6, and have no obvious difference, which can be used to confirm that the temperatures are basically same in position 1 and position 2 when the fire broke out, while the microstructures of traces in position 3 traces is small, density fragment crystals, shown in Figure 7. According to differences, it could be identified that the temperature in position 1 and 2 is higher than position 3 when the fire occurred, which was caused by the electric water heater worked on no water heating condition.

Under the circumstance of overheating, because of the water in the thermos burned dry, the electric water heater losses the heat exchange environment, which induces the temperature to continue to rise due to the heat power generated by the heating wire is not easy to diffuse. Within 1min to 2min, the casing reaches to the highest temperature, about 750 °C, it is easy to roast combustible materials, cause a fire. Since the melting point of steel is 1430°C, while the fire scene temperature is generally 900°C~1200°C, the casing of electric water heater will not melt. However, the grain growth rate of the internal microstructure formed by different heat before the fire happened between the terminal position without heating wire (i.e. position 3) and the position with heating wire (i.e. position 1 and position 2) will be distinctly differences. Thus, when outside fire impacts on the casing again, the microstructures of selected positions will appear significant differences.
