Failure Analysis and Detection Technology Research of Hub Bolts of Aircraft Main Wheel

Abstract—The hub bolt of the main wheel of a large civil aircraft is an important bearing part in the take-off and landing process of the aircraft. The bolt will be detected by fluorescence or magnetic powder in each tire disassembly process. It is found in the application that even if some bolts pass the magnetic particle detection, they will still break in the process of use. Bolt breakage not only increases the probability of tire damage, but also seriously endangers flight safety. In order to find out the cause of bolt fracture and put forward the corresponding solutions. In this paper, damage bolts are taken for failure analysis, and it is found that most of the fracture positions of threads are located at the root of the fourth thread. According to the characteristics of the fracture, traditional ultrasonic method was used to carry out in-service detection research. The results showed that the shear wave probe with a frequency of K2.2 and 2M could detect 1mm deep cracks at the end of the thread. This method is simple to operate, does not need to dismantle the bolt, can respect the spot con

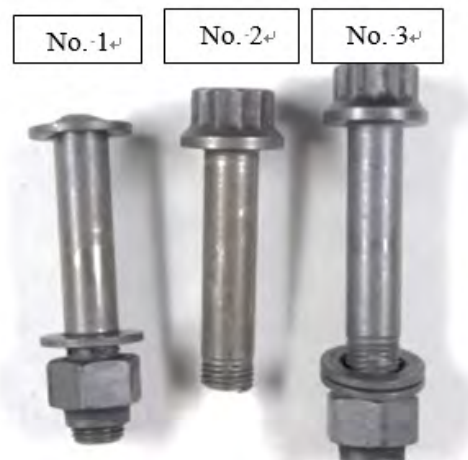
FIGURE I. MACROSCOPIC MORPHOLOGY OF BOLTS

The macroscopic morphology of the three bolts is shown in Figure I, where the fracture position of the first bolt on the left is located at the bolt head and the fracture position is close to the transition arc (arc chamfer) area (hereinafter referred to as bolt no. 1) of the bolt head. The fracture position of the middle bolt in Figure. I is at the thread position, and the fracture is in the fourth thread area (hereinafter referred to as bolt no.2).

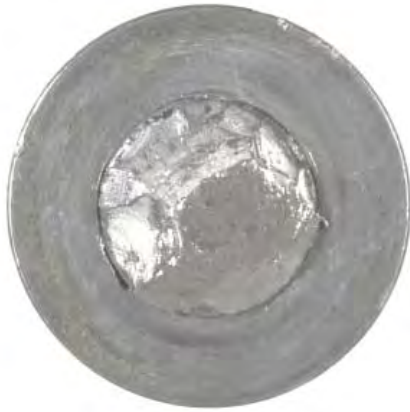
FIGURE II. MORPHOLOGY OF THE FRACTURE OF LEFT BOLT

The macroscopic morphology of the fracture position of the left bolt (hereinafter referred to as bolt no. 1) in Figure I is shown in Figure II. The bolt gasket is stuck at the fracture position and cannot be removed. The surface fluctuation of the fracture is large, the macroscopic morphology of different regions of the whole fracture is greatly different, and some regions have the characteristics of suspected fatigue beach grain.

The fracture of no. 1 bolt is characterized by multi-source fatigue fracture, and there are traces of gasket contact, extrusion and deformation at the origin location of multiple crack sources. It shows that the fracture of bolt no. 1 is related to the gasket. The structural characteristics of both sides of the gasket are different, the inner ring edge on one side is a right-angle transition, and the other side is an r2-3 transition arc chamfer. In this case, the right-angle transition side is installed on the nut side.

Refer to other relevant information (737-800 structural repair manual), which requires that the radian side of the gasket is installed relative to the radian side of the bolt. If the installation is reversed, the edge of the right Angle chamfering Angle will contact the transition arc of the bolt to form local point contact or line contact. Under the action of bolt torque, local stress will be concentrated to form micro-damage, which will lead to fatigue cracking in the subsequent service process.

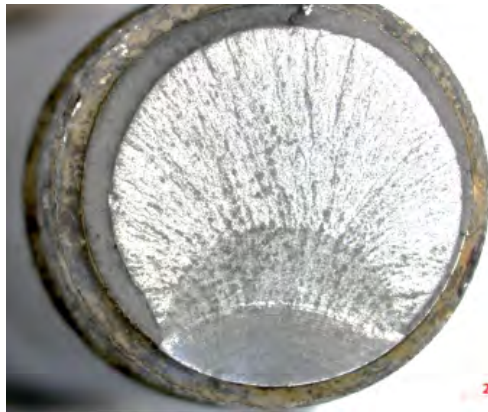
FIGURE III. MACROSCOPIC MORPHOLOGY OF INTERMEDIATE BOLT (HEREINAFTER REFERRED TO AS BOLT NO.2)

Figure I macroscopic morphology of the fracture of the intermediate bolt (hereinafter referred to as bolt no. 2) is shown in Figure III. The fatigue damage characteristics of the bolt fracture are very significant, with obvious fatigue beach grain characteristics.

Figure III shows the microscopic morphology of the location near the fatigue crack source of no.2 bolt, which can be seen in the fatigue grain distribution on the sand beach. The fatigue crack takes the crack source as the origin and extends outward along the vertical direction of the fatigue sand grain. The micro morphology of the fatigue crack source area is shown in FIG. III. The fatigue crack originated from the thread root area, which was the point crack source, and originated from an indentation with a length of about 10 microns at the thread root.

Bolt no.2 is a point source fatigue fracture. The origin position is located at the root of the fourth thread, which is usually the maximum stress position. According to the fracture morphology of no.2 bolt and dimple structure of the instantaneous fracture area, the fracture is a normal stress tensile fracture.
