Analysis of Damage Level of Flexible Pavement on the May Zen Road Section, Kalidoni District, Palembang

N. L. Husni et al. (eds.), Proceedings of the 7th FIRST 2023 International Conference on Global Innovations (FIRST-ESCSI 2023), Advances in Engineering Research 232, https://doi.org/10.2991/978-94-6463-386-3 9

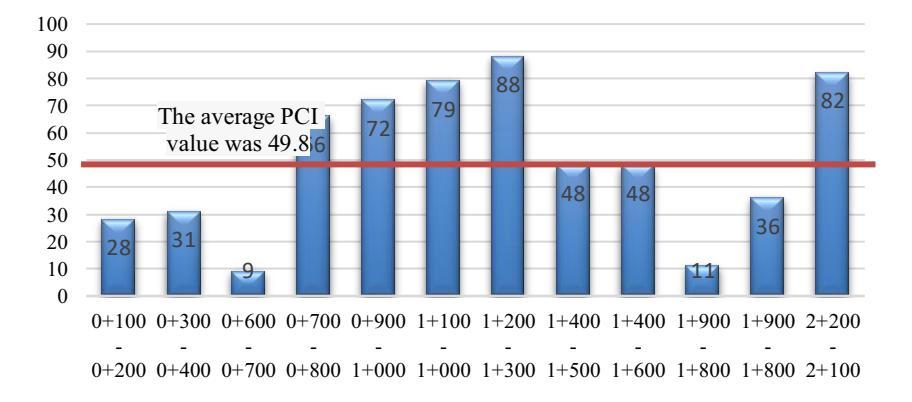
Fig. 1. The Average PCI (Pavement Condition Index) value

After determining the type of treatment for each road damage level based on the PCI value, it was found that 6 sections needed Reconstruction/Recycling, 1 section required Routine Maintenance, 1 section needed structural maintenance, and 3 sections needed periodic maintenance. The average PCI value for the May Zen road from STA 0+000 to 2+200 is 49.8, categorized as moderate (fair).
