2nd International Conference on Automation, Mechanical Control and Computational Engineering (AMCCE 2017)

# Analysis of 220kV Oil Immersed Inverted Current Transformer Fault and Precautions during Operation

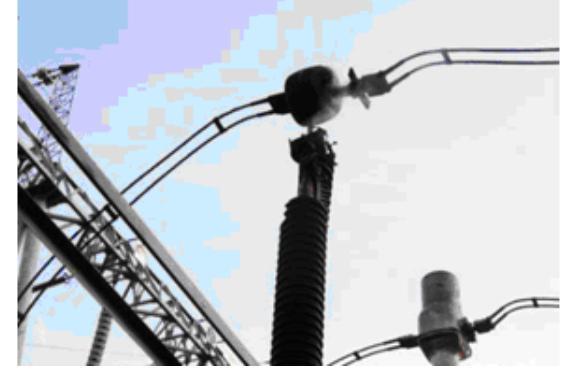
On October 2016, a B-phase current transformer exploded in a substation, when the weather was good. Operation and maintenance personnel on-site inspection found that the upper B-phase current transformer porcelain damage, Metal shell collapse broken, with expander fell off. (Figure 2)

Figure 2 B-phase current transformer burst the upper part

a. The outer insulation of the low-voltage coil shield had been completely burnt, and it had a significant upper discharge point on shield metal shell. (Figure 2)

The transformer was found that there is oil leakage phenomenon in the inspection on September 12, which was regarded as general defects. There was a local heavy rain on October 10, as the transformer body affected by rainfall, the temperature dropped rapidly, rainwater leakage along the parts into the body, resulting in the main insulation damp, finally the shell high voltage (phase voltage) on the secondary winding shield (ground potential) discharged breakdown. Leakage of oil storage tank caused by the main insulation breakdown was the main reason for this failure.

Pressure release device failed to timely action, was the main reason for the burst of oil conservator and porcelain sets.

1) Organize a comprehensive investigation, take the same type of current transformers special patrol, check high-pressure side leakage, and take measures.

2) In view of the structural characteristics of the oil immersed inverted current transformer, the primary and secondary windings are both located in the head of the transformer, and the internal insulating oil is less (about 60% of the vertical current transformer), in the event of leakage of oil, it's easily lead to cause the main insulation damp, and then the occurrence of insulation breakdown discharge, resulting in transformer explosion. Therefore, it requires operation and maintenance personnel should focus on inspection of the oil immersed inverted current transformer in the routine inspection, while strengthening the infrared precision temperature measurement.

3) Revised detailed guidelines issued by the State Grid evaluation of transformer equipment, state assessment guidelines in the inverted instrument transformer oil leakage from the "state of care" to upgrade to "critical state".

5) Require manufacturers to re-calculate the expansion of the release pressure value, to ensure that the when there is transformer internal failure, it can timely release of internal pressure to prevent the occurrence of body and casing from burst.

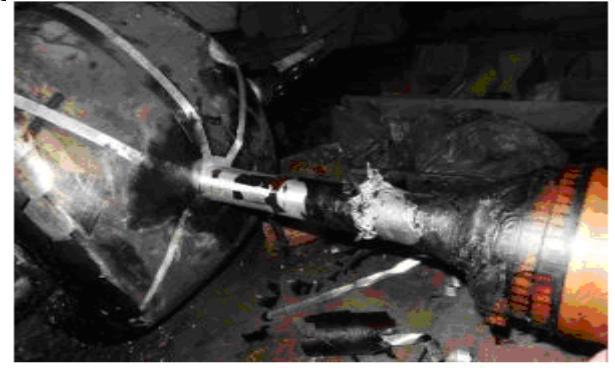
b. Insulation of the upper part of the lead-tube (where it was connected to the shield) had been burned, and the insulation below the center had not been damaged. (Figure 3)

Figure 3 Insulation of the upper part of the lead pipe burns

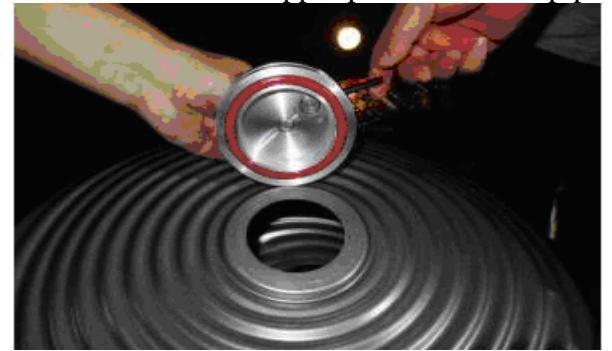
c. Metal expander cover and expander failure was not separated, the box expander surface inspection found no leakage point, and expander tank safety valve did not action. (Figure 4)

Figure 4 Expander tank safety valve did not action
