## X-ray Detection Research of Current Transformer

**Abstract**— Since the structure of electromagnetic current transformer is fully enclosed, When the fault occurs, using the traditional electrical insulation detection methods only detected whether it has defects or not. We cannot analysis the form and nature of the defects by using that detection method. In this paper, we use X-ray DR detection technology on the 35kV electromagnetic current transformer. After the disintegration of the device, we verify the detection result by the X-ray DR detection system. From the results, we can see that compare with the other electrical insulation detection methods; the X-ray DR detection technology can be more intuitive found the location of the defect.

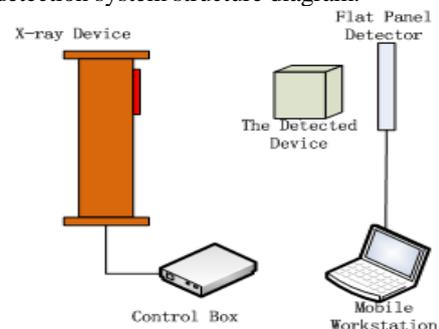
Fig.1 X-ray DR Detection System structure diagram

X-ray DR digital imaging technology is the most advanced digital imaging technology. It using a hard flat panel detector to receive the remaining X-rays through the subject device, then converts the signal to digitized current. In the last via a data connection inside the device, the images displayed directly to the mobile workstation. For the detection of different locations, we can simply move the imaging plate without having to replace the imaging film. Compared with traditional film imaging technology and CR, X-ray DR digital imaging technology not only greatly improves the detection efficiency and due to the small size of the detection equipment, it has portable and real-time characteristics. At the same time, X-ray DR detection system has powerful image processing capabilities. It can use the conventional image processing method such as image denoising and image enhancement to optimize the image. It also has high resolution and snr. The figure below shows the X-ray DR detection system structure diagram.

When in field test, we can adjust the parameter values of the X-ray machine by the control box. These parameters include tube voltage U, the tube current I, the focal length F, the exposure amount T and collection frequency. Through adjusting these parameters, it could change the penetrating power of the X-ray and the image gray. The collected images through the flat panel detector displayed directly on the mobile workstation after processing. Finally, the collected image could be processed by using the image processing software which comes from the system. So that we could clear, intuitive observe the internal of devices<sup>[4-5]</sup>.

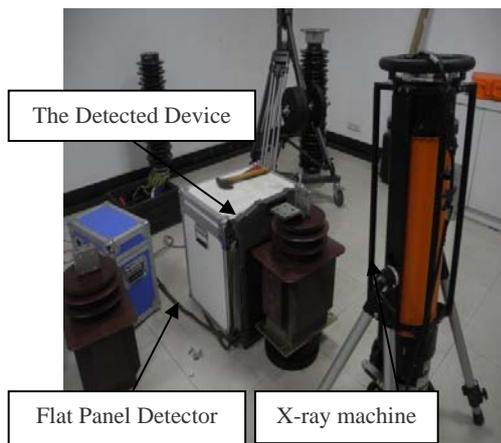
Fig.2 Equipment Layout

The current transformers are arranged according to the position shown in Figure 2. The occurrence port of X-ray machine is aligned to the core and winding of current transformer.

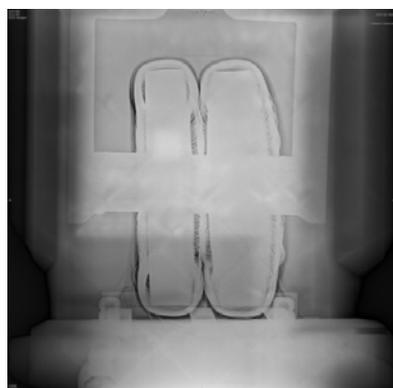
Fig.3 The B-phase TA X-ray image

Through the X-ray images, we can see that the secondary winding lead of B-phase TA is neat at the bottom of the TA and the epoxy resin casts tidily, no bubbles, impurities, etc. While, we find the secondary winding lead of C-phase TA is curve and overlapping. And the secondary winding lead of C-phase TA is too close from the first side of the copper plate. To contrast with the marked of nameplate, the position of fault is located in the 1S1 leading-out terminal of secondary terminals. Through the X-ray image, we preliminary inferred the C-phase TA has been breakdown is due to the lead of secondary winding too close from the first

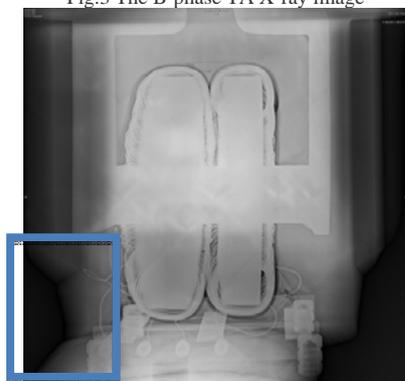
Fig.4 The C-phase TA X-ray image

side. The manufacturing process of current transformer is unsophisticated lead to the insulation breakdown. Before pouring, the secondary winding lead is not fixed or firmly fixed, resulting in the secondary lead flying out and closing from the first side. At the same, due to the secondary winding lead of C-phase TA is curve and overlapping, there will be mechanical stress in the insulating resin where have defects. Due to the presence of mechanical stress, after pouring completed, there will be a hole in the position. Once the hole is generated, During use, there will produce reactive gas (ozone, nitrogen oxides) in the hole and corrosive local insulation. This will cause unrecoverable insulation damage. With the gradual increase of the extent of corrosion, after some time of operation, the insulation properties will continue to fall leading to a sudden breakdown [6-7].

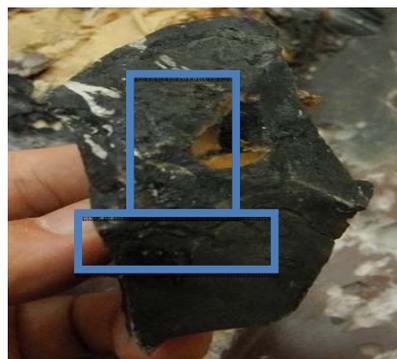
Fig.5 the Hole and Creepage

In the process of disintegration, there is some odor gas overflow with burning smell. From the fig.5, the fragments are the insulating material around the secondary winding 1S1 of C-phase TA, there is obviously hole and creepage phenomenon. Around the hole, we find the epoxy resin

become to brown and there is a carbonized conductive channel. From the fig.6, we find the primary winding of copper; this is the inflection point of a copper plate through the core. At the same time in the position we find the phenomenon of creepage. It showed that because the manufacturing process, resulting in the primary winding and the secondary winding is too close. That is why the insulation is breakdown. From the result of disintegration, we find the conclusions coincide with the results of X-ray detection. It shows that Through X-ray DR detection technology, the diagnostic results of the current transformer is accurate and effective.
