Exploring Gambir Station by Wheelchair

Abstract— Everyone should enjoy the need for a trip. Nevertheless, wheelchairs user cannot feel the same. Often their trips are hampered because the facilities provided are not friendly to wheelchair users, one of which is the railway station. Gambir Station as one of the largest stations in Jakarta should be an example for other stations to provide equal opportunities for all passengers, including wheelchair users to able to explore Gambir Station comfortably. Therefore, in this paper, the author will evaluate what aspects of facilities for wheelchair users at Gambir Station. This research uses qualitative methods that focus on whether the wheelchair facilities provided in Gambir Station has aligned with Indonesia Ministry of Public Works Regulation No. 30/PRT/2016 and Accessible Train Station Design for Disabled People. The study employs an analysis method which includes wheelchair circulation, parking area, and passenger loading zones, door and entrance, elevator, restroom, furniture, and signages. The study also conducts an experiment and interviews on the head of Gambir Station customer service and prospective train passenger who is a wh

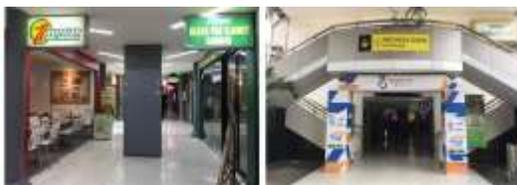
Figure 2: Southern entrance, Gambir Station

Based on observations from the southern entrance access to the main lobby, researchers found no problems because the door openings and circulation area at the southern entrance had a width of 355 cm. In some areas, there is a narrowing because there are building columns in the middle of the room. The distance between the column and the wall is 143 cm so that wheelchair users can still get through this narrowing (see figure 2). However, the problem is that many shops put x-banners or signages outside the store area so that the narrowing area disturbs the circulation of wheelchair users.

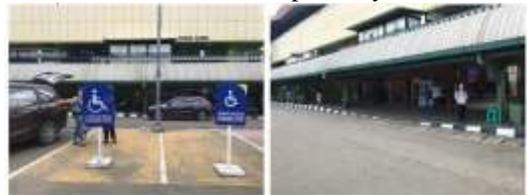
Figure 3: (a) parking area; (b) western circulation

Gambir Station has provided two disabilities parking areas which are marked by disability signs (see figure 3). This parking area is near the west entrance of Gambir Station. The distance from the disabilities parking areas to the entrance is 760 cm. However, the size of each parking area is only 230 x 453 cm. This parking area does not meet the minimum standard of the disabilities parking area, which is 370 x 550 cm. Besides, this parking area also does not provide a free area for access and entry for wheelchair users, where the

minimum standard of the free area is 120 cm.

However, the surface of the corridor is made of conblock. Use conblock as a flooring material on the surface of the corridor is not appropriate because the rough texture will cause wheelchair users to need more power to be able to access the pathway.

From the results of observations, experiments, and interviews, researchers learned that several facilities needed to be upgraded or added to Gambir Station. The first is a parking facility where the weather is still not following the standard, and there is no circulation area for wheelchair users. The surface of the western and

eastern corridors needs to be improved using smoother material but still resistant to outside buildings and not slippery when it rains. The height of check-in kiosks and direct purchase counters needs to be considered and may be able to add special check-in kiosks and direct for disabilities. Respondents strongly complained about restroom facilities. It is best for the manager to provide disabilities restroom on the outside area of the boarding gate and pay attention to the dimensions and height of restroom equipment in existing disabled restrooms. Elevator facilities although adequate. However, it should not only find in the northern gate area but also can be provided in the southern gate area so that the disabled people in wheelchair users are not too far away in accessing the elevator. The last problem is the problem of borrowing a wheelchair. Respondents complained about the location of borrowing a wheelchair located after the boarding gate. This problem makes it difficult for prospective passengers who want to borrow a wheelchair because it is located too far from the entrance. Preferably a wheelchair loan can be placed near the entrance.

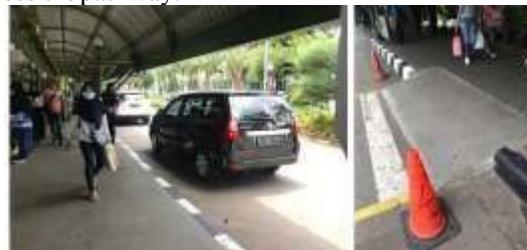
Figure 4: (a) passenger loading zone; (b) ramp

Passenger Loading Zones is located eastern of Gambir Station. Passenger Loading Zones are directly related to the entrance and eastern circulation pathway (corridor). The width of passenger loading zones at Gambir Station only has a width of 250 cm and has not met the minimum requirements of 360 cm. Besides, the ramp found in this area also has a tilt of 12°, even though the standard specified is a maximum of 6°. This condition will make it difficult for wheelchair users to access the ramp. In the western circulation area, the corridor width is 296 cm which meets the requirements. However, the surface of the corridor is the same as that in the western corridor, which is made of conblock. The choice of conblock material on the surface of the corridor is not appropriate because the rough texture will cause wheelchair users to need more power to be able to access the pathway.

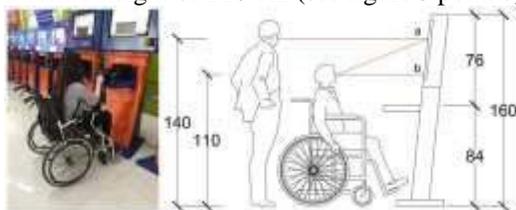
Figure 5: Check-in kiosk, Gambir Station

The main lobby area of Gambir Station has a reasonable right circulation path, but the main lobby problems are at the check-in kiosk and direct ticket counters. The kiosk check-in available at Gambir Station has a table height of 84.5 cm, the centre height of the screen about 135 to 140 cm (see figure 5 point a), and the overall height of the furniture is 160 cm. The maximum table height for disabled persons is 85 cm, so the check-in kiosk table at Gambir Station is appropriate, but the screen is too high, making it difficult for wheelchair users to see it. We recommend that the screen

has a centre height of 110 cm (see figure 5 point b).

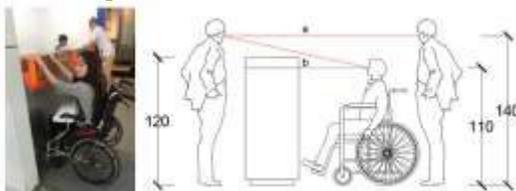
Figure 6: Direct ticket counter, Gambir Station

In the area of the direct ticket counter, it has height problems, the same as what happened at the check-in kiosk. The height of the direct purchase counter is 110 cm (see figure 6) where the ideal height for wheelchair users is 85 cm. Also, there are also problems with differences in floor height in the area (see figure 6). The problem of + 3 cm floor differences cause wheelchair users to have difficulty accessing it so that they need help from others.

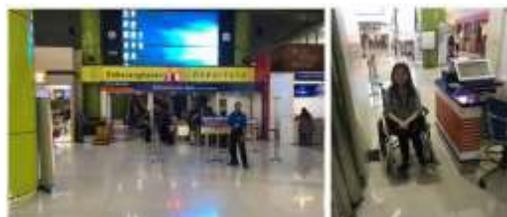
Figure 7: Boarding gate, Gambir Station

The boarding gate is the entrance that serves to check the ticket of prospective passengers in order to enter the waiting area. Gambir Station has four boarding gates where the leftmost boarding gate is the largest boarding gate commonly used for wheelchair users. This boarding gate has a width of 95 cm and is according to the standard.

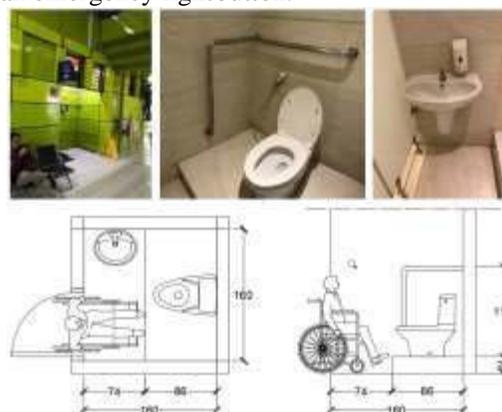
Figure 8: Disability restroom (south gate), Gambir Station

In the second restroom (located near the south gate), it has disabilities restroom. On the outside of the restroom and restroom door, there are disabilities signages. This restroom has a size of 160 x 160 cm. The height of the toilet only has a height of 42 cm while the standard height is 45-50 cm. This restroom has handrails, but the handrails are too high, which is 110 cm, while the handrail height standard is 70- 75 cm. The height of the tissue box is 118 cm, while the standard height is 65 cm. The height of the sink is only 75 cm while the standard height is 85 cm. The fatal problem is that a wheelchair can not enter this restroom because there is an elevation that makes the wheelchair exceed the room and the door cannot be closed (see figure 8), and does not have an emergency lightbutton.

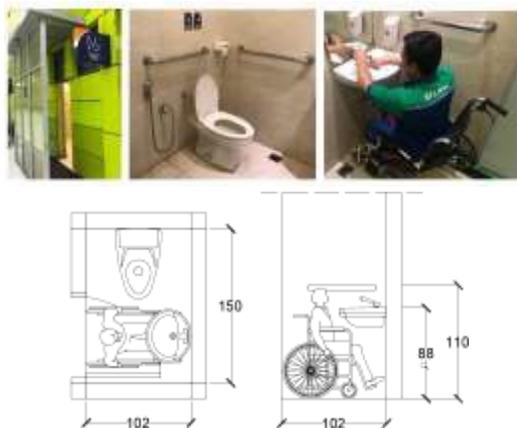
Figure 9: Disability restroom (north gate), Gambir Station

The third restroom is near the north gate. This restroom also has disabilities restroom and has a disabilities signages on the outside and front of the restroom door. However, outside the restroom entrance, there is a barrier. This barrier makes it very difficult for wheelchair users to get into the restroom because it is not possible to manoeuvre in a narrow area (see figure 9). The second problem is that the restroom door opens inward. This problem makes it difficult for wheelchair users to close the door when inside. Another problem is the handrail which has a height of 110 cm, and a tissue box as high as 114 cm that does not meet the standard, and the sink is slightly too high, which is 88 cm even though the standard is a maximum of 85 cm. However, the height of the toilet and the amount of space are appropriate.

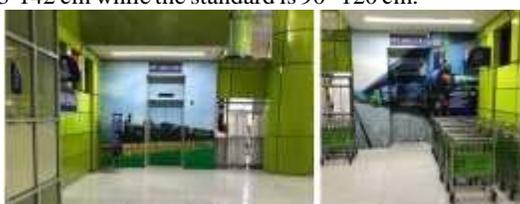
Figure 10: Elevators, Gambir Station

There are two elevators at Gambir Station. These elevators have dimensions of clean space of 180 x 240 cm, equipped with handrails, and an outer panel as high as 110 cm. However, what is not following the standard is the height of the inside panel as high as 113-142 cm while the standard is 90- 120 cm.

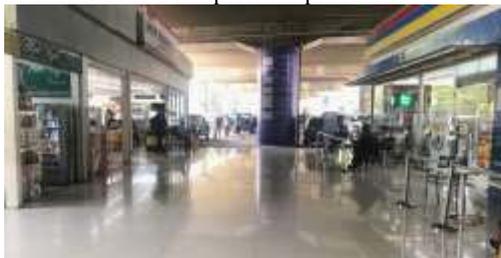
Figure 11: Northern exit Access, Gambir Station

The circulation path at the northern exit has met the standards and has smooth flooring material so that wheelchair users do not experience problems.
