Analysis of Pedestrian Facilities: Case Study of Tarumanagara University Campus I

Fanny Budiyanto
Student of Magister Architecture,
Tarumanagara University, Jakarta,
Indonesia
fanny.budiyanto@gmail.com

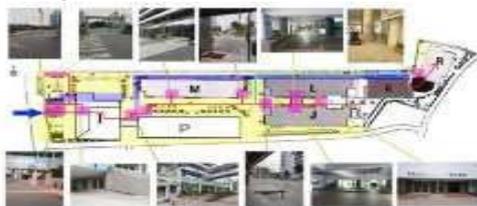
Figure 6: Pedestrian With Special Needs Circulation Flow.

The pedestrian path at Tarumanagara University Campus I can be mapped into 2, main pedestrian pathways and pedestrian paths with special needs (See Figure 5 and Figure 6). Areas that are not roofed or open are marked in yellow and a closed area is marked in blue.

Based on the picture above, pedestrian paths can be access between one building to another with the main paths or alternative paths. But for pedestrians with special needs, the paths provided are limited so that access becomes further and detour.

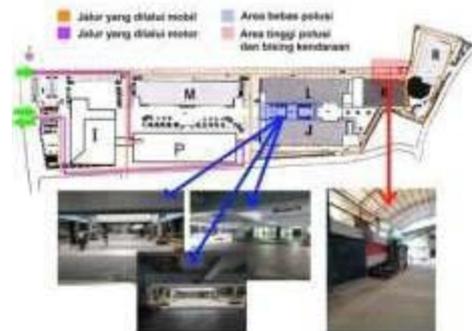
Figure 9: Vehicle Circulation Flow.

Based on the circulation flow of motorized vehicles, you can see areas that are still exposed to motorized vehicle emission. In addition there are several areas that produce diesel machine emission such as the area of mechanical engineering workshops that often conduct engine tests that produce noise and vehicle fumes (See Figure 9).

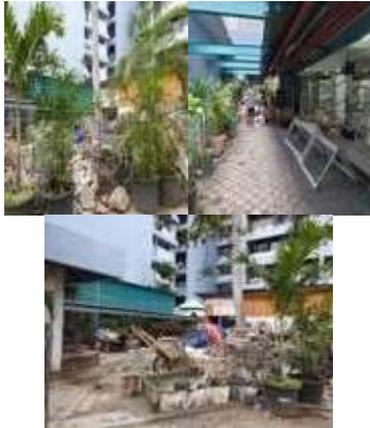
Figure 11: Construction Waste on Campus.

Mostly the pedestrian sidewalk are clean and well maintained, but there are still some areas where construction waste is on the alternative routes (See Figure 11). In addition there are no graffiti around the pedestrian path, but it is necessary to repaint some buildings and facilities available on the pedestrian path.

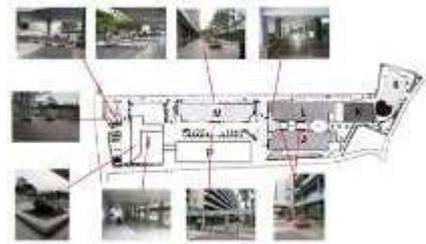
Figure 15: Seating Facilities.

Other supporting facilities such as seating, are numerous and put closely together. Within a 180 m radius it is still available (see Figure 15). But unfortunately there are supporting facilities such as seats that have been damaged and have not been updated (see Figure 16).

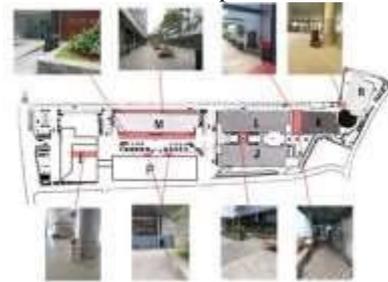
Figure 17: Location of Trash Bin.

Trash bins are provided but not spread evenly on campus. Only main lanes have consistent placement of trash bin.
