Endodontic Retreatment and Restoration Using Fiber Post and Lithium Disilicate Crown

Tedi Pramayanto¹, Wignyo Hadriyanto², Tri Endro Untoro²

This case report aims to inform the results of the Lithium Disilicate crown restoration which is reinforced with fiber reinforced composite post on the maxillary right central incisor after root canal treatment. Case report. A 33-year-old male patient came to the the Clinic of Conservative Dentistry Dental Hospital of Universitas Gadjah Mada with complaints of a crown on maxillary right central incisor which felt unsteady and didn't pain. The patient treated his teeth 7 years ago and received endodontic treatment with post and crown. Percussion and palpation tests showed periodontal tissue is normal. Periapical radiographs showed non-hermetic root canal treatment, crown with short post and periapical area were radiolucent. A diagnosis of tooth 11 was previously treated with asymptomatic apical periodontitis. Tooth 11 were treated retreatment with a step back and vertical warm obturation technique. The choice of the final restoration was a lithium disilicate crown with fiber reinforced composite post. Conclusion. Evaluation of treatment resul

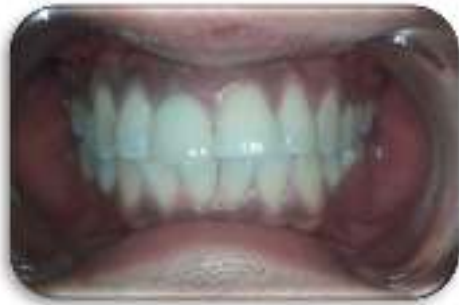
Figure 7. Final result

The third visit, the temporary crown was removed and cementation of the lithium disilicate crown using resin cement (Rely X, 3M ESPE). The maxillary right central incisor was smeared with bonding material, wait for a moment then the lightcure are activated. Inside of the crown etched using hydrofluoro acid and smeared with silane material, wait for a moment then bonding material was applied and activated by light for 10 seconds. The resin cement was mixed to the inside surface of the lithium disilicate crown and then inserted, then activated the resin cement with light for 20 seconds. The excess resin cement was cleaned, an occlusion check and articulation were carried out using

an articulating paper and check proximal contact with dental floss (Figure 7).

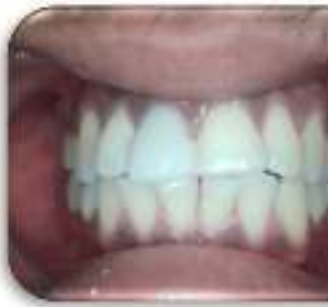
Figure 8. Evaluation of the treatment

Evaluation of treatment results was carried out three months after the insert of the lithium disilicate crown. Subjective examination, the patient said there were no complaints of pain, and the treated teeth could be used for mastication. Percussion examination, the patient did not respond to pain, palpation of the buccal mucosa did not provide pain, no mobility from the maxillary right central incisor. The mucosal tissue around the lithium disilicate crown look healthy, there is no gingival inflammation (Figure 8) and the radiographic evaluation was showed healing in the apical tissues (Figure 9).
