Precast Concrete Columns Strengthened With CFRP and GFRP Laminates Under Eccentric Load

Abstract—This paper presents the experimental results of precast concrete columns strengthened and repaired with externally bonded carbon fiber reinforced polymer (CFRP) and glass fiber reinforced polymer (GFRP) laminates. The aims of the study were to investigate the structural behaviors of a precast concrete column with a notch and the efficiency of CFRP and GFRP laminates in strengthening and repairing the columns subjected to eccentric load. A total of 15 precast concrete columns with notches were tested up to failure. Load was applied on a column notch causing eccentric load on a column. The specimens were equally divided into five groups based on the types of fiber reinforced polymers and damage conditions of columns (undamaged or partially damaged): columns with non-strengthening/repairing; columns with CFRP strengthening; columns with GFRP strengthening; columns with CFRP repair; columns with GFRP repair. The results were compared and discussed in terms of load carrying capacity, lateral deflection, and mode of failure. It was concluded that the application of CFRP and GFRP laminates in

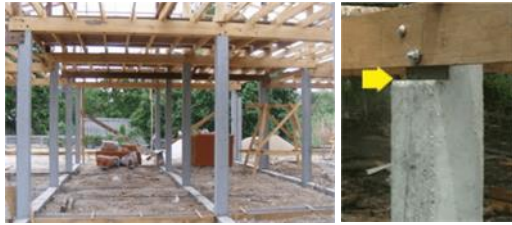
Fig. 1. Concrete-wooden home (left) and beam-column connection (right).

precast columns are fabricated from manufacturing plants before transporting to the site, it is convenient to form them into the particular shape suitable for some structures such as concrete-wooden homes as shown in Fig. 1. Such columns have notches at the top end in order to place wooden beams which are generally bolted to the side of columns. The beam-column connection is illustrated in Fig.1. Based on the notch and connection, a column is subjected to eccentric concentrated load transferred from beams.

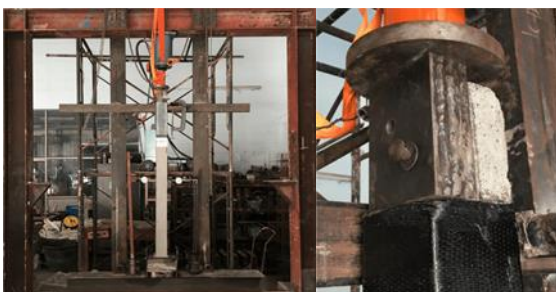
Fig. 2. Test setup and a simplified beam-column connection.

In the experimental program, 15 full-scale destructive tests were conducted on precast concrete columns repaired and strengthened with both CFRP and GFRP laminates. The load was applied using a hydraulic jack on a rectangular solid steel block placed on the column notch. The block was bolted to the lateral side of the top part of the column representing a wooden beam and beam-column connection in a realistic construction practice. Pinned end restraints were applied at the bottom end and at the notch location of the column. Lateral deflections at mid height of the column where maximum deflections occurred were measured in both directions using dial gauges. While the hydraulic pressure was increased gradually during testing, crack initiation and crack propagation were continuously observed. The test setup and connection between a steel block and column are depicted in Fig. 2.

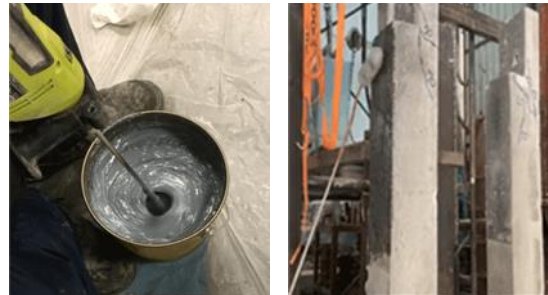
Fig. 3. Mixing of epoxy resin (left) and coating column of substrate (right).

Both CFRP and GFRP laminates were carefully bonded to the specimens according to the recommendations from ACI 440.2R-17 code [9] and the prescribed installation procedures from the manufacturer. After the substrate surfaces were cleaned, epoxy was well mixed from two components and applied onto a precast column as illustrated in Fig. 3. When the

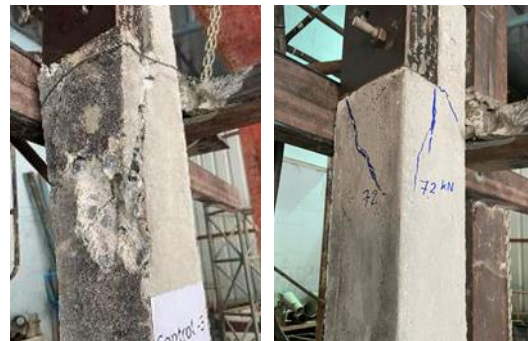
Fig. 4. Failure of control specimen (left) and pre-cracked column for FRP repair application (right).

According to the experimental observation of non-FRP strengthening columns, the initial cracks were visually detected at corners of the column notch where the stress concentration occurred. As the applied load gradually increased, the cracks propagated downward at an approximate 45 degree angle from the corners to the edges of the column and crack width continued to grow. Simultaneously, hairline cracks took place at the bolt hole and propagated downward due to an axial compression. The crack pattern of pre-cracked specimens at the applied load of approximately 75% of the average ultimate load was demonstrated in Fig. 5 (right). The specimen finally failed at the ultimate load due to a sudden shear failure representing a brittle behavior as shown in Fig. 5 (left).

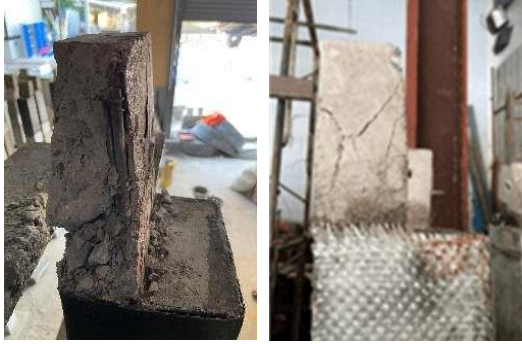
Fig. 5. Failure of strengthened columns using CFRP laminates (left) and GFRP laminates (right).

For both groups of strengthened specimens C-STR and G-STR, the ultimate failure mode also was shear failure. However, specimens could carry load although shear cracks propagated throughout the failure plane due to the confinement of CFRP/GFRP laminates. The failure part of the column on which the steel block was placed was slightly slipped out, and thus the compressive load was transferred to a bolt connection instead. Consequently, the tip of the column which connected to the steel block was severely damaged as illustrated in Fig. 6.

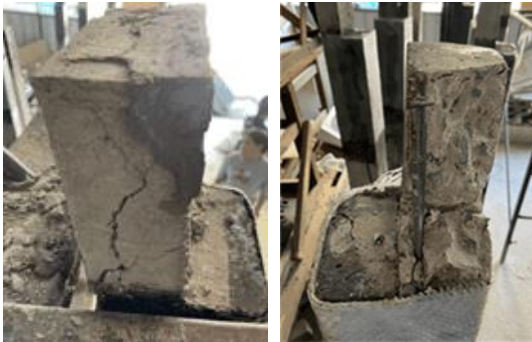
Fig. 6. Failure of repaired columns using CFRP laminates (left) and GFRP laminates (right).

The failure characteristic of both sets of repaired specimens C-REP and G-REP is the same as that of strengthened specimens as shown in Fig. 7.
