Failure Analysis and Performance Assessment of Tubular Air Heater at PLTU South Sumatra V

ABSTRACT

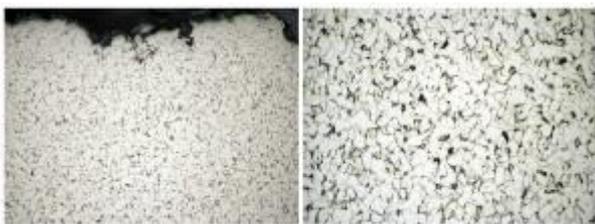
Figure 2 The microstructure of the failed air heater tube.

The Air heater tube was cut and prepared for metallographic examination. The preparation for metallographic examination includes mounting, grinding, polishing and etching. The etching was conducted by using a Nital solution to reveal the microstructure. The images in Figure 2 show the cross-section observation of the failed air heater tube. The specimen for metallography analysis is taken from the failed air heater tube, respectively. The macro photography shows that the tube is classified as an ERW tube as the long seam weld is observed on the cross-section.

The other image represents the microstructure of the failed air heater tube. The air heater tube's microstructure is identified as ferrite (white grains) and pearlite (dark grains). It is usual for low alloy carbon steel, whereas for the carbon content of 0.07% and 0.09%, the ferrite grains will dominate the microstructure. No cracks are found in the microstructure, and the corrosion process causes grains degradation. There is no abnormality in the microstructure of the failed air heater tube.

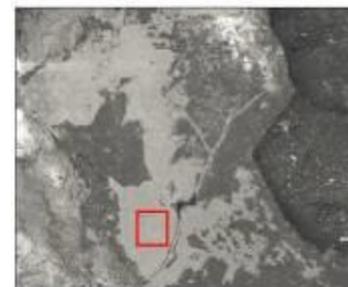
Figure 5 Fracture of yellow-white corrosion products.

A scanning electron microscope test was conducted on the fracture surface area of the failed air heater tube to observe the fracture's feature, as seen in Figure 3 and Figure 5. EDX test result on surface fracture is presented in Figure 4 and Figure 6.

The corrosion products from the reaction of carbon steel with sulphuric acid can be distinguished visually as a yellow-white layer on the air heater tubes' surface. This type of corrosion is called low-temperature acid dew-point corrosion and frequently occurs in heat recovery systems such as air heaters of steam power plants [5]. Other consequences of the formation of liquid sulphuric acid (H₂SO₄) are that it attracts the ash deposition on the tube surface, creating another threat of corrosion, i.e., under-deposit corrosion. Tube plugging could also be caused by this deposition/fouling effect from the attracted ash.
