Functional Damage Assessment Visually on the Road Using Pavement Condition Index (PCI)

The road becoming the object of discussion in this study is Triwidadi Street, Pajangan, Bantul, Yogyakarta road section, located 14 km from the zero-point of Bantul Regency. The expanse of land is in the form of a hilly and mountainous area. It is a regency road with secondary local road functions. There are many tourist destinations at these locations, such as Selarong Cave, coconut shell craft, Pulosari Ravine, Ngembel spring tourism, and etc. This excellence is crucial to support the economic cycle of the people concerned.

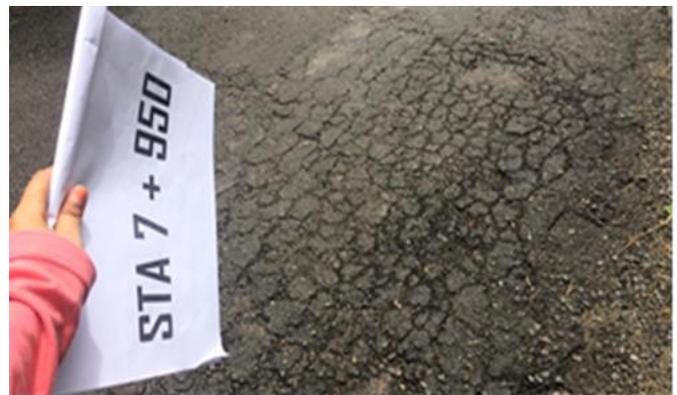
Fig. 4 Alligator Cracking at the location STA 7+950

Figure 4, 5, 6 and 7 display some of the types of damage that exist in the field. It is very clear from the picture above that the damage is in alligator cracking, weathering, raveling, potholes, edge cracking, and still a lot of damage but cannot be displayed as a whole. Interestingly, this road is quite visually apprehensive; this will impact the comfort of road users.

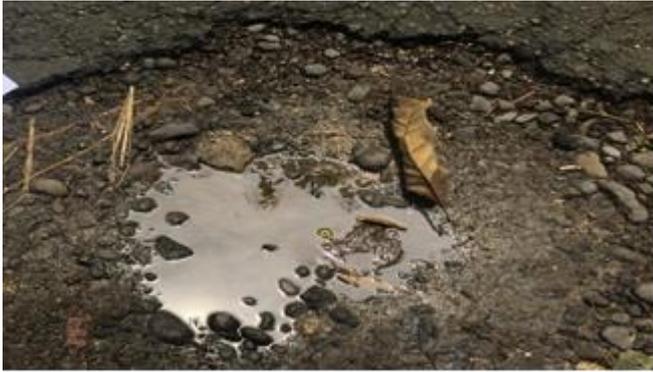
Fig. 6 Potholes at the location

One of the road damages was caused by water. Water not only damages the function but also damages the structure of the road. The absence of drainage, the inadequate cross-slope of the road can cause puddles in the road, and water will seep in to disrupt the road's stability and strength.

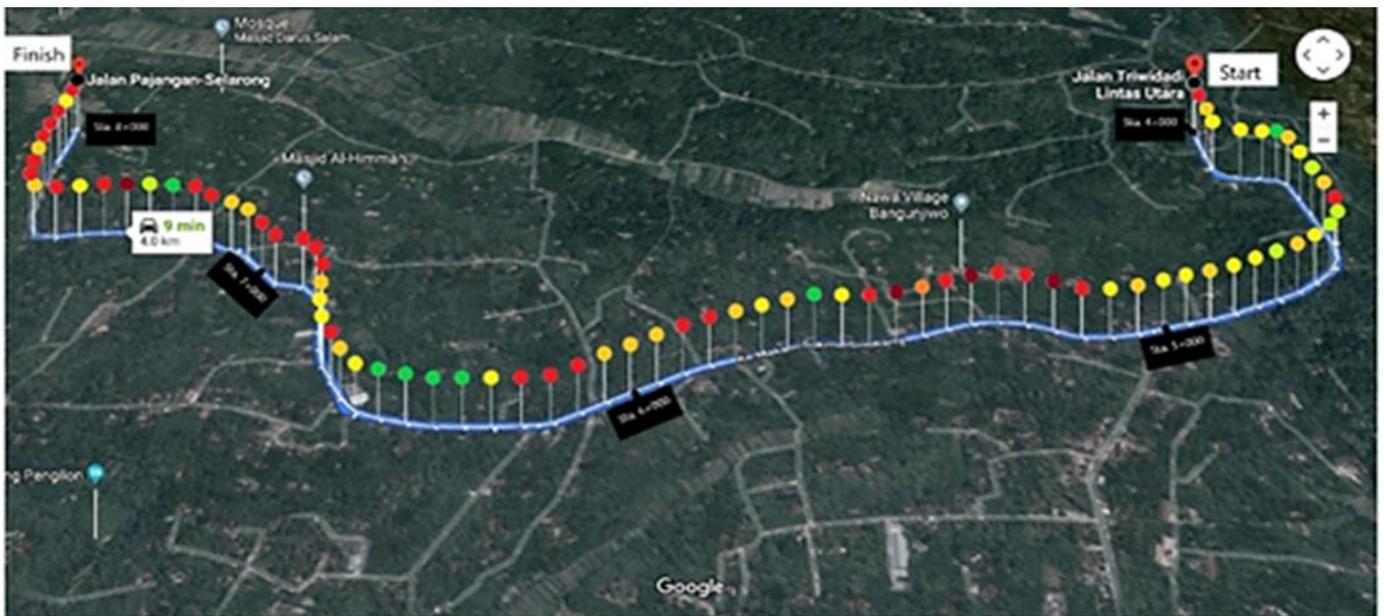
Fig. 17. Stripping map pavement condition index with colour indicator

Fig. 17 above illustrates the analysis results stripping map using a 4 km long PCI in each section. These roads can be said to have damage. The farther the road, the more visible the road condition is colored red, which indicates the road is serious.
