# Wheelchair-Accessible Toilet at Gambir Station

**Keywords:** Accessible, Disabilities, Gambir Station, Toilet, Wheelchair

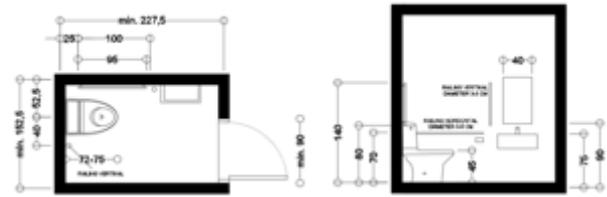
Figure 1. Disability toilet configuration

Every toilet for males and females must have at least one disability toilet or have one disability toilet in separate sections. Disability toilets must be equipped with signs/symbols of "Disability" with the embossed printing system on the outside and have enough space to enter and exit wheelchair users with a minimum of 152.5 x 227.5 cm [13]. The height of the closet seat is around 45-50 cm. Toilets must be equipped with a handrail; the handle is recommended to have a right-angled shape pointing up to help the movement of wheelchair users [14]. The minimum opening width of the door is 90 cm and opens outwards. The toilet must be equipped with an emergency light button on the toilet inside to sign if something dangerous is happening. The minimum Washbasin size is 45 x 60 cm, with a height of 75 cm for wheelchair users-free space under the Washbasin at least 60 cm from the Washbasin's edge (Figure 1).

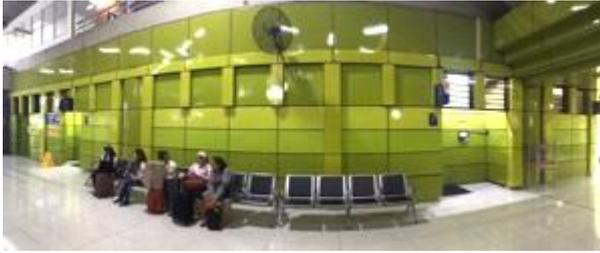
Figure 9. Existing photo of toilet B [7]

Based on research conducted, researchers found that Toilet B already has a disability toilet, where there was one disability toilet room in the male's room and one disability toilet room for the female's room (Figure 9). In this toilet, researchers observed in detail the male's disability toilet. Based on these observations, the researchers found a disability symbol on the outside of the toilet and the front of the toilet door. The disability toilet area is 160 x 160 cm. However, there is a floor elevation in the closet area, which causes the wheelchair not to enter fully into the toilet room because the elevation blocks it (Figure 10-11). Another problem is the toilet closet, which is too low, 42 cm, while the standard toilet closet for wheelchair users is 45-50 cm. This toilet has facilitated a handrail with a height of 110 cm, while the standard height of the handrail is 70-75 cm. The tissue holder in this toilet is also placed too high, which is 118 cm, whereas the tissue holder's standard height for the disabled is 65 cm. The emergency light button is also not provided on the toilet.

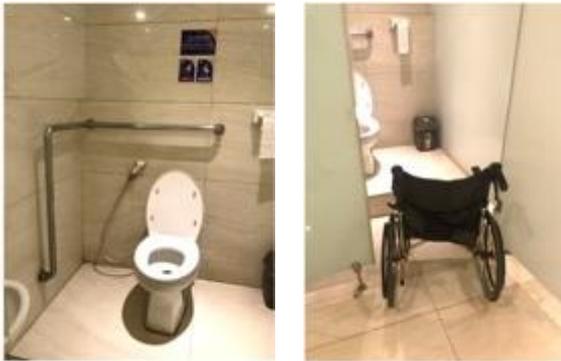
Figure 10. Interior of male disability toilet B [7]

No.	Facility	Criteria	Fulfilled	Information
1	Toilet	Closet Height: 45-50 cm	Not Fulfilled	Height of the toilet seat 42 cm
		Handrail Height: 70-75 cm	Not Fulfilled	Height of handrail 110 cm
		Tissue Box Height: 65 cm	Not Fulfilled	Height of tissue box 118 cm
		Toilet Dimension: 152.5 x 228,5 cm	Not Fulfilled	Area 160 x 160 cm
		Floor Material: not slippery	Fulfilled	Using mate ceramics
		Disability signage's	Fulfilled	Disability signage's at the outside of the toilet
		Emergency light button	Not Fulfilled	Do not have
		The toilet door opens to the outside	Fulfilled	The toilet door opens to the outside
2	Washbasin	Minimal width: 80 cm	Not Fulfilled	Width of Washbasin 50 cm
		Maximum height: 85 cm	Not Fulfilled	Height of Washbasin 75 cm
		Not sharp edges	Fulfilled	Not sharp edges
		Mounted on the wall	Fulfilled	Mounted on the wall
		The faucet uses a lift system	Not Fulfilled	Using the rotary system

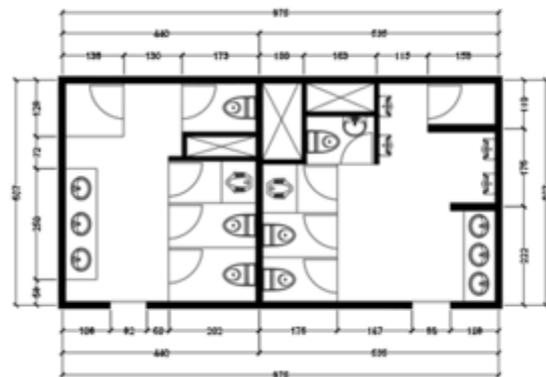
**Figure 19.** Existing Layout of Toilet C

Toilet C also already has a disability toilet. There are one male's disability toilet room and two female's disability toilet rooms (Figure 16). In this toilet, researchers observed in detail the men's disability toilet (Figure 17). Based on observations made on male toilet C (Figure 18), it is known that the disability toilet already has a disability symbol on the outside and front of the toilet door. There is a partition (barrier) at the front of the toilet. This partition (barrier) serves to block the direct view of the toilet. However, the partition (barrier) makes it difficult for wheelchair users to access the toilet because they have to manoeuvre in a narrow area. This disability toilet room has a room area of 102 x 150 cm, where the minimum standard is 152.5 x 227.5 cm. This toilet door opens inward, causing wheelchair users to have difficulty closing the door. This toilet-handrail height of 110 cm and 114 cm of the tissue box, which is not suitable. The Washbasin provided is not ideal, where the width of the Washbasin is only 50 cm with a height of 88 cm, while ideally, the width is 85 cm, and the maximum height is 85 cm. Another problem is the use of a rotary system on a water faucet that should use a lift or tap system.

No.	Facility	Criteria	Fulfilled	Information
1	Toilet	Closet Height: 45-50 cm	Fulfilled	Height of the toilet seat 48 cm
		Handrail Height: 70-75 cm	Not Fulfilled	Height of handrail 110 cm
		Tissue Box Height: 65 cm	Not Fulfilled	Height of tissue box 114 cm
		Toilet Dimension: 152.5 x 228,5 cm	Not Fulfilled	Area 102 x 150 cm
		Floor Material: not slippery	Fulfilled	Using mate ceramics
		Disability signage's	Fulfilled	Disability signage's at the outside of the toilet
		Emergency light button	Not Fulfilled	Do not have
2	Washbasin	The toilet door opens to the outside	Not Fulfilled	The toilet door opens to the inside
		Minimal width: 80 cm	Not Fulfilled	Width of Washbasin 50 cm
		Maximum height: 85 cm	Not Fulfilled	Height of Washbasin 75 cm
		Not sharp edges	Fulfilled	Not sharp edges
		Mounted on the wall	Fulfilled	Mounted on the wall
		The faucet uses a lift system	Not Fulfilled	Using the rotary system
