# Flexural Strengthening Reinforced Concrete Beams Subjected to Flexural Damage with CFRP

Aridi Wijaya Pradana<sup>1,\*</sup> Mardiana Oesman<sup>1</sup>

<sup>1</sup> Civil Engineering Department, Bandung State Polytechnic

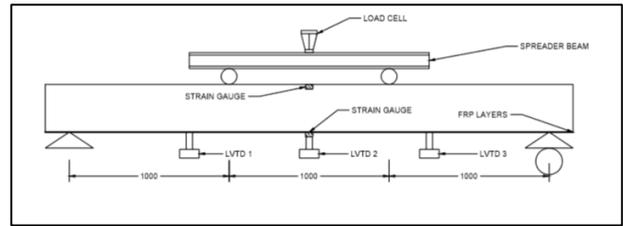
Figure 3 Illustration of Testing.

After the FRP layer was installed, to determine the strain that occurs in the FRP, a strain gauge was attached to the bottom surface of the FRP layer, in the middle of the beam span. Likewise, a strain gauge was installed on the surface of the top fiber of the concrete beam in the middle of the span, to determine the amount of strain that occurs in the maximum compressive fiber of the concrete, as shown in Figure 3.

The loading tests on reinforced concrete beams with FRP were carried out until failure; but before the beams were reinforced with FRP, the beams had carried out initial testing. The tests were carried out with load control, monotonic loading, and third points with a loading frame capacity of 500kN. The loading was done incrementally until the tensile reinforcement yielded. This can be seen from the strain gauge attached to the tensile reinforcement. During the test, changes in the magnitude of the load, the deformation that occurs in the concrete and reinforcement, as well as the pattern and distribution of cracks on the surface of the concrete beams were observed. After the yield strength of the tensile reinforcement was reached, loading and testing were stopped. Furthermore, repairs were made to the test objects that have been damaged, namely on the lower surface of the concrete due to the cracks that occur. Grouting was done to cover and filled the cracks that occur. Then, reinforcement was carried out by attaching a layer of FRP along and as wide as the bottom surface of the beam, according to the planned number of layers of FRP. The FRP layers were pasted with epoxy adhesive on the bottom surface, along the concrete beam. Beam 02 was installed with one layer of FRP, and Beam 03 was installed with 2 layers of FRP, and Beam 04 was installed with 3 layers of FRP.

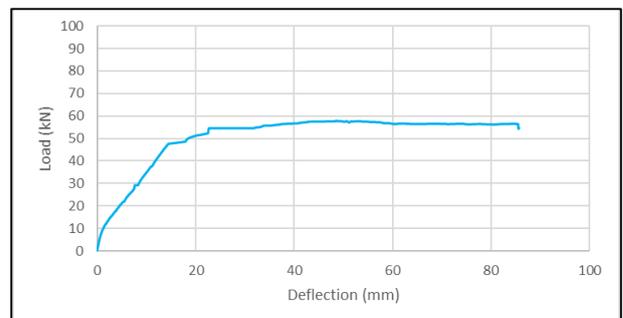
Beam 01 was a control beam, the beam without FRP reinforcement. Figure 4 shows a graph of the load-deflection relationship from the test results of beam 01 subject to the flexural load. The maximum load was 58kN with a deflection that occurred in the middle of the span of 46 mm. While the maximum deflection at mid-span that occurred just before the beam collapsed was 85.71 mm when the beam was loaded at 54.54 kN.

Figure 4 Beam 01 Load-Deflection Relationship.

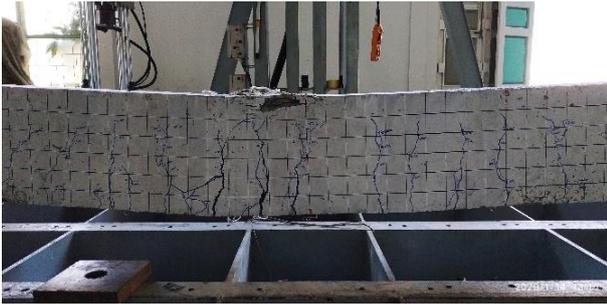
**Figure 5** shows the crack pattern of beam 01. The first crack occurred when it reaches a load of 7.27 kN. The crack began to occur in the middle of the span, in the large moment region. The cracks developed relatively perpendicular to the neutral line of the beam, approaching the neutral axis. These cracks were classified as flexural cracks. Cracks developed followed by oblique/diagonal cracks from the face of the load point to the support. These oblique cracks were a continuation of flexural cracks and were known as flexural shear cracks. The stiffness and ductility of the reinforced concrete beam were 9.35 kN/mm, and 2.00, respectively.

**Figure 5** Crack pattern of Beam 01

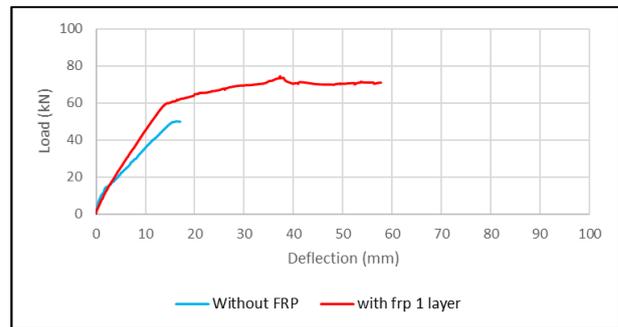
Beam 02 was the concrete beam with 1 layer of FRP reinforcement. **Figure 6** shows a graph of the load versus the deflection relationship of the test results of beam 02 to the flexural load. The graph shows that the first crack of the beam, at initial testing, occurred when it reached a load of 11.03 kN with a deflection that occurred in the middle of the span of 1.75 mm. The test was stopped when steel tensile yielded, reached a strain of 0.01862. It reached a load of 49.70 kN and the deflection at the mid-span reached 16.98 mm. The stiffness of the beam was 6.30 kN/mm.

Furthermore, the cracks that occurred in the beam were patched with an epoxy-based until it reached the setting time. Then, the beam was reinforced with a CFRP layer. **Figure 6** shows a graph of the load vs. deflection relationship of the test results of beam 02 which has been reinforced by CFRP against bending loads. The graph shows that the first crack of the beam occurred when it reached a load of 9.7 kN with a deflection that occurred in the middle of the span of 1.51 mm. The maximum load that occurred reached 74.53 kN at a deflection of 57.69 mm. The maximum deflection at mid-span that occurred just before the beam collapsed was 57.69 mm when the beam was loaded at 71.16 kN.

**Figure 6** also shows a comparison of the graph without and with CFRP reinforcement, which shows the difference in stiffness values. The stiffness and ductility

of the reinforced concrete beam were 6.42 kN/mm, and 3.33, respectively.

**Figure 6** Beam 02 Load-Deflection Curve Relationship

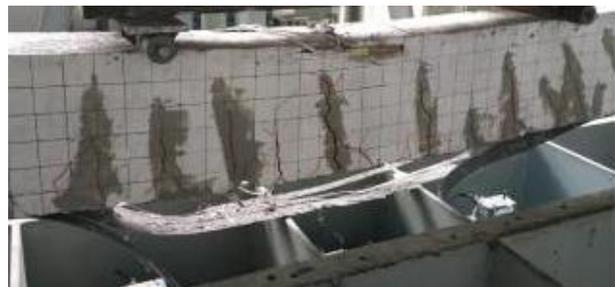
After the beam was reinforced with the CFRP sheet, there were no new cracks occurred in the beam. The test was stopped when debonding occurs between the concrete interface and the CFRP layer, when the load reached 58 kN at a distance of one-third of the span, as shown in **Figure 7**. The bond failure between the concrete surface and the CFRP layer occurred when the concrete had not collapsed as indicated by the concrete strain value 0.000563.29, which means that the concrete had not collapsed ( $\epsilon_c=0.003$ ); while the strain of the tensile reinforcement had yielded. However, testing continued, so that at this stage only concrete worked to withstand the load on the test object. The beam collapsed at a load of 71.16 kN. **Figure 7** shows that the crack pattern that caused the failure was the dominant flexure. Therefore, the cause of the failure that occurred was a flexural failure.

**Figure 7** Crack pattern of beam 02

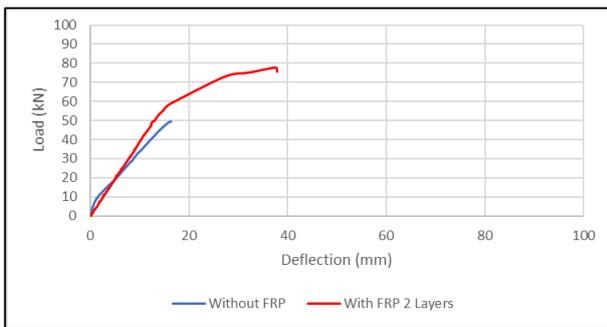
Beam 03 was the concrete beam with 2 layers of FRP reinforcement. Figure 8. shows a graph of the load vs. deflection relationship of the test results of beam 03 to the bending load. The graph shows that the first crack of the beam occurred when it reached a load of 7.65 kN with a deflection that occurred in the middle of the span of 0.85 mm. The test was stopped when the reinforcement has yielded when the reinforcement reached a strain of 0.019 when it is loaded with 49.05 kN and the deflection at the center of the span reached 16.32 mm. The stiffness of the beam was 9.00 kN/mm.

Furthermore, the cracks that occurred in the beam were patched with an epoxy-based until it reached the setting time. Then, the beam was reinforced with a CFRP layer. **Figure 8** shows a graph of the load vs. deflection relationship of the test results of beam 03 which has been reinforced by CFRP against bending loads. The graph shows that the first crack of the beam occurred when it reached a load of 6.04 kN with a deflection that occurred in the middle of the span of 1.55 mm. The maximum load that occurred reached 77.773 kN at a deflection of 37.87 mm. The maximum deflection at mid-span that occurred just before the beam collapsed was 37.87 mm when the beam was loaded at 77.54 kN.

**Figure 8** also shows a comparison of the graph without and with CFRP reinforcement, which shows the difference in stiffness values. The stiffness and ductility of the reinforced concrete beam were 6.42 kN/mm, and 3.33, respectively.

**Figure 8** Beam 03 Load-Deflection Relationship

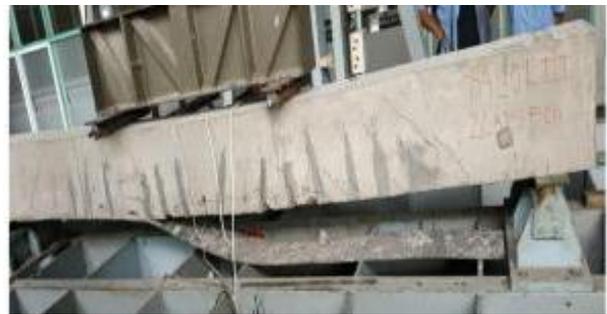
After the beam was reinforced with the CFRP sheet, there were no new cracks occurred in the beam. The test was stopped when debonding occurs between the concrete interface and the CFRP layer, when the load reached 71.6 kN at a distance of one-third of the span, as shown in Figure 9. The bond failure between the concrete surface and the CFRP layer occurred when the concrete had not collapsed as indicated by the concrete strain value 0.000421, which means that the concrete had not collapsed ( $\epsilon_c=0.003$ ); while the strain of the tensile reinforcement had yielded. However, testing continued, so that at this stage only concrete worked to withstand the load on the test object. The beam collapsed at a load of 71.6 kN. Figure 9 shows that the crack pattern that caused the failure was the dominant flexure. Therefore, the cause of the failure that occurred was a flexural failure.

**Figure 9** Crack pattern of beam 03 CFRP

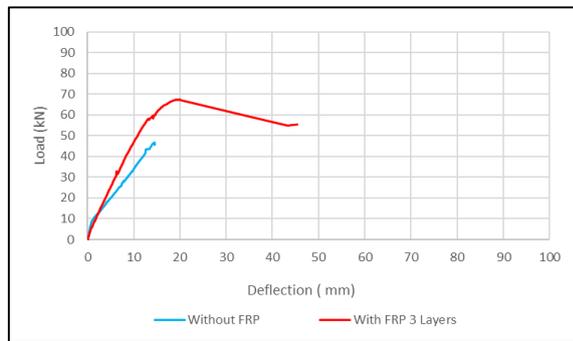
Beam 04 was the concrete beam with 3 layers of FRP reinforcement. **Figure 10** shows a graph of the load vs. deflection relationship of the test results of beam 04 to the bending load. The graph shows that the first crack of the beam occurred when it reached a load of 7.85 kN with a deflection that occurred in the middle of the span of 0.75 mm. The test was stopped when the reinforcement has yielded when the reinforcement reached a strain of 0.0198 when it is loaded with 46.00 kN and the deflection at mid-span reached 14.52 mm. The stiffness of the beam was 10.46 kN/mm.

Furthermore, the cracks that occurred in the beam were patched with an epoxy-based until it reached the setting time. Then, the beam was reinforced with a CFRP layer. Figure 10 shows a graph of the load vs. deflection relationship of the test results of beam 04 which has been reinforced by CFRP against bending loads. The graph shows that the first crack of the beam occurred when it reached a load of 4.33 kN with a deflection that occurred in the middle of the span of 0.57 mm. The maximum load that occurred reached 67.33 kN at a deflection of 45.38 mm. The maximum deflection at mid-span that occurred just before the beam collapsed was 45.38 mm when the beam was loaded at 58.54 kN.

Figure 10 shows also a comparison of the graph without and with CFRP reinforcement, which shows the difference in stiffness values. The stiffness and ductility of the reinforced concrete beam were 7.59 kN/mm, and 1.86, respectively.

Figure 10 Beam 04 Load-Deflection Relationship

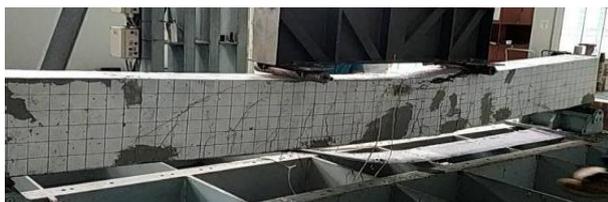
After the beam was reinforced with the CFRP sheet, there were no new cracks occurred in the beam. The test was stopped when debonding occurs between the concrete interface and the CFRP layer, when the load reached 66.65 kN at a distance of one-third of the span, as shown in Figure 11. The bond failure between the concrete surface and the CFRP layer occurred when the concrete had not collapsed as indicated by the concrete strain value 0.000302, which means that the concrete had not collapsed ( $\epsilon_c=0.003$ ); while the strain of the tensile reinforcement had yielded. However, testing continued, so that at this stage only concrete worked to withstand the load on the test object. The beam collapsed at a load of 58.54 kN. Figure 11 shows that the crack pattern that caused the failure was the dominant flexure. Therefore, the cause of the failure that occurred was a flexural failure.

Figure 11 Condition of Beam 04 Collapsed

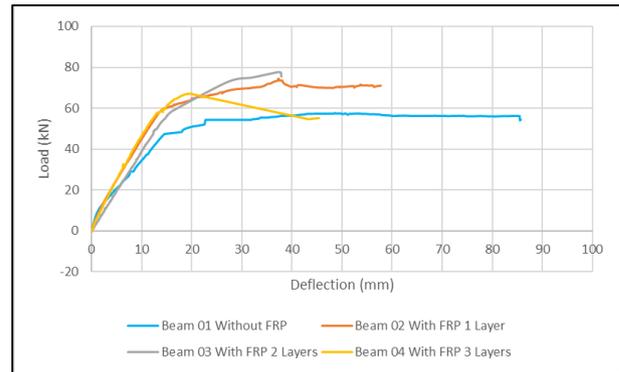
The effect of CFRP on reinforced concrete beams can be seen in Figure 12. From the graph, beam 03 with 2 layers of CFRP reinforcement has the highest increase in strength, which is 34.63% compared to beam 01, which was without CFRP. Beam 04 with 3 layers of CFRP reinforcement has the smallest increase compared to the others, which is 16.58%. This may be because the maximum number of layers of CFRP has been passed so that it has decreased the strength. Meanwhile, from layer 1 to layer 2 there is an increase, it was 29.05%.

Figure 12 Comparison of Load-Deflection

The behavior of reinforced concrete beams after being reinforced with FRP does not differ much in each layer. The ratio of the maximum load of normal concrete with 1 layer of FRP increased by 29.05%, for 2 layers of FRP it has increased by 34.63%, and 3 layers of FRP has increased by 16.58%.
