3D Model of Pavement Distress Based on Road Gradient Using Unmanned Aerial Vehicle

¹Civil Engineering Department, Politeknik Negeri Bandung, Indonesia

ABSTRACT

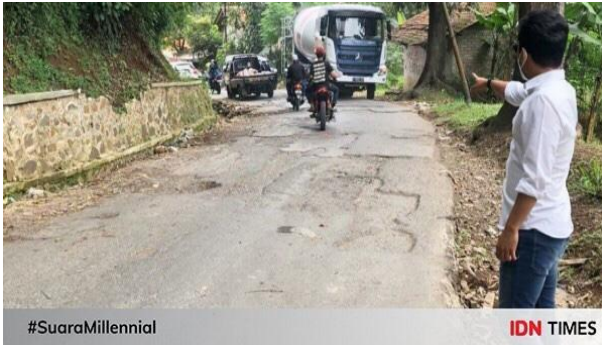
Figure 2. Damaged road due to heavy loading KCIC Project (IDN Times Jabar, 2021).

Since 2018, West Bandung Regency has been an area affected by the construction of the Jakarta Bandung Fast Train (KCJB) National Strategic Project by PT Kereta Cepat Indonesia China (KCIC). The area that experienced the most serious impact from the construction project was Kanagasari Village, Cikalongwetan District. The Walini Tunnel was built along 608m with a diameter of 14.3m which became the first tunnel that was successfully penetrated in this KCJB Project. The impact of the tunnel construction is very visible on the pavement distress of the Cikalong-Cipeundeuy road because the road is access for heavy vehicles to the project (Figure 2).

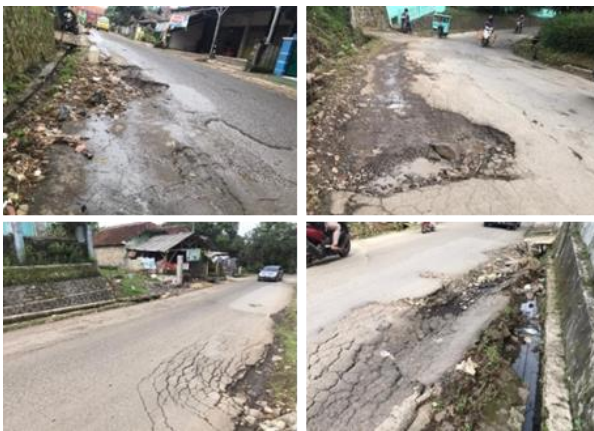
Figure 3. Pavement distresses in Cikalong-Cipeundeuy road.

The pavement distress on the Cikalong-Cipeundeuy road has been very severe and has caused many traffic accidents such as vehicles falling due to the collapsed road causing casualties. The road condition is currently experiencing severe damage along the 4.5km which varied from light, moderate, to severe damage. Pavement distress in Cikalong-Cipeundeuy road can be seen in Figure 3.

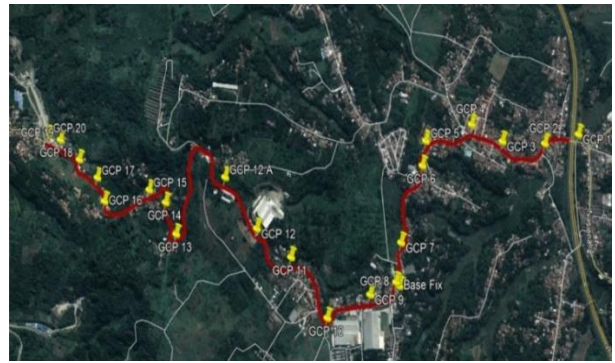
Figure 4. Research object and GCP positions.

The drone used in this study is the Phantom 4 Pro, which has a flight time of up to 30 minutes and has a Two-Frequency Signal Control 2.4 & 5 Ghz with a range of 7km. The drone was flown at a height of 15m and an overlap of 60% to photograph a 4km road with a total of 21 Ground Control Points (GCP) (Figure 4). The shooting was done on 2x projects by dividing 4km into 2 parts (Figure 5). GCP observations were carried out using a Leica 900 Geodetic GPS using the Real-Time Kinematic (RTK) 1 set method. The GCP coordinates are shown in Table 1.

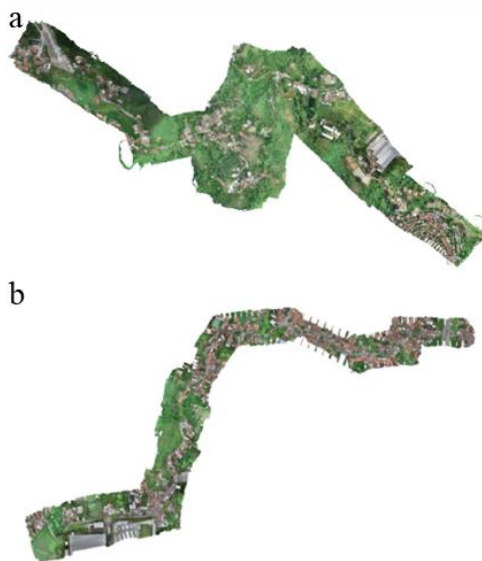
Figure 5. Aerial photo align.

From the results of shooting using drones, 2388 photos were obtained. Furthermore, photo processing is carried out using Agisoft Metashape Professional software. Starting from the Align photo stage, which is reconstructing photos from aerial photos based on flight paths and predetermined conditions such as area boundaries and 60% overlap so that a sequential and orderly overlay of photos is obtained (Figure 5). In this study location, the next step is to input GCP coordinates on each aerial photo. The results of the bundle adjustment process obtained a total RMSE of 2 cm (Fig.5a) and 2 mm (Figure.5b). This RMSE difference is caused at location 5b there is a difference in ground level and more trees which can affect the accuracy of GCP observations in the field. The number of GCPs at location 5a is 9 points less than at location 5b.

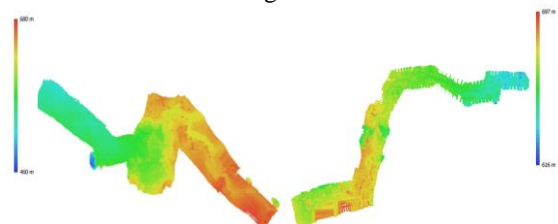
Figure 6. Digital Elevation Model.

The next process is Build Dense Cloud. This process aims to obtain a 3D model based on the classification of points and the level of density of the points used. The higher the quality of the photos used, the closer and more points will be produced. In this study, the process with Medium quality was chosen. After the Dense Cloud Build process is complete, it is continued with the 3D Mesh Build process to display a 3D model visualization based on the overlay of point classification and density resulting from the Dense Cloud process. From the results of the Build 3D Mesh, a Digital Elevation Model (DEM) can be made as shown in Figure 6.

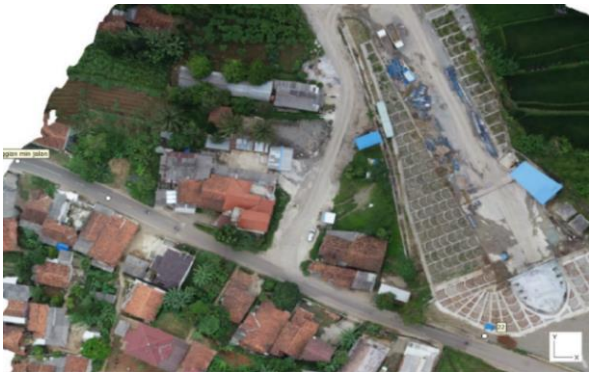
Figure 7a. 3D Model (top view).

The following is a 3D model produced in this study shown from the top view (Figure 7a) and side view (Figure 7b).

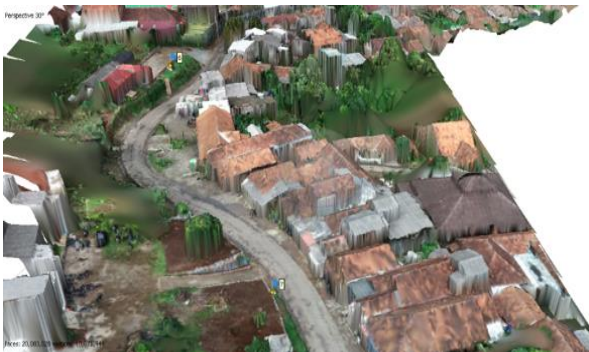
Figure 7b. 3D Model (side view).
