Esthetic Restoration of Enamel Hypoplasia: A Case Report

Maida Fitri^{1,3*} Kamizar, Kamizar²

ABSTRACT

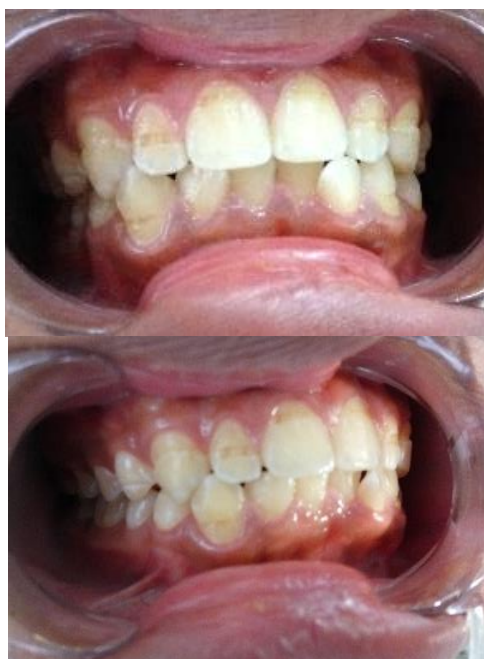
Based on clinical examination, was found enamel defect at 11, 12, 13, 14, 21, 22, 23, 24, 33, 43, 34, and 44. The diagnosis is enamel hypoplasia and the treatment plan is direct composite resin restorations.

Figure 1. Initial photo from clinical examination, above: front view (left), looks right (right)

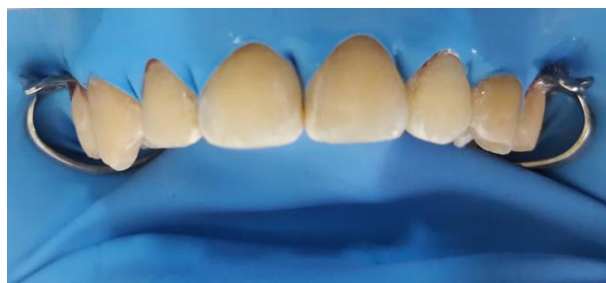
Figure 2. After the restoration of RK to the teeth of the upper jaw

The first visit taking historical and complete clinical examination and continued with restorations in the teeth of the upper jaw, namely 11, 12, 13, 14, 21, 22, 23 and 24. Shade selection should be determined before isolating teeth. The teeth was isolated with a rubber dam (Nictone), then brushed on the labial surface, so that debris and plaque disappear. After that, made a minimal preparation, then the teeth was etched for 15 seconds, washed, applied bonding agent (3M ESPE Adper), and then curing. Restoration used microhybrid composite resin (3M ESPE Z250 Universal) shade A3,5 for lesions in cervical area, and shade A3 for lesions in incisal area, then added translucent color. The application tools restoration instrument (LMarte), used to applied the material and then cured with a unit light-emitting diode (LED) for 20 seconds. Polished the composite resin used polishing tools (soflex 3M).

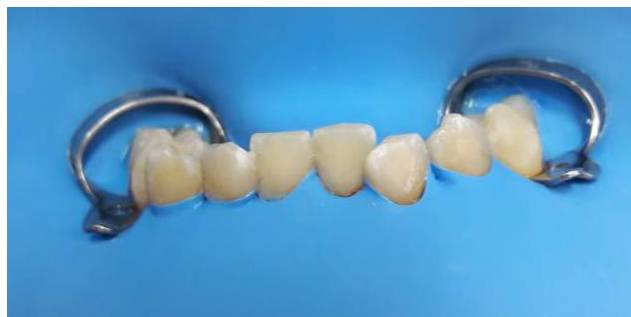
Figure 3. After the restoration of Composite Resin in the teeth of the lower jaw

The next visit, restore the mandibular teeth with the same method. Before teeth preparation, applied the rubber dam (Nictone) then brushed the labial surface of the tooth so that debris and plaque disappear. Then, minimal preparation was done. After that, the tooth was etched, cleaned, and applied bonding agent (3M ESPE Adper) in the cavities. Restoration is done with microhybrid composite resin (3M ESPE Z250 Universal) shade A3,5 for lesions in the cervical area and shade A3 for lesions in the incisal area, then added translucent color, cured with the light-emitting diode (LED) unit for 20 seconds. Polished the composite resin using soflex to made smooth surface.

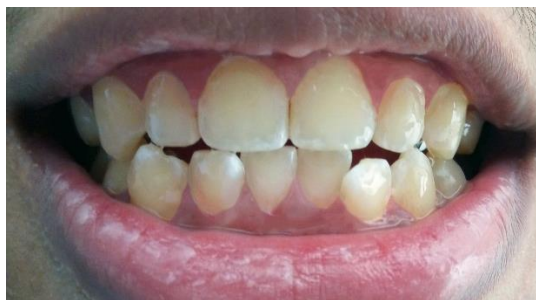
Followed up at 2 months after the restoration and the results showed no complaints from patients. Based on clinical examination restoration complete with a smooth composite surface and there is no discoloration of the restorative material.

Figure 4. Evaluation after 2 months
