Coastal Environment and Ancient Tomb Damage: A Case Study of The Tomb of the King and Hadat Banggae at Majene West Sulawesi Indonesia

The Hadat Banggae Kings Tomb Complex contains 480 ancient tombs. These ancient tombs have been mixed with new tombs, most recently in 1985 the addition of new tombs was stopped. In general, the technique of making graves that is recognized is the technique of connecting in layers and having supporting poles at each corner and having a stone or wooden headstone. In addition, there is also an antero tomb, which is a monolith stone tomb carved into a square shape. Usually there is a hole for a headstone above it. All types of rock that make up the tombs in the Hadat Banggae ondongan Tomb Complex are divided into two types, namely coarse porous coral and fine porous sedimentary rocks. In addition, some tombs use wood for headstone. Of the total ancient tombs, both with and without limbs, there are 68 graves that use wooden graves. The methods are used like field survey, archaeological data collection is carried out by using archaeological survey techniques such as, measurement, and description of damage and weathering at the site. Interviews are used to

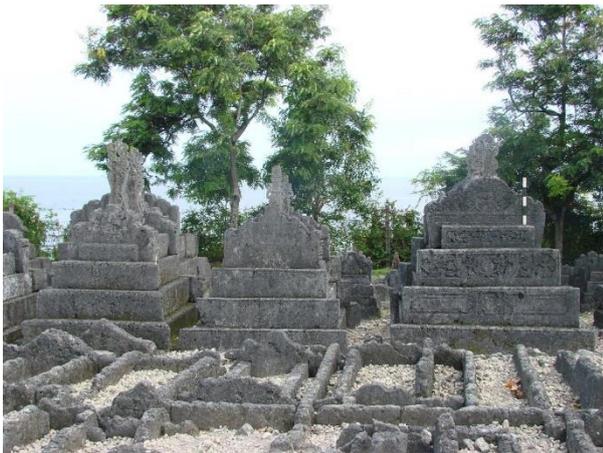
The movement of water and wind that carries salt elements, considering the level of salination of the coastal environment is quite high and the media that carries salt elements or other damaging chemicals. The site for the ancient tombs of the Kings of Hadat Banggae suffered some damage due to the high level of salination (salt).

Besides being able to cause postula on the rock, salt can also corrode, high salt levels can make the rock more brittle, experience degradation.

Figure 1 Physical damage of ancient tombs (Doc. Andi Oddang, 2020)

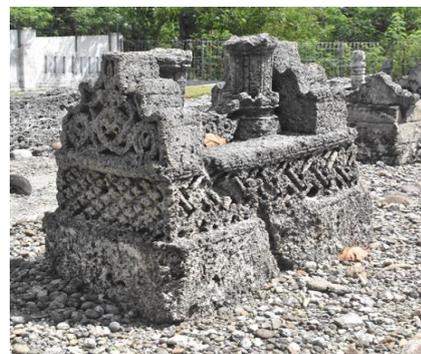
Degradation of materials on cultural heritage objects due to the potential for the environment and climate that carries destructive elements. This destructive factor triggers other damage, such as when the salt content in the rock increases, the salt is carried by water or wind. When the temperature is high, the salt carried by the water enters through the pores of the rock. Salt that has entered the body of cultural heritage objects, if the temperature around the salt is low, then the salt will turn solid in crystalline form. This condition is if the salt has increased the temperature inside the object, then the salt will find a way out through the pore. The pressure of salt will form postules on the surface, a kind of boil or bubble on the surface of the object. If this happens repeatedly and there is no rescue treatment, the postules will break, leaving a trail of holes in the object (see figure 2). The rock surface in the tomb looks rough and in some parts there are holes. Severe cracks in the wall of the mesh.

Figure 2 Physical damage to large cracks in the tomb (Doc. Andi Oddang, 2020)

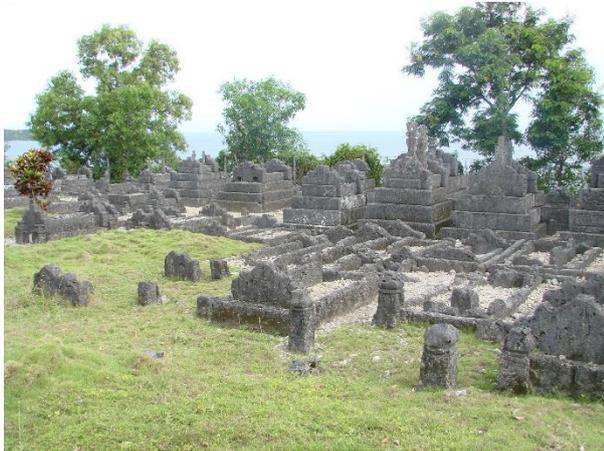
Biological weathering of the stone tombs, some graves are attacked by moss, algae, lichen, and are overgrown with several lower plants. This condition can exacerbate the damage to those previously damaged, both in the unstable position of the tomb and the feeding condition that tends to have degraded material. Damage to graves that have weathered due to moss [11].

Figure 3. Biological Weathering of the ancient tombs (Doc. Andi Oddang, 2020)

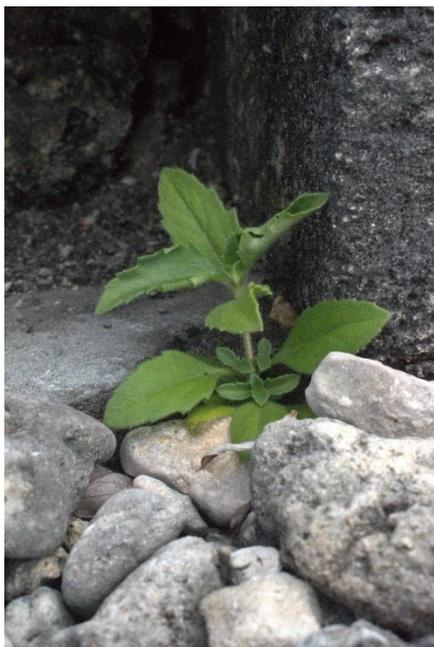
Figure 4 Biological weathering on the stone tombs overgrown with low-level plants (Doc. Andi Oddang, 2020)

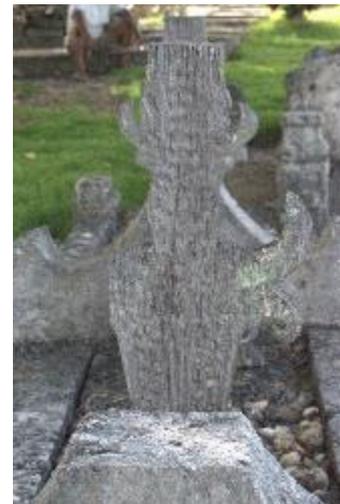
Vandalism in the form of beatings (in the process of making /forming work) can also result in the cracking of the work or the loss of some material. The scavenging and shrinkage caused by temperature can alter the physical properties of brick materials. Heat fertilization or movement can produce a force strong enough to cause a rift [1]. Fractured objects or wakes can be caused by two things, firstly, the shift in the center of gravity of some building components so that there is a shift in the weight force to achieve a new balance, and secondly, due to a decrease in the carrying capacity of the building. under the structure. The shape of the cracks due to the movement of the structure of the building is usually large at the top and smooth at the bottom [1]. This can happen in both stone and wood objects. In addition, uncontrolled human activity factors can be the most fatal cause of damage to cultural reserves. Observations at the tomb complex showed that 37 headstones had suffered mechanical damage in the form of damage and obliqueness. The observable form of damage is fractures and 7 oblique headstones. The damaged part of the headstone is the trunk on the legs and shoulders, as well as the head of the headstone. In addition, on the headstone part is also found fragments of ornaments.

Figure 5 cracks in the wooden headstone (Doc. Andi Oddang, 2020)

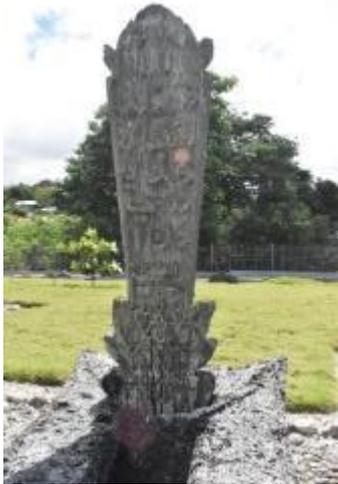
The use on the surface of the wood causes the surface to become slippery so that it is no longer visible. Observations on the headstone show the worn part is found on the motif so that the shape and writing on the headstone is not clearly visible. There are nine worn wooden tombstones.

Figure 6 Wear on the surface of the wooden headstone (Doc. Andi Oddang, 2020)

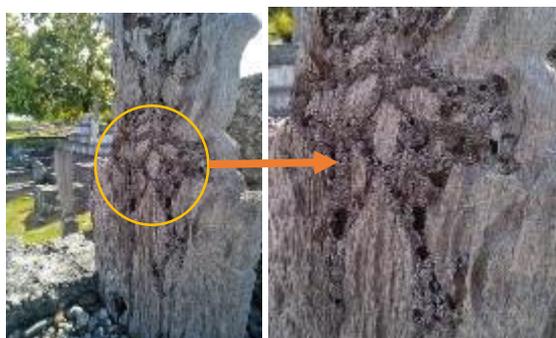
Based on observations, there is a wooden headstone that suffered a termite attack on the body of the headstone. This tombstone is in the first sector area.

Figure 7 One of the wooden gravestones that was attacked by termite insects (Doc. Yusriana, 2020)

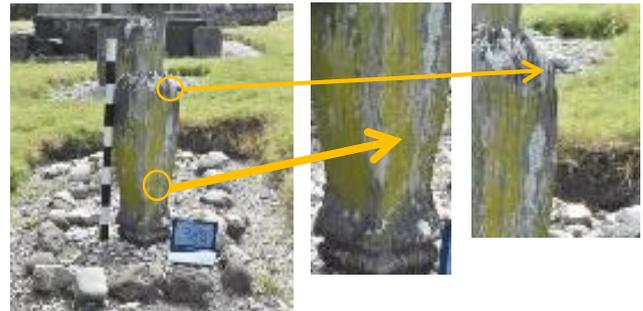
Based on observations, a total of 64 wooden headstones were overgrown with moss. The impact of fungal growth is the removal of stains on the surface of the wood. The resulting stains are green, bright green and blackish. The further impact of fungal growth is to cause weathering. According to the information, the wood material used for the manufacture of the headstone is Sappu wood (Mandarnese language) or ulin. The environmental condition of the headstone is four meters from the ketapang tree.

Figure 8 Moss on the surface of a wooden headstone (Doc. Andi Oddang, 2020)

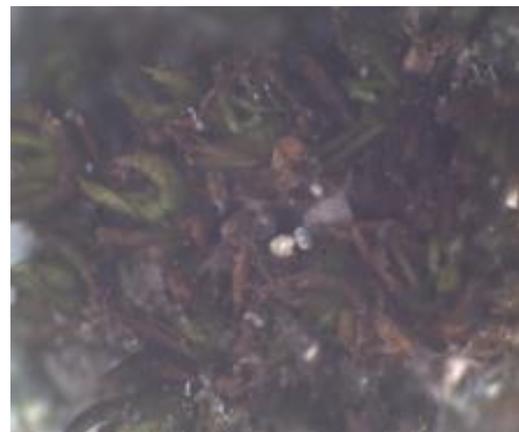
Figure 9 Laboratory identification results of Bryopsisida (Source:: Muda, 2020)

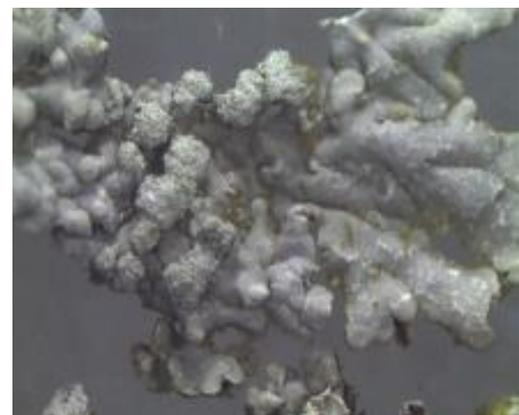
Figure 10 Laboratory identification results of Lichens (Source: Muda, 2020)
