The Dynamics of Changes in the Coastline of the Sayung Coastal Community in Demak Regency Using Remote Sensing Imagery

Abstract. Shoreline changes indicate dynamic events in coastal areas. Communities around the coast will feel the impact of changes in the coastline. The purposes of this study are (1) to analyze the level of shoreline change from 2015 to 2021 and (2) to analyze the effect of tidal flooding on shoreline changes in Sayung District, Demak Regency. This study used descriptive qualitative analysis and the Normalized Different Water Index (NDWI) method and conducted accuracy and validity tests. Analysis of tidal flooding is a factor that influences shoreline changes by using an analysis of the distribution of affected areas so that areas that often experience tidal flooding can be identified. (1) The results of this study are significant abrasion and accretion from 2015 to 2021 in a coastal village with a beach length of 20.9 km which has experienced 122.14 Ha of coastal abrasion and 17.53 Ha of accretion with an abrasion percentage (86%) and accretion (14%). Overall rate of abrasion (17.44 Ha/year) and accretion (2.50 Ha/year). (2) Tidal flood areas that occur in coast

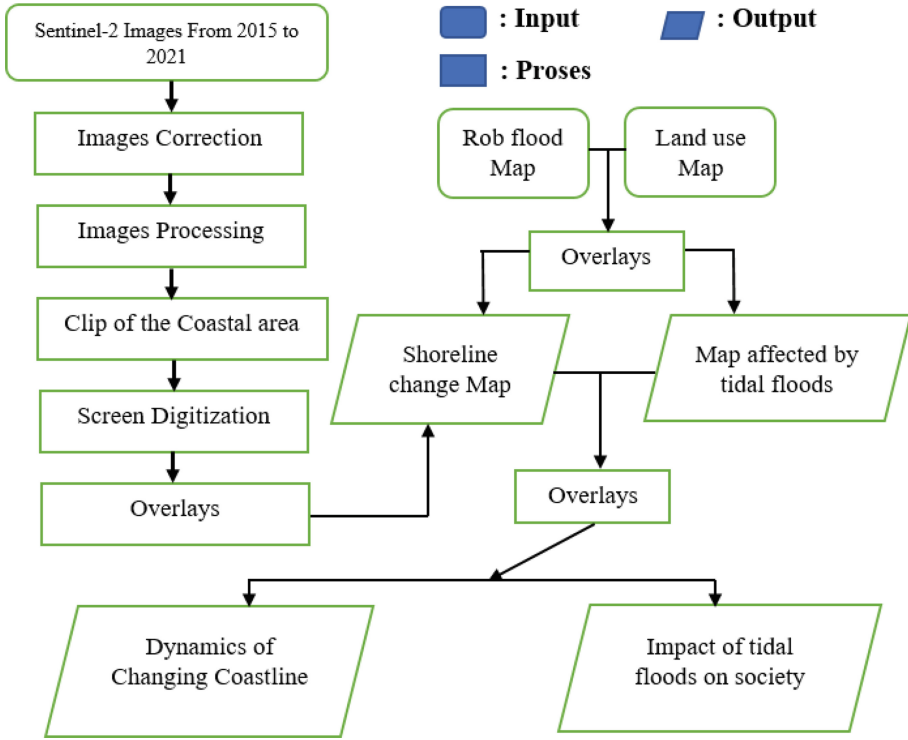
Fig. 2. Research flow chart

The overlay technique in this study was used to determine the level of shoreline change and the effect of tidal flooding on shoreline changes as information for researchers to compare multitemporal changes. Overlay method between the 2015 shoreline change map and the 2021 shoreline change map. The output of the overlay results is a shoreline change map which can be analyzed using a descriptive method. Spatial analysis was carried out to analyze the degree of shoreline change using a method that is commonly used, namely the calculation of the End-Point Rate (EPR). The latest data or in the following year. From these results it can be seen the level of shoreline change and the impact of shoreline changes for communities around the coast of Sayung District, Demak Regency. And also descriptive analysis of the data analysis method used to identify shoreline changes is descriptive analysis (Sujaweni, 2014). To get the results of this study through the stages in Fig. 2.
