Add Water and Get Problems, to Solve: Geotechnical Problems with Steep Rock Faces in Soft Sandstone and Limestone Varieties, Including the Effects of Water

Ulf Köhler^(✉) and J. Engelhardt

geoplan-ingenieure Dr. Köhler GmbH, Weimar, Germany
post@geoplanweb.de

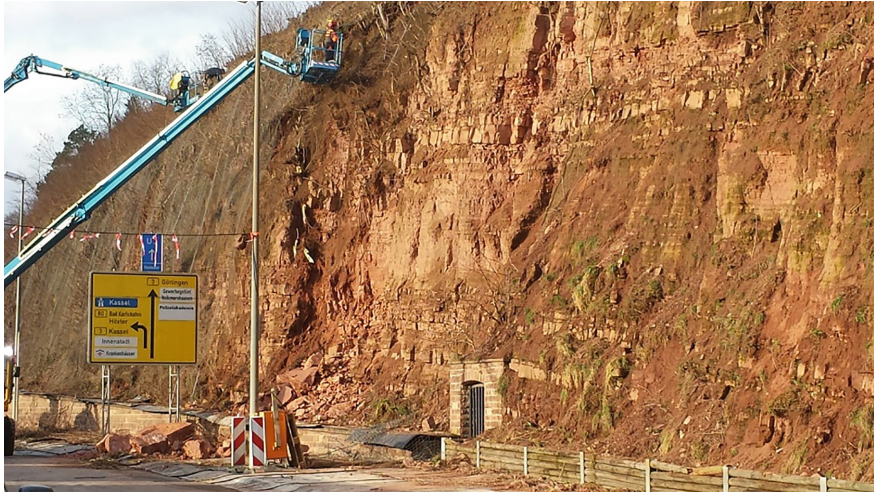
Fig. 2. Rock face in sandstone with strong signs of alteration after about 55 years of standing.

The mechanical behavior of a weathered layer that gradually develops on the surface of rock, is not to be described with the properties of rock, but with those of a soil. In this case, the friction angle of the resulting soil (25...35°) on it's own is much lower than the inclination of the created slope (70...85°). This soil is therefore not stable at all (Fig. 1-left and Fig. 2).

A particular case of a rock construction project in the Weser Sandstone (Early Triassic - Sollingen Formation) (Figs. 2 and 6) gives many important hints to these questions. An existing cut slope, which was constructed in the 1960s and secured only with a slack mesh without extensive anchoring, had already shown striking material erosion and local landslides for several years. The slope itself appeared to be largely stable. The weathered layer to be used for the design was initially estimated to be 50 cm thick. After

Process (a): Observation and geological measurements during the construction period showed that the entire rock face (Fig. 2) has apparently relaxed since the cut was made, so that not only water pressure, but also various tension cracks in the structure had to be considered. Tension cracks of different depth and inclination ($78...90^\circ$) were assumed (Fig. 9).

Process (b): Observation during the construction period showed (Fig. 2 / Fig. 6) that the surface of the rock face is intensively loosened by weathering processes after completion of the construction work. In addition to the adaption of the anchors for the processes (a) and water influence, it was necessary to cover the rock surface with erosion protection mats in a partial area of the mesh. The covering can be differentiated, and has not to be continuously.

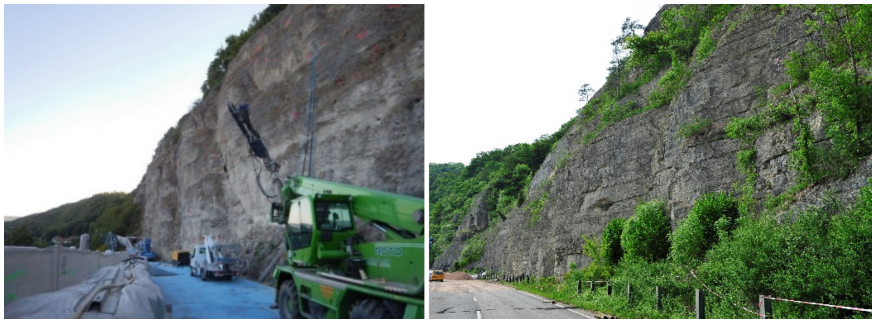
Fig. 5. Two construction projects (Dornburg-Camburg and Holzminden) which are geologically very similar but 200 km away from each other

The two construction projects in Fig. 5, which are geologically very similar but 200 km apart from each other, had a number of similar features that determined the structure and degree of weathering of the entire rock face at elevations up to over 40...80 m. In both cases, bed rocks were significantly formed by river erosion combined with folding processes and disruption, resulting in the typical K1-K3 alignment. Another significant influence on the stability was the cutting of roads, which made the rock faces significantly steeper.

Let’s look at one of the two construction projects, the one on the right in Fig. 5 (Fig. 11).

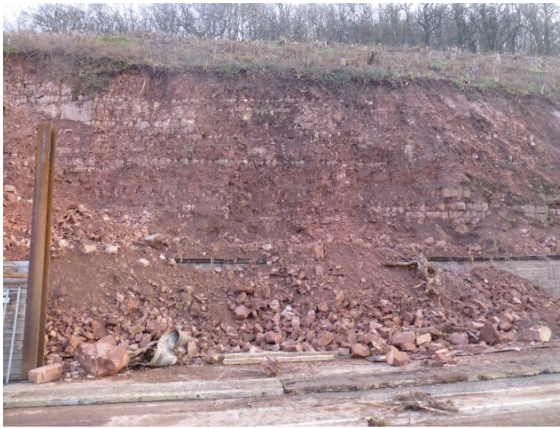
Fig. 6. Sandstone slope with the eroded weathered layer.

the slope had been cleared, relevant deep-reaching loosening in the rock structure became apparent. During the 55 years of operating, weathered shells of up to 1 m thickness and locally deeper fissures had formed in large areas as a result of loosening. Individual larger and smaller rock towers up to a maximum height of about 7 m have collapsed (Fig. 6).

Every cut in a rock face changes the previous equilibrium. Loosening processes, as shown in Fig. 7, are the result. The decisive factor is the size of the rock fragments that will gradually form. The main effects are frost in combination with fissure water, water pressure and hydromechanical processes, which can lead to outpour of weathered material (Fig. 6).

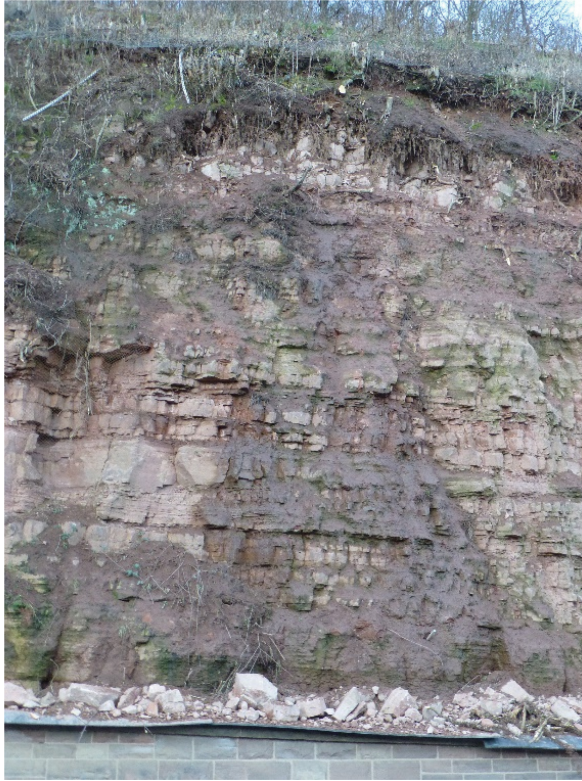
Fig. 8. Fissure water leakage (intermittently, after precipitation) from the sandstone slope

The rock face in Figs. 2, 6 and 8 has been flowed through for a long time during the construction period, when it rained. During this time, fissure water has been formed in the slope and has flowed through the freshly exposed rock surface and leaked at different heights (Fig. 8).

These water leakages were initially not visible, because the weathered shell had detached itself from the faultless rock face, due to a significant opening of fissures, long before the construction work started.

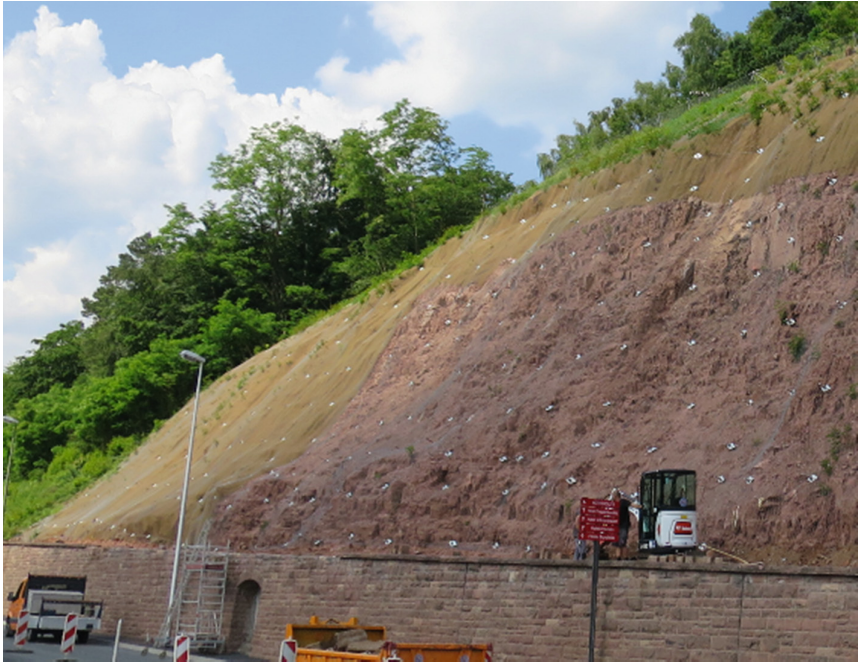
Fig. 10. Construction after completion with erosion protection mats applied in certain areas.

For these areas it was assumed that the weathered layer could be up to 1m thick. The design of the mesh was dimensioned for 1 m weathered layer and permeability. Figure 10 shows a part of the measure after completion with anchors, mesh and partly with erosion protection mats under the mesh.

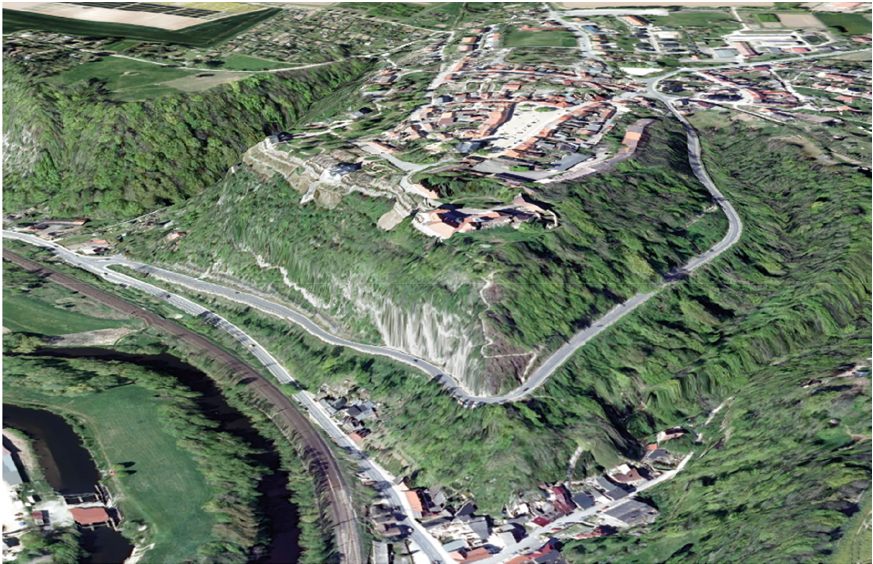
Fig. 11. Overview of the whole slope area and the Saale river on the left hand side – view to south-western direction [Data source: DOP20 and DEM1 – GDI-TLBG 2020].

The construction section is located on the west side of the erosion valley of the Saale river in eastern Thuringia. Geologically the construction section starts just above the

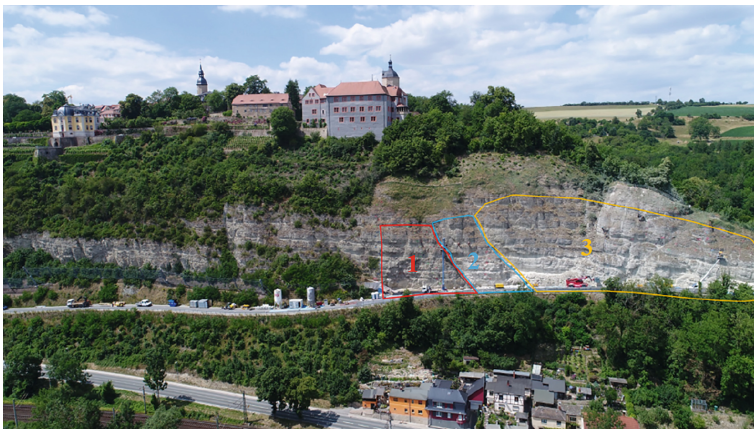
Fig. 13. Division of the wall into three structural complexes

The rock face was divided up into 3 structural complexes (SC) with typical features after the geological survey and evaluation of the drone images (Fig. 13):

- SC 1 – pillars
- SC 2 – shells
- SC 3 – strains, overhangs, bulges.

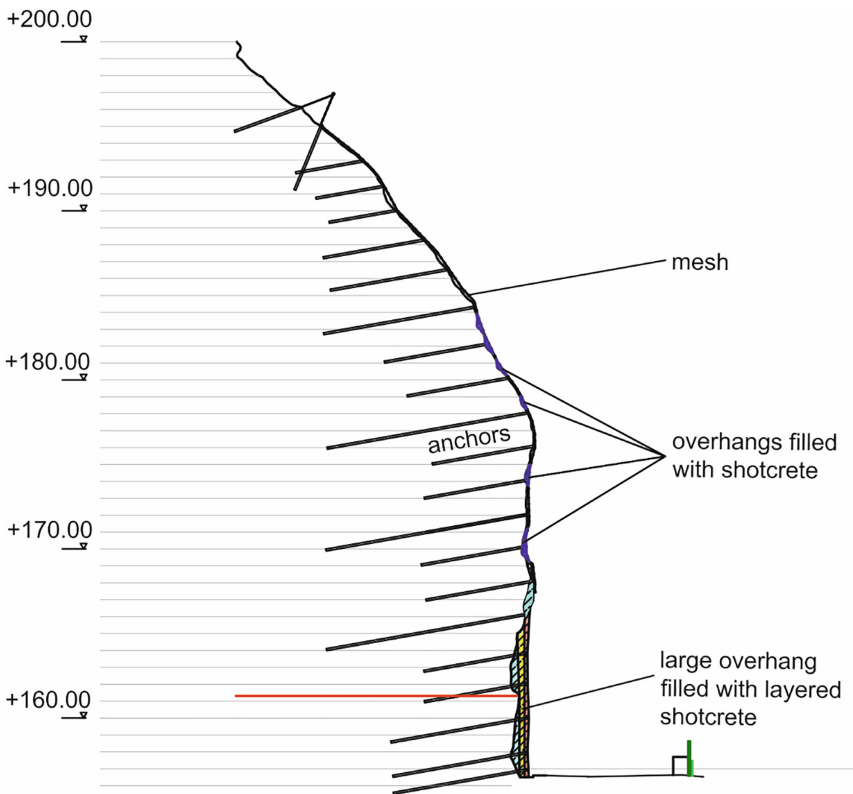
Fig. 18. One of many design sections - simplified

by long anchors until a sufficiently stable “monolith” is formed. Structurally unstable areas had to be filled with shotcrete in several stages. Reinforced shotcrete could only be installed after 1 or 2 unreinforced layers had been installed. In some areas, a set of anchor plates was placed on top of the anchors prior to the final shotcrete shell in order to increase stability during construction. The construction process was therefore very challenging. It was necessary to adjust the final design step by step considering all observations on site, especially the results of many anchor stress tests. Figure 18 shows one of the many cross sections.

Areas with overhangs, which had to be filled with shotcrete before installing the anchors. Are marked in blue (Fig. 18). Below, blue/yellow/red show the three layers of reinforced shotcrete that were required to fill the largest voids. Step 1: blue- 1st layer of shotcrete; Step 2: Drilling of anchors and installation of 1st set of anchor plates to

ensure bonding of anchors to reinforced shotcrete in the time before completion. 3rd step: installation of 1st layer of reinforcement and application of “yellow” shotcrete. 4th step: Installation of 2nd layer of reinforcement and application of “red” shotcrete and installation of 2nd set of anchor plates. Red lines show the location of the main K1 fissures. The majority of anchors reached at least 2, the longer ones reached 3 shells. The analysis showed that not all anchors needed to be anchored in the 3rd shell.

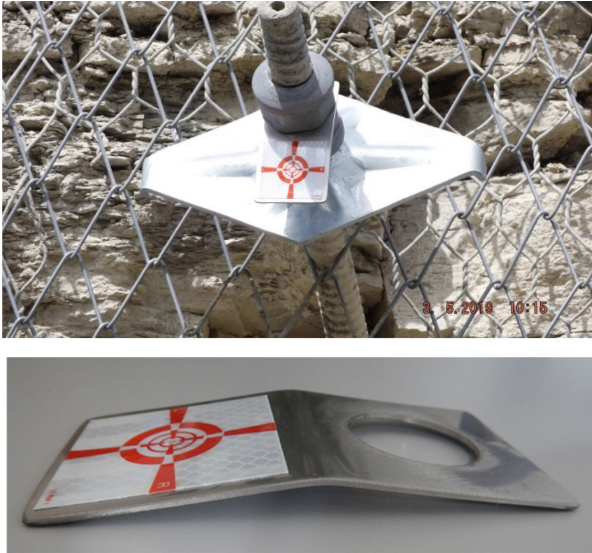
Fig. 20. Measuring marks

The measuring marks (Fig. 20) have a size of 7x14 cm, with a hole in the upper half so that the plates can be pushed onto the anchors/nails. A target is attached to the lower half of the plate, which is very easy to aim at for tachymetric measurement and can also be identified very well in the drone image. The plates have been angled in the middle so that the measuring marks can be targeted when surveying from the road.
