On the Use of Dips and RocFall for Designing Structures in Highly Fractured Igneous Rocks in the Chilean Patagonia

Néstor René Espinoza Guillén¹(✉), Jorge Andrés Arriagada Triana²,
and Lorna Andrea González Martínez¹

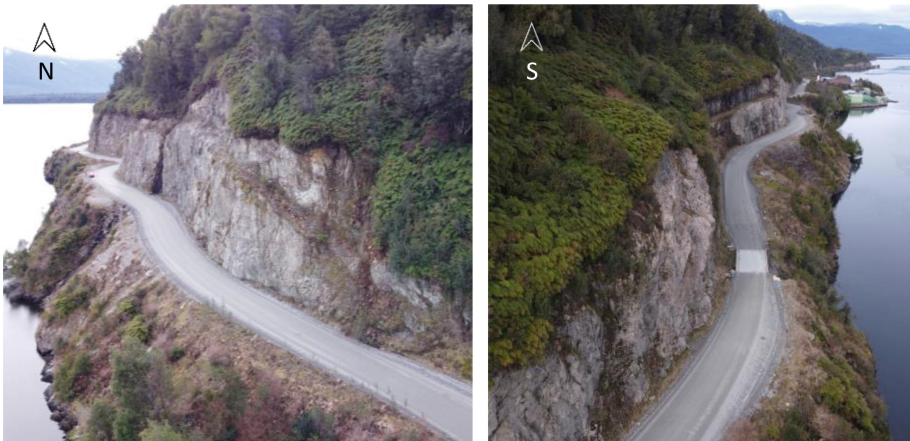
Fig. 2. Images from the low drone flight during the fieldwork at Route 7. August, 2022

that will be accompanied by cutting and securing slopes of varying heights from a few meters to more than 70 m in some sectors (Fig. 2) in a mass of very fractured igneous rock that tends to form blocks of different geometries and with different types of failure possibilities.

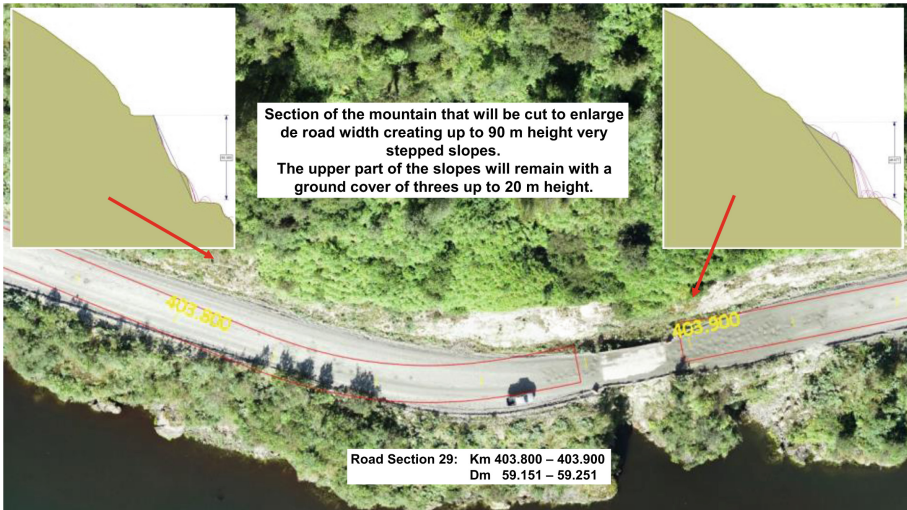
Fig. 5. Possibility of a generalized shear failure of the fractured rock slope, both before the planned blasting works, and after those works, considering the use of presplitting in the blasting plan

overturning on a flat base is considered, the situation changes since in general there are 5 critical cases out of a total of 52 with a probability of occurrence of only 9.62% and 5 critical cases if the family of discontinuities 3 is considered for 16 possible cases with 31.25%. For the case of flexural overturning, there is only one critical case out of 52 possibilities, leaving a probability of occurrence of only 1.92% (Fig. 5).

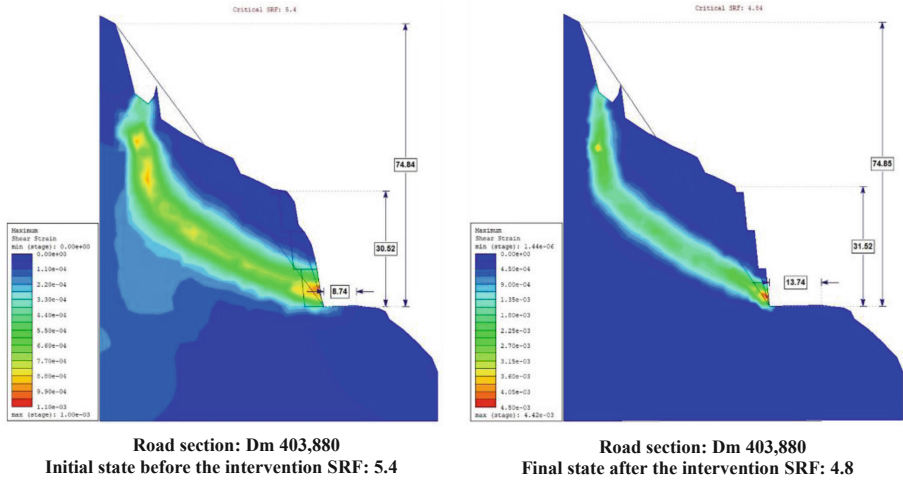
Fig. 6. Possibility of a wedge failure of a block of intact rock over the intersection of two discontinuities of section 4

Once the safety of the road from a possible fall of rock blocks was determined, a model was created using the RS2 program. The model included the three most important families of discontinuities in the rock mass properties with the objective to determine the possibility of a failure due to a general cut in the slope, before and after the intervention to widen the road. Said intervention will consist of cutting works using explosives that will create slopes reaching up to 90 m in height in some sectors. Due to past experience of damage to the rock mass, it was therefore recommended to proceed with blasting, considering the use of precut or controlled blasting techniques (Fig. 6).
