Study on the Influence of Non-Uniform Corrosion on the Reliability of New Steel-Mixture Composite Bridge

Abstract. The ABAQUS software was used to study the effect of non-uniform corrosion on the reliability of the new steel-concrete composite girder bridge. The non-uniform corrosion mechanism was analyzed, and the formation process of the pitting corrosion pit was known. Combined with Python programming, the random etching pit of the structural floor was established, and the stress of the steel bottom plate of the new steel-concrete composite beam bridge before and after corrosion was explored, and it was found that the stress of the steel bottom plate in the middle span under non-uniform corrosion increased by 18.2% compared with the non-corrosion. Further calculating the reliability index of the bridge before and after corrosion, all met the requirements of the specification, and it was found that the reliability index of the new steel-concrete composite girder bridge under non-uniform corrosion was reduced by 15.5% compared with the non-corrosion.

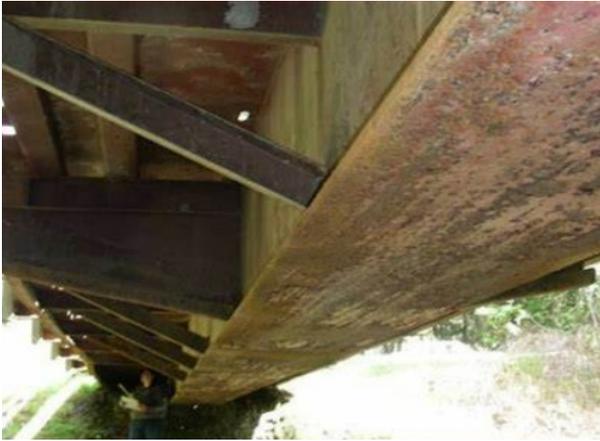
Fig. 1. Corrosion diagram of steel structure

The traditional corrugated steel web composite box girder is easy to crack the concrete bottom plate under the action of positive bending moment^[9]. In recent years, domestic scholars have improved it, and put forward a new type of steel-concrete composite structure -- corrugated concrete composite structure bridge with steel bottom plate. After the concrete bottom plate is replaced by the flat steel bottom plate, the structure's self-weight is further reduced, the use of concrete is reduced to a certain extent, the problem of domestic steel overcapacity is solved to a certain extent, the construction process is reduced, the construction cost is saved, and the structure has good economic benefits^{[4][6][16]}. Gansu has a vast area, diverse geology and climatic types. In general, the climate is dry, and the temperature difference between day and night is large. The corrosion problem of various types of salts, especially in the environment of de-icing salt, is more serious (Figure 1). Due to the initial defects of bridge manufacturing process, non-uniform corrosion often occurs.
