# Study of the Durability and Strengthening of Historical Building Construction in Yogyakarta

## ABSTRACT

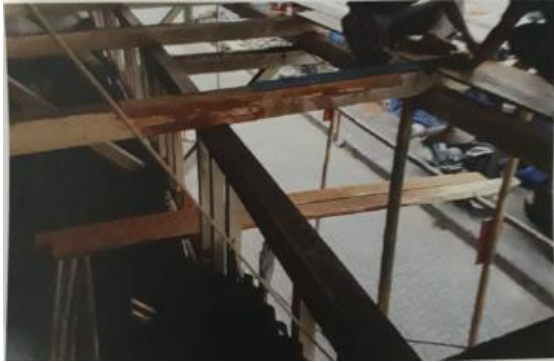
It is undeniable that the age of the building is a matter of concern in renovation and rehabilitation work, many wood materials have been damaged, especially porous, weathered, as shown in **Fig. 1** and **Fig. 2**.

Fig 1. Gandhok Kilen roof truss

From **Table 1** above it can be seen that the roof is a critical component, because the main pattern of damage starts from the damaged roof covering so that rainwater can enter through the gap. Because the incident had been going on for a long time and was not immediately repaired, damage such as weathered, porous and moldy occurred in the framing components of the trusses, rafters, battens, beams, even to the column structure that supports the trusses. Apart from that, from the narrative of Pura Pakualaman, the roof components have high material value because they use high quality teak wood from Perhutani and are quite a complicated part of the work.

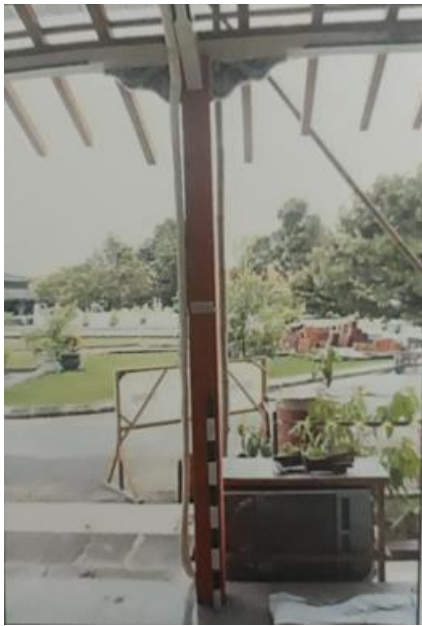
Fig 2. Replacement of saka wood (columns) in the Gandhok Kilen Building

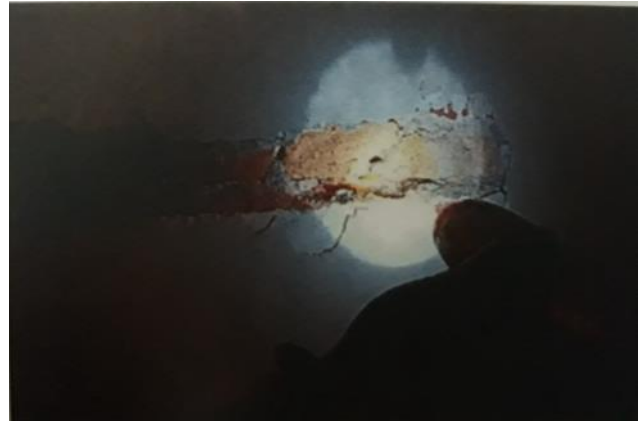
Another factor causing damage to the Pura Pakualaman building was the 2006 earthquake which cracked the walls at several points. The improvement efforts that have been made are by the grouting method, shown in **Fig 3**, **Fig 4**, **Fig 5**, and **Fig 6**.

Fig 3. Cracks in the Parangkarsa Building Wall

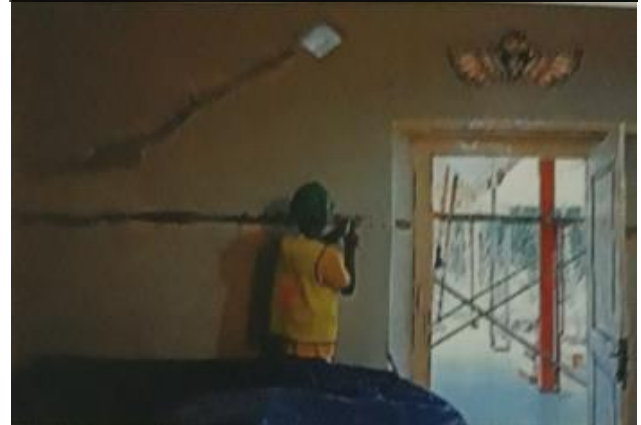
Fig 4. The Wall Breaking Work of the Parangkarsa Building

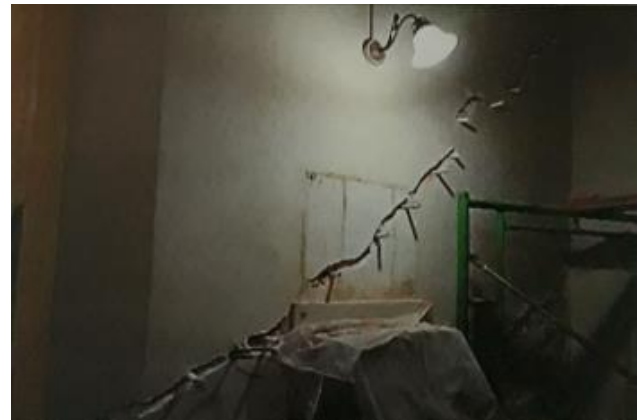
Fig 5. Pipework for Sikagrout Injection

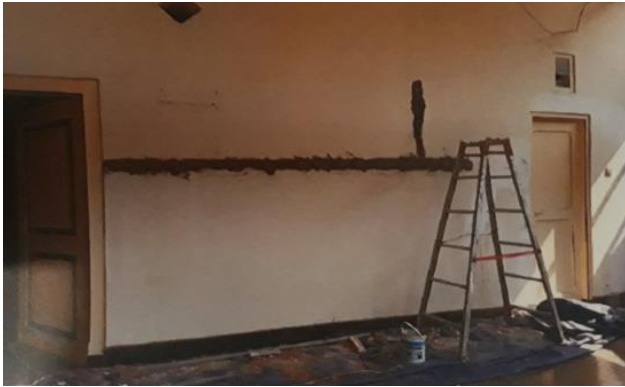
Fig 6. Final results of grouting work
