Analysis of low fuel pressure on the common rail system on the engine of wheel loader WA500-3 (case study at PT Sapta Indra Sejati site Samarata)

Denny Hendra Cipta, Ismail Ramli

Politeknik Negeri Nunukan
Nunukan, Indonesia

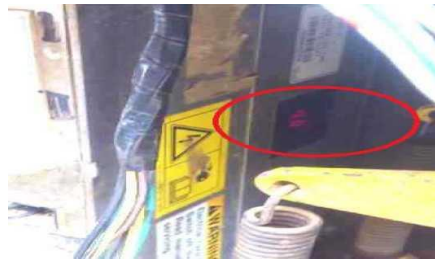
Inspection then carried to the Engine Control Module. The screen shows error code 7b. According to the shop manual this means: no-pressure feed by supply pump. Based on this data, it can be assumed that the next action is to check the unit's fuel system. these inspection steps are: conducting a visual inspection of the fuel pump, primary pipping, common rail and secondary primary pipping by starting the engine at low idling and stopping the engine, so that afterwards conduct a visual inspection of these components, to determine whether there are signs of leakage or seepage of fuel (diesel) in these components. The ECM is shown in Fig.1.

Fig. 1. Inspection on the ECM information screen

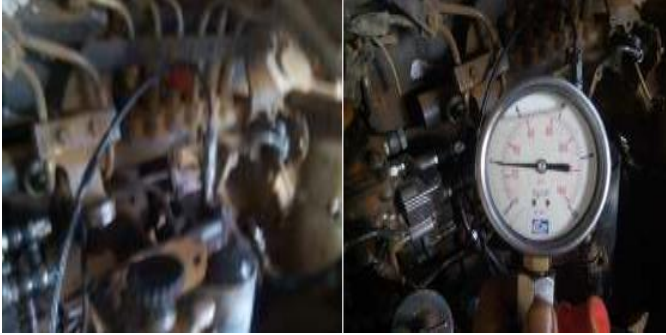
Measurements are made with measuring tools in the form of a 10 kg / cm² pressure gauge which is installed at the measurement pressure tap point located between the feed pump-fuel filter-supply pump. After the tools are installed, start the engine with a high idling position, so that the needle of the pressure gauge moves and shows the system pressure. The low pressure circuit measurement is shown in Fig.2.

Fig. 2. Low pressure circuit measurement

The result of the low pressure circuit pressure measurement is shown in Table V. This shows that the actual value is still within the allowable value. This means that the low pressure circuit is in good condition.

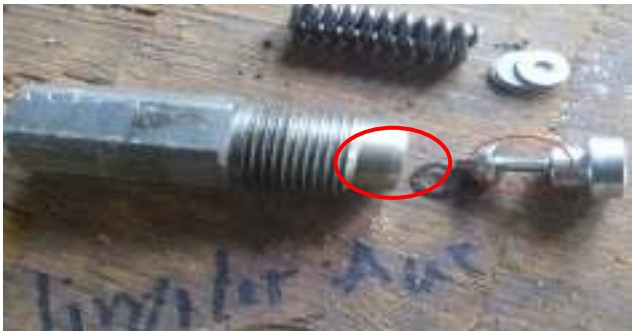
Based on the results of the MCR (Machine Condition Report) data obtained, it is concluded that there is wear on the pressure limiter inner parts valve (guide), which resulted in leakage of the pressure limiter from the common rail. The guide in the pressure limiter is shown in Fig.3.

Fig. 3. Pressure limiter valve guide

The wear on the valve guide causes pressure leakage. The pressure limiter valve opens prematurely (opens before reaching the specified pressure) so that the pressure on the common rail is inadequate to push fuel on the injector (fuel low pressure in common rail). The low pressure also means less volume of fuel sprayed by the injector into the cylinder, resulting in symptom of low engine power

Wear on the guide because the guide is a component that rubs directly mechanically with the body. The friction is driven by fuel pressure after the fuel pressure reaches 140 Mpa (1430 kg/cm²) setting the pressure limiter, thus opening the fuel line. After the fuel pressure returns to normal, it will be pushed back by the spring to close the fuel line after the pressure returns to normal below the pressure limiter setting.

After it is known that there is an abnormality in the measurement results of from pressure limiter fuel drainage volume, it is confirmed that there is a fuel leak from the common rail leading to the return channel of the fuel tank. Thus, the solution to the problem is to replace the pressure limiter assembly in accordance with the recommendations from the WA500-3 shop manual.

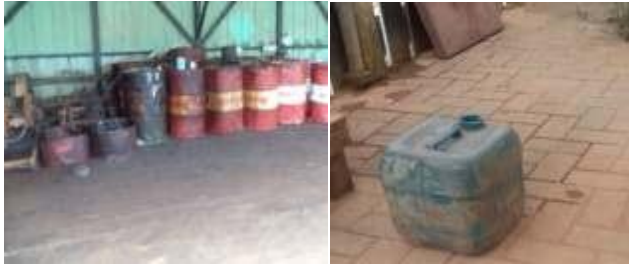
The wear also can be caused by the use of contaminated fuel which causing the loss of lubrication properties of the diesel fuel. Contamination of fuel can be caused by diesel fuel mixed with water and exposed to sunlight (heat), this occurs due to inadequate storage such as storage in an open area that is subjected to rain, sunlight and condensation. The actual fuel storage in the field is shown in Fig.4.

Fig. 4. Inadequate fuel storage

In addition to replacing components, diesel fuel samples were taken from the wheel loader unit to check for contaminants in the fuel also fuel quality standards and storage standards are established to ensure that the fuel remains free of contaminants to prevent unnecessary wear on the fuel system components.
