# Comprehensive Detection Method and Leakage Prevention Measure for Classical Garden Pond

**Abstract.** The issue of leakage in classical garden ponds after prolonged use is highly pronounced. The exerting effects are not only detrimental to the overall landscape of the garden but also lead to the wastage of valuable water resources. This paper takes the detection and remediation project of leakage in a classical garden landscape pond in Shanghai as a case study. Focusing on the formidable challenges encountered in investigating leakage in classical garden ponds, demanding on-site implementation conditions, and the elevated requirements for surrounding environmental conservation, a comprehensive approach encompassing terrain measurement geological exploration, and high-density electrical resistivity non-destructive testing is employed to conduct leakage detection in the ponds. This approach enables the accurate identification of leakage locations and the targeted establishment of flexible vertical impermeable barriers. Through comparative analysis utilizing water level monitoring, it is demonstrated that this leakage prevention remediation initiative effectively resolves the issue

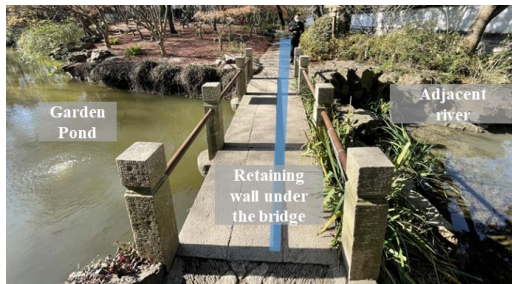
southern China. Within the garden, there is a scenic water pond located adjacent to the river on the northern side, with stone revetments lining both sides of the river. Between the pond and the revetments, a concrete retaining wall of unspecified dimensions has been constructed, as depicted in Fig. 1. Since 2021, the water level in the Qiuxiapu pond has been steadily decreasing, accompanied by evident signs of water leakage. Automated water level monitoring data reveals an average daily decline of approximately 3.5 cm, with a daily leakage volume of approximately 65.6 m<sup>3</sup>.

**Fig. 1.** Laylayout of pond and river

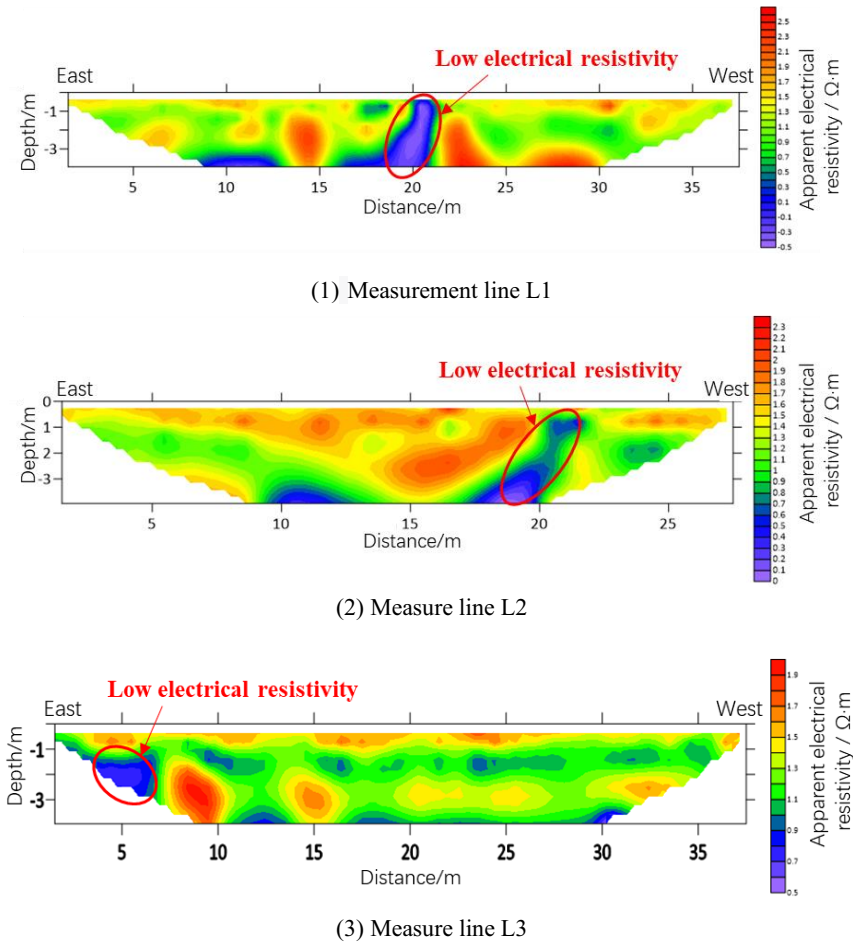
The data obtained from non-destructive testing is subjected to inversion processing to obtain the resistivity-depth profiles of each survey line position, as illustrated in Fig. 4. The detection profiles indicate that the overall impedance within the survey range is homogeneous, with only a localized relative low-resistivity anomaly enclosed within the red contour. Through comprehensive analysis considering the field conditions, it is evident that significant low-resistivity anomalies exist in the resistivity profiles at positions 18.5 m to 21.5 m along survey lines L1 and L2, while the resistivity profiles at other positions of these survey lines exhibit good layering characteristics. Furthermore, the low-resistivity anomaly observed at positions 0.0 m to 6.0 m along survey line L3, in close proximity to the river channel, is attributed to the presence of high water content in the soil layers adjacent to the river. The resistivity profiles at the remaining positions of survey line L3 demonstrate overall good layering characteristics without any significant anomalies. Based on comprehensive analysis considering geological

survey results, the suspected locations of leakage channels are circumscribed as shown in the following figure. The notable thickness of backfilled soil at this location, coupled with a relatively high moisture content below the initial water level, constitutes the primary cause for the occurrence of anomalies.

Fig. 4. High-density electrical resistivity testing achievement profile

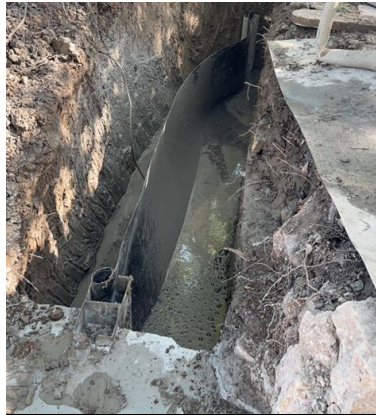
**Fig. 5.** HDPE-bentonite composite leakage prevention system

Taking into account the leakage location, causes, and on-site construction conditions, the proposed leakage prevention measure entails the implementation of a flexible leakage prevention barrier between the north side of the pond and the river channel, thereby interrupting their hydraulic connection while preserving the hydraulic circulation within the pond and its surrounding environment. To ensure an effective leakage prevention outcome for the landscape pond and enhance its practicality and longevity, an innovative composite leakage prevention system using HDPE and bentonite (Fig.5) has been employed.

The impermeability of the HDPE membrane flexible vertical impermeable wall is more than 100 times that of the traditional rigid vertical impermeable wall, with an extremely low permeability coefficient ( $k < 10^{-12}$  cm/s). It possesses high extensibility, strong formability, and applicability to various terrains. At room temperature, the material exhibits excellent corrosion resistance and durability<sup>[5]</sup>. To prevent the interstitial space between the impermeable membrane and the foundation trench from becoming a leakage channel, self-healing mineral soil such as bentonite<sup>[6-8]</sup> is used as backfill material. By introducing high-purity natural cohesive soil to the conventional cementitious matrix, the self-compactness and impermeability of the material are improved, and it can bond with the surrounding soil to form a unified whole. This approach is environmentally friendly and non-polluting because it significantly reduces cement consumption. By innovatively combining these two materials, a dual impermeable system is formed, effectively compensating for the shortcomings of a single impermeable material as an isolation barrier.

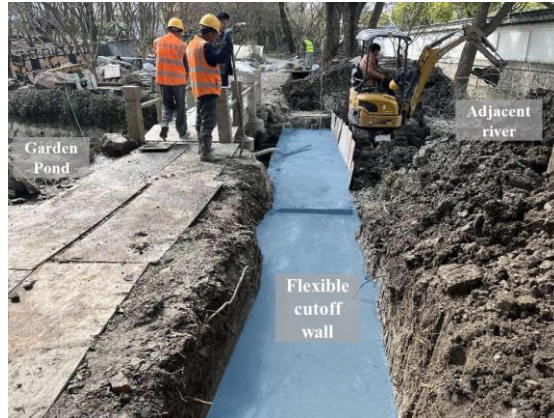
**Fig. 6.** Flexible cutoff wall construction

The specific implementation process is as follows: (1) A cofferdam is constructed outside the original retaining wall position on the north side of the pond and at the narrowest part in the middle. The pond water is then drained to provide construction conditions. (2) The original brick retaining wall is preserved, and a trench is excavated along the inner side. The length of the trench is approximately 40 m with a width of 0.8 m. The actual excavation depth is based on reaching a depth of 0.5m into the second layer of silty clay. Excavation is carried out in sections, and timber supports are placed on both sides of the trench to prevent collapse. (3) The bottom of the trench is cleaned, leveled, and compacted. Along the centerline of the excavated trench, a 3-meter-long galvanized double-hole steel square tube is buried every 3 meters. The verticality must be ensured during the insertion process. (4) HDPE impermeable membrane is inserted into the double-hole square tube, with the impermeable membrane passing through fine slits on both sides of the square tube. The square tube is then filled with a specially formulated impermeable liquid. (5) Grout is injected on both sides of the impermeable membrane, and after the grout is filled, the timber supports are removed. The flexible impermeable wall is then cured for a period of time to form a complete structure, as shown in Fig. 6. (6) After the construction is completed, the ground is restored by back-filling soil and landscaping. The cofferdam is removed, and the pond is filled with water to restore its original appearance. Subsequent water level monitoring is conducted. The construction adopts small-scale construction equipment and low-carbon construction techniques, which not only ensures the landscape of the pond during the construction process but also minimizes noise generation, thereby reducing environmental impact.

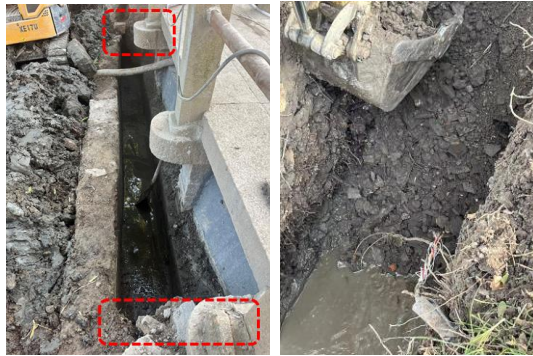
During the process of governance, it was discovered that large amounts of tiles and construction waste, approximately 30cm thick, were present below the 1.5m depth of the west-side backfill, forming multiple direct leakage channels. Additionally, evident leakage channels were observed at the junction between the two sides under the bridge and the middle of the original concrete dam on the north side, as shown in Fig. 7, which is consistent with the results of the previous leakage detection.

Fig. 7. Leakage location and situation

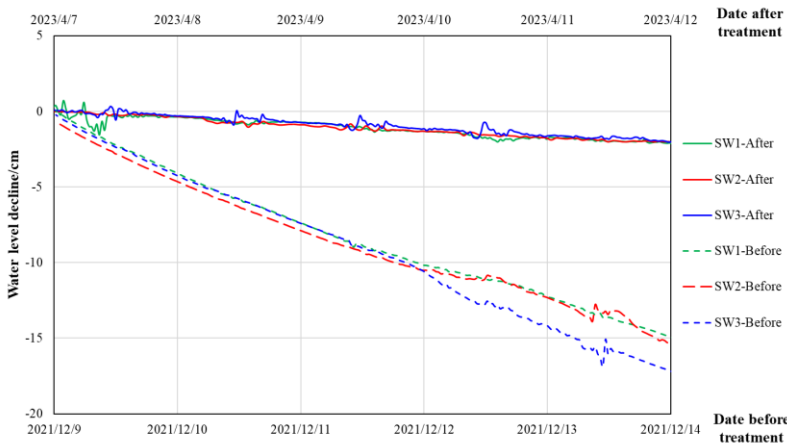
In early March 2023, the on-site implementation of a flexible leakage prevention barrier was completed. After a period of maintenance, the ponds were filled with water, and the automated water level monitoring platform continuously monitored the water level changes. Currently, over a month has passed, and by comparing the water level data of the ponds before and after the remediation (Fig. 8), it can be observed that the water level at the SW2 monitoring point on the north side of the pond, as well as the water levels at SW1 and SW3 on the south side of the second-phase pond, have remained relatively stable. The rate of water level decrease has significantly reduced from 3.44 cm/day before the remediation to 0.45 cm/day, indicating that the leakage pathways in the former ponds have been largely blocked, demonstrating a significant improvement in the effectiveness of the remediation measures.

Fig. 8. Comparison of the pond water level before and after leakage control treatment
