Numerical Simulation Study on the Mechanism of Loess Slope Landslide Formation under Rainfall Effects

Abstract. In the Ili region of Xinjiang, there are a large number of loess slopes. Combined with the high rainfall in the Ili Valley, it often poses hazards to engineering construction. Under the influence of rainfall, the moisture content of the loess increases significantly, leading to sliding and failure at the contact surface between the loess and gravel layers. In order to comprehensively analyze the mechanism of loess surface slope landslide under the effect of rainfall, this study conducted field sampling of typical landslides in the area and performed laboratory direct shear tests and finite element numerical simulation studies. The results showed that: after the increase in moisture content, the cohesive strength of the loess increased to some extent, but the internal friction angle continued to decrease, resulting in a continuous reduction in shear strength. The contact surface between the loess and gravel layers was prone to sliding and failure. Under self-weight conditions, the maximum displacement was 3.7cm, while under rainfall conditions, the maximum displacement re

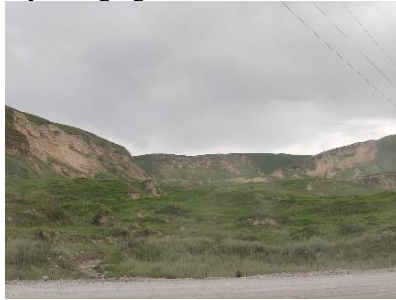
Fig. 1. Galante ring chair loess landslide

Based on the typical loess slope of Jialangputu in Ili River Valley (Figure 1), the surface loess of the slope has obvious particle characteristics, which is obviously affected by rainfall, and the binding force between particles is weaker than that of sand and clay. In addition, due to the prominent characteristics of loess particles, its permeability is relatively low. Under the action of rainwater, the strength of loess will change significantly. When the water content is low, the skeleton structure of loess is relatively stable, showing high strength and stability. However, once the water content exceeds a certain level, the strength of the loess will decrease sharply, which will seriously reduce the stability of the loess slope. In addition, due to the large porosity of the loess, it is easy to destroy the skeleton structure of the soil after rainfall infiltration, which leads to the collapsible behavior of the loess and further reduces the stability of the slope. The mechanical strength of loess itself is relatively low, and it is affected by the type of loess, water content and void ratio, so the mechanical properties of loess are relatively unstable. Combined with the meteorological elements of the region from 2016 to 2020 shown in figure 2 through geological disaster exploration, it is found that many obvious sliding deformations and even landslides in the region occurred during heavy rains, even after continuous light rains. Therefore, this paper mainly studies the

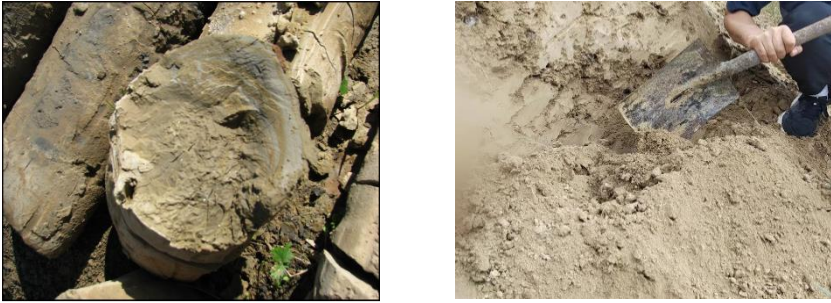
Fig. 3. loess samples

The main work of indoor direct shear of loess in Yili area of Xinjiang selected in this test is the determination of natural water content, as well as the ratio of different water content and indoor direct shear test. The undisturbed loess samples were obtained by drilling soil method to reduce the disturbance to the soil. The loess obtained by drilling soil method and granular soil is shown in Fig.3.

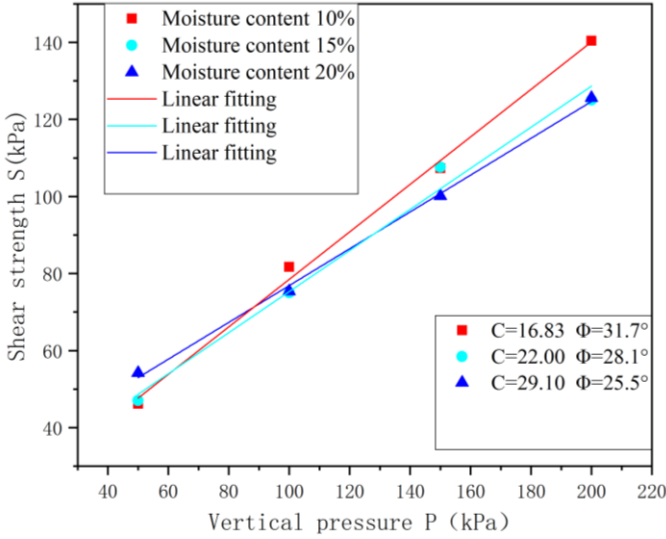
Fig. 5. Shear strength and vertical pressure relationship curve

1) It can be concluded from the indoor direct shear test that the cohesion increases with the increase of water content, the internal friction angle decreases, and the shear strength decreases with the increase of water content.

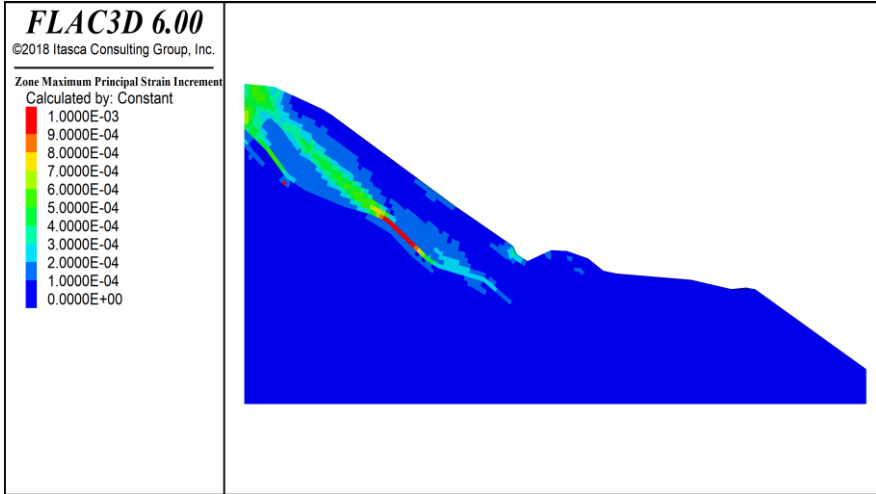
Fig. 9. Plastic strain cloud diagram in natu-ral state

and range of plastic strain can be observed. As shown in Figure 9, the plastic strain zone in the natural state is mainly concentrated in the trailing edge of the landslide body, and the plastic strain zone is more dispersed. As shown in Figure 10, the plastic strain zone under rainfall begins to gradually penetrate the whole slope compared with the natural state, and the slip surface is relatively concentrated at the interface between the loess layer and the gravel layer. This is mainly due to the obvious changes in the physical and mechanical properties of the loess under the action of rainfall, and the gravel layer forms an obvious interface, so the plastic zone begins to penetrate the entire landslide area.
