# Experimental Study on the Failure Modes of Reinforced Loess Slopes with Frame Pre-stressed Anchors under Rainfall Influence

Yanpeng Zhu<sup>a</sup>, Ao Wang<sup>\*</sup>, Anping Huang<sup>b</sup>, Linping Wu<sup>c</sup>, Dong Cheng<sup>d</sup>

Lanzhou University of Technology, Lanzhou, 730050, China

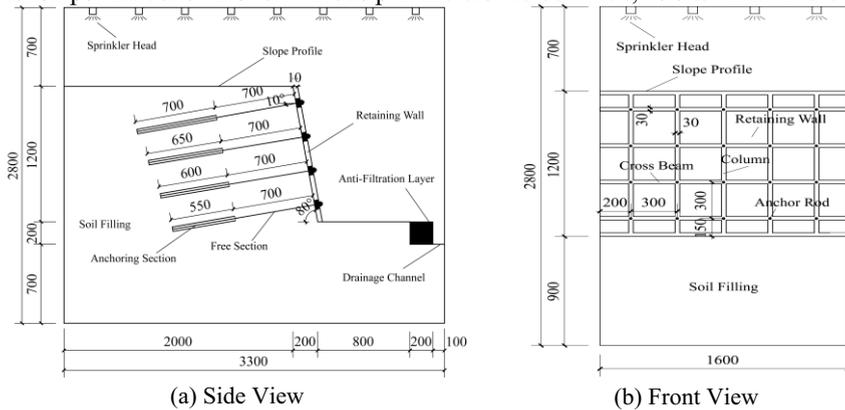
Fig. 1. Schematic Diagram of Model Dimensions /mm

The prototype slope is a single-tier loess slope reinforced with frame anchors, with a height of 12 m and a slope of  $80^\circ$ . The retaining board has a thickness of 100 mm, and the cross-sectional dimensions of the frame columns and beams are  $300 \text{ mm} \times 300 \text{ mm}$ . C30 concrete is used for construction, with anchor rod spacing of 3 m and a  $10^\circ$  angle with the horizontal direction. The model box used for the experiment has dimensions of  $3.30 \text{ m} \times 1.60 \text{ m} \times 2.80 \text{ m}$ . Based on the dimensions of the prototype slope and the model box, a geometric similarity ratio  $C_L$  of 10 is applied, as shown in Figure 1.

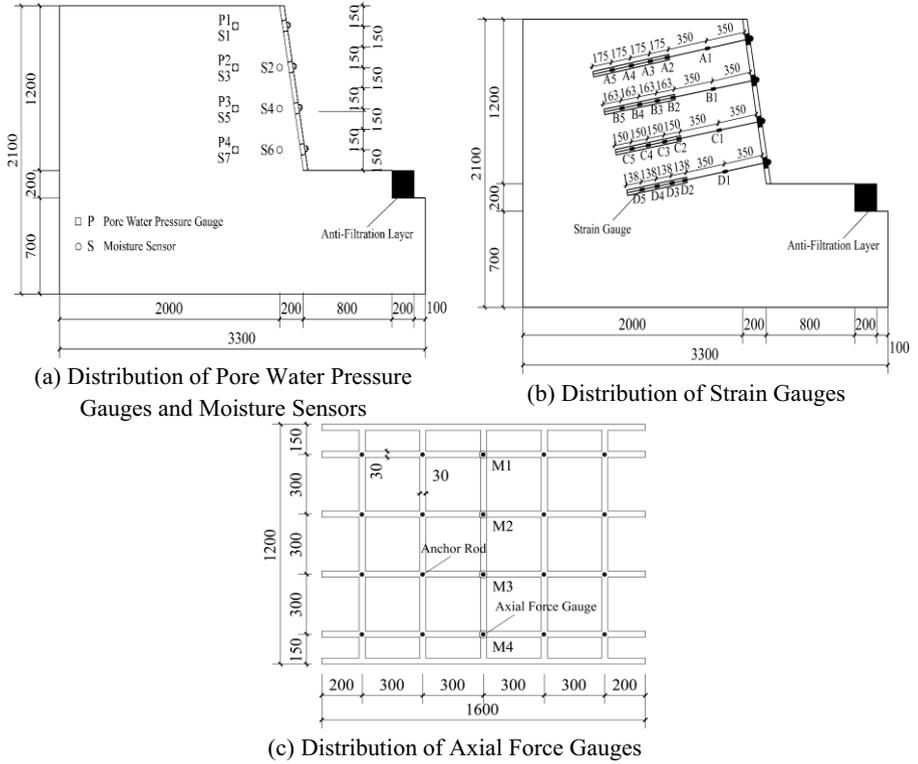
Fig. 2. Sensor Arrangement

To measure the variations in volumetric water content, pore water pressure, and anchor rod axial force, the experimental instruments mainly consist of an artificial rainfall device, moisture sensors, pore water pressure gauges, axial force gauges, strain gauges, DH3816N dynamic data acquisition instrument, and a moisture data acquisition instrument. The arrangement of sensors is illustrated in Figure 2.

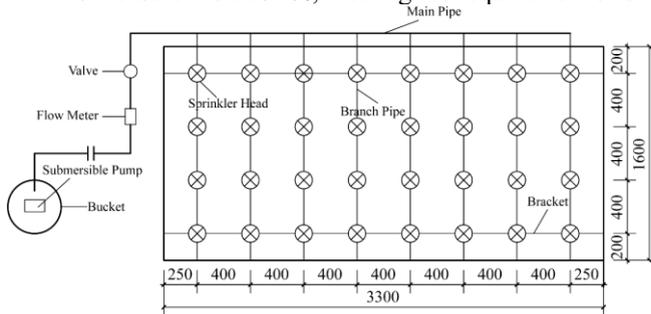
Fig. 3. Design of Artificial Rainfall Devices

Figure 3 shows an artificial rainfall device designed and fabricated according to experimental requirements. To simulate real rainfall conditions, atomizing nozzles are used to reduce the initial velocity of raindrops, minimizing the erosive effect on the slope surface. Before the experiment, the rainfall amount is determined using a rain gauge. The rainfall intensity is calibrated to be approximately 45 mm/h, and the uniformity of rainfall is measured to be 94%, meeting the requirement of over 80%.

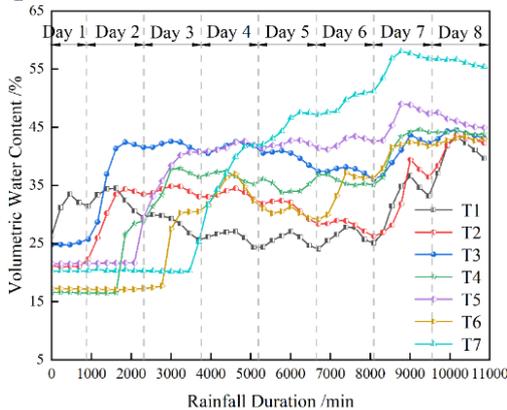
**Fig. 4.** Variation of Volumetric Water Content with Rainfall Duration

Figure 4 shows the variation of volumetric water content at different measurement points over time. At the start of rainfall, before the wetting front reaches the measurement points, the water content remains at its initial value. As rainwater infiltrates, the wetting front gradually reaches the measurement points, causing a rapid increase in water content. The ponding water at the slope top continues to infiltrate, leading to a continued increase in water content even after rainfall ceases. During the infiltration phase, water content decreases and stabilizes gradually, exhibiting a quasi-periodic variation in the later stages.

(1) The response of volumetric water content to rainfall follows a distinct sequence. The response of deep soil moisture content is observed later than that of shallow soil, and the response of soil moisture in the middle of the slope is observed later than that below the slope surface. This is due to the presence of a gap between the retaining board and the slope model, forming preferential pathways.

(2) Assuming vertical infiltration at the slope top and horizontal infiltration below the slope surface, the migration rate of the wetting front can be approximately estimated using response time and infiltration depth, as shown in Table 3. The data indicates that the average migration rate of the wetting front below the slope surface is approximately  $0.553 \times 10^{-3}$  m/min, while the average migration rate perpendicular to the slope top is  $0.388 \times 10^{-3}$  m/min. As the depth increases, the migration rate of the wetting front

gradually decreases, with the horizontal migration rate slightly greater than the vertical migration rate.

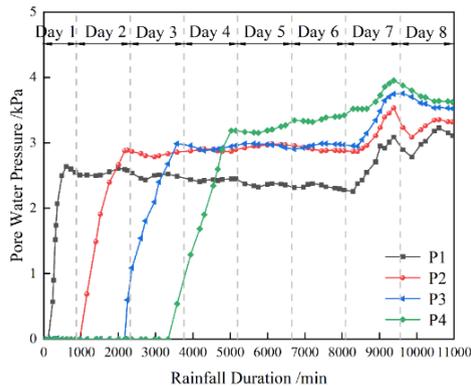
**Fig. 5.** Variation of Pore Water Pressure with Rainfall Duration

Figure 5 illustrates the variation of pore water pressure at different depths over time. In the early stages of rainfall, the pore water pressure at each measurement point remains at its initial value. As rainwater infiltrates and the wetting front reaches each measurement point, the pore water pressure rapidly increases in succession. During the infiltration phase, as water gradually percolates downward and the upper soil transitions from saturated to unsaturated, the pore water pressure decreases. In the mid-stage of rainfall, as rainwater continues to infiltrate, the pore water pressure at each measurement point gradually stabilizes. In the later stages of rainfall, as the slope forms a potential sliding surface, the pore water pressure at each measurement point rapidly increases. This is because the internal drainage of the slope is obstructed, resulting in excess pore water pressure.

It can be observed that the trend of pore water pressure variation is generally consistent with the volumetric water content, but the response of pore water pressure gauges to rainfall infiltration is delayed compared to moisture sensors. This delay is due to the fact that when the wetting front reaches the moisture sensor, the water content changes immediately. However, the wetting front first passes through the permeable stone of the pore water pressure gauge, causing the pore water pressure to change only after the wetting front has passed.

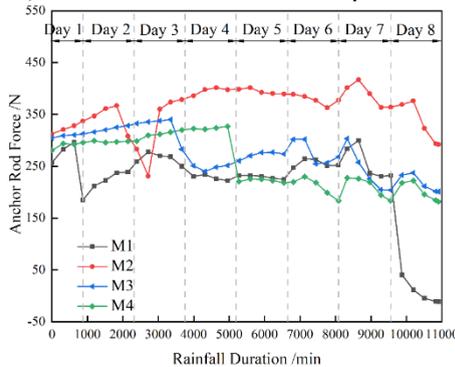
Fig. 6. Variation of Axial Force with Rainfall Duration

Figure 6 shows the variation of anchor rod axial force at different depths over time. During the rainfall process, the axial force of anchor rods at different depths follows a consistent trend with rainfall duration. In the early stages of rainfall, the axial force of the anchor rods shows a linear increase. This is because rainwater infiltration increases the soil moisture content, significantly increasing the weight, and thereby increasing the sliding force of the slope. To resist slope movement, the axial force of the anchor rod increases. When rainfall has just stopped, due to the incomplete infiltration of some rainwater, the axial force of the anchor rod continues to increase for some time after rainfall cessation, but at a slower rate. In the mid-stage of rainfall, with continuous rainwater infiltration, the axial force of the anchor rod decreases significantly before stabilizing. This occurs because rainfall causes soil softening, which consequently diminishes shear strength and reduces the initial consolidation pressure of the upper soil layers. At the M2 location, the axial force decreases from 270 N to 150 N, showing a relatively large reduction during the infiltration phase. This indicates that rainwater infiltration has a significant impact on the axial force of the upper anchor rod. It is evident that rainfall has a substantial influence on the shallow soil of the loess slope reinforced with prestressed anchor rods, highlighting the need to strengthen the monitoring of the axial force of the upper anchor rod. In the later stages of rainfall, the axial force of the anchor rod fluctuates due to cracks accelerating water infiltration. The axial force shows a slight increase, and during the nighttime infiltration phase, the axial force slowly decreases again. Eventually, due to the collapse of the soil behind the retaining board and the loss of soil around the first-layer anchor rods, the reinforcement is exposed, leading to failure, and the axial force at M1 drops to 0 N.

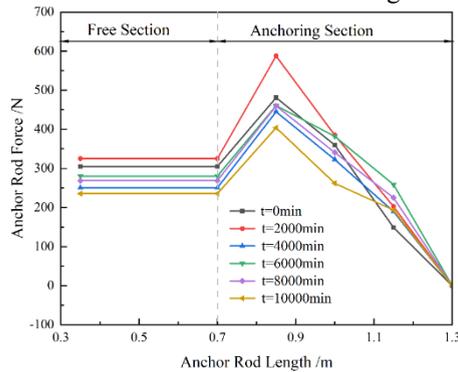
Fig. 7. Variation of Axial Force along the Length of the Anchor Rod

Figure 7 displays the variation of axial forces along the length of the third row of anchor rods at different time points. It is evident that the distribution pattern of axial forces along the length of the anchor rods during rainfall shows no significant changes.

The axial force in the free section of the anchor rod remains relatively constant along its length, while in the anchored section, the axial force follows a pattern of being larger in the middle and smaller at the ends. The maximum axial force is reached at a length of 0.85 m, and the axial force at the end of the anchor rod is 0 N. With the increase in rainfall duration, the overall axial force values at the same position gradually increase, followed by a decrease in the later stages of rainfall. This is attributed to the transition of the slope from unsaturated to locally saturated conditions from top to bottom as rainwater infiltrates during the early stages of rainfall. The matric suction in the unsaturated zone decreases and the effective stress increases, leading to vertical settlement and accompanying horizontal displacement. The support structure restricts the horizontal movement of the soil, causing an increase in axial force in the anchor rod. As rainwater infiltrates from top to bottom, the local saturation of the soil changes as follows: small  $\rightarrow$  large  $\rightarrow$  small. This results in a transition process of the soil experiencing local unsaturation  $\rightarrow$  local saturation  $\rightarrow$  local unsaturation. Rainwater infiltration also gradually reduces the frictional force between the anchor and the soil, causing a slight decrease in axial force. During the rainfall process, the effects on the axial forces at the end and middle of the anchored section are most significant. As the length of the anchor rod increases, the influence of rainfall on the axial forces gradually diminishes.

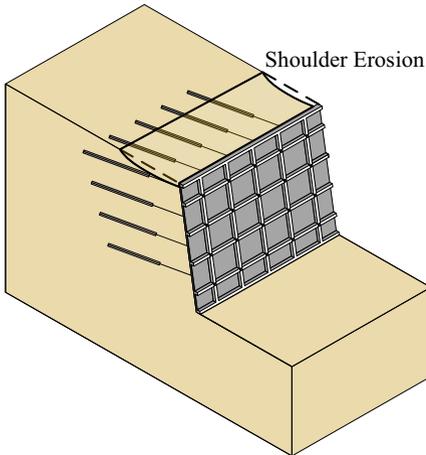
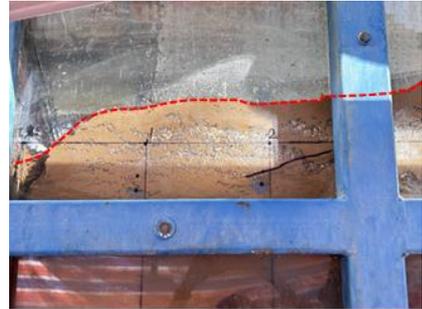
(a) Shoulder Erosion

(1) **Shoulder Erosion:** In the initial stages of rainfall, vertical settlement occurs in the front edge soil of the slope. Rainwater flows along the slope surface, concentrating at the front edge of the slope, leading to erosion of the slope shoulder. The erosion intensity gradually weakens from top to bottom, as shown in Figure 8(a).

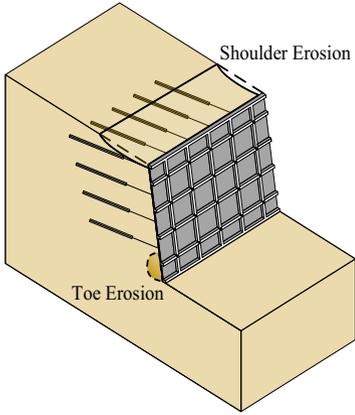
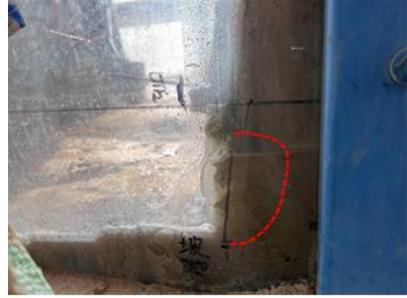
(b) Toe Erosion

(2) **Toe Erosion:** Rainwater flows into the gap between the retaining wall and the slope, and accumulates at the bottom of the slope without timely drainage, causing

softening of the slope toe. This favors the formation of a weak surface at the slope toe, as shown in Figure 8(b).

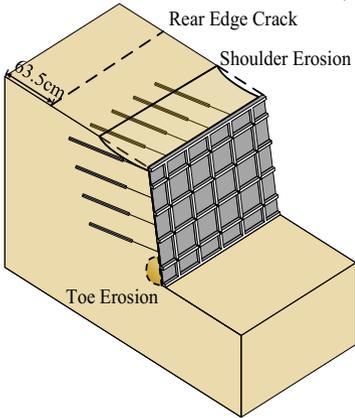
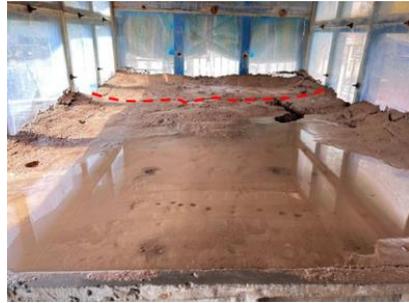
(c) Formation and Development of Rear Edge Cracks

(3) Formation and Development of Rear Edge Cracks: With the infiltration of rain-water, the moisture content increases, and the loess material softens, resulting in a reduction in shear strength. Under the influence of the self-weight of the soil and percolation forces, the softened soil cannot sustain the existing load, and the upper soil has a tendency to move downward along the slope surface. Eventually, transverse cracks form at the rear edge of the slope and gradually expand, as shown in Figure 8(c).

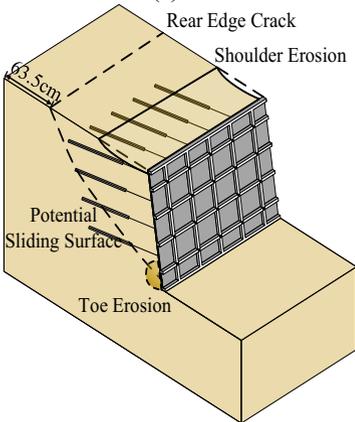
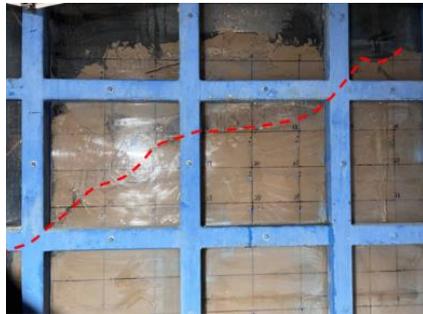
(d) Formation of Potential Slip Surface

(4) Formation of Potential Slip Surface: Due to the extension of joints and the generation of cracks, the slope undergoes deformation. During the deformation process, some soil experiences poor drainage, resulting in excess pore water pressure and a reduction in effective stress. When the soil strength decreases to a critical value, a slip surface forms from the rear edge crack to the slope toe, as shown in Figure 8(d).

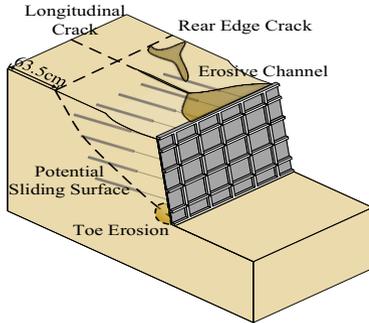
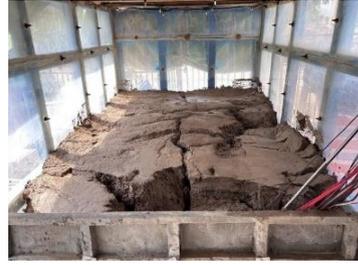
(e) Formation of Erosive Channel

(5) Formation of Erosive Channel: Shear cracks gradually extend into the deeper and central parts of the slope, causing erosion and soil loss on the slope surface. An erosive channel forms in the middle of the slope shoulder, leading to the exposure of the first-layer anchor bars and subsequent failure, as shown in Figure 8(e).

Through the comparative analysis with the experimental results of Zhang et al. [10], it is observed that the evolution characteristics of cracks in loess slopes under rainfall conditions are consistent before and after support. However, due to the restriction of the retaining wall, large-scale landslides did not occur, and the failure mode transformed from overall sliding to erosion-induced failure. Therefore, in practical engineering, it is essential to implement proper drainage measures at the slope top to avoid erosion-induced failure.
