# Application and Study of Notched Over-Beams Based in Masonry

China Construction Sixth Engineering Bureau Co., Ltd., Yazhou, Sanya, Hainan, China

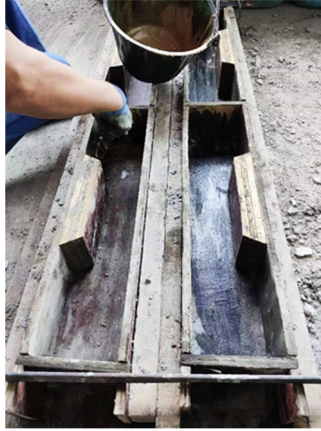
After formwork setup, reinforcing bars (rebar) are arranged according to the design specifications. This step is crucial for increasing the stability and load-bearing capacity of the beam. After rebar placement, concrete is poured into the formwork, and care is taken to avoid any deformation that could compromise the beam's structural integrity (as shown in Fig. 3).

**Fig. 3.** Reinforcement Arrangement of Prefabricated Notched Over beam

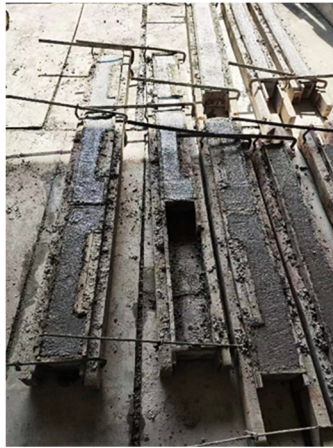
After the reinforcement bars are properly positioned according to the design, fine stone concrete is poured into the formwork. The concrete strength must align with the specifications outlined in the drawings and meet design requirements. During the pouring process, it is essential to ensure that the concrete is densely packed. To achieve this, small vibrating rods are used to vibrate the fine stone concrete, ensuring that the concrete fills all gaps and voids, enhancing its structural integrity and durability (as illustrated in Figure 4).

**Fig. 4.** Concrete pouring and forming of notched over beams

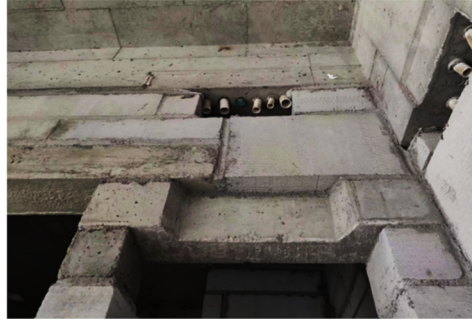
The installation of prefabricated notched over beams involves several critical steps to ensure structural integrity and proper alignment. First, the location and size of the electrical power boxes are determined based on the drawings and masonry layout. Mortar is then applied to create a uniform base, followed by the careful placement of the over beam, ensuring that the notched sections align with the pre-embedded conduits to avoid the need for additional cutting. An infrared laser is used to calibrate the perpendicularity and flatness of the over beam, ensuring it meets design and code requirements. Finally, joints between the over beam and the masonry are finished to enhance both stability and aesthetics (as illustrated in Figure 5).

**Fig. 5.** Prefabricated notched over beam installation
