# Adaptation and Preservation of "Salib Suci" Catholic Church in Bandung City

**Abstract.** Bandung, one of the cities used as the centre of government during the Dutch colonial era, has various relics that still survive today, one of which is a worship building. Worship buildings generally have a different architectural style to become landmarks in an area. Until now, religious buildings left over from the colonial period still exist as places of worship. This paper will describe the preservation efforts carried out at the Salib Suci Church, a Catholic Church founded in line with the development of Bandung towards the East in the early 19th century. By field observation method and creating documentation, data was obtained regarding the preservation efforts that had been carried out concerning the status as a Cultural Heritage Building. Considering its age, weather changes and city development, what restoration efforts have been made so this Church does not experience physical changes? Apart from that, some adaptations have been made related to the developments of Bandung City. One of which is conversion, both to address the increase in the number of congregations and the needs of

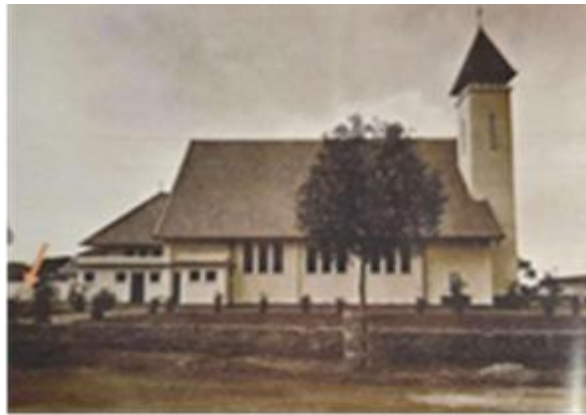
**Fig. 2.** Photo, circa year 1929

On 17 August 1927, the Heilige Kruis Stichting or Holy Cross Foundation was built, which ran schools throughout the Bandung Diocese. In 1930, the Brothers of St. Aloysius came to Bandung and founded the MULO (*Meer Uitgebreid Lager Onderwijsschool*) or Junior High School. Seeing the successful development of mission work in East Bandung, the Blessed Holy Cross Church was built in 1929 [6]. The Salib Suci Catholic Church applies the Indische Empire or Neo-Classical architectural style. Following what Handinoto [8] stated, the colonial architectural style developed in the 18th to 19th centuries was the Indische Empire architectural style. The Church was built with dimensions of 14.3m x 33.6m with an area of around 613 m<sup>2</sup>, which has not changed to this day, as seen in Figure 1 and the photo of an old façade in year 1929 (Figure 2).

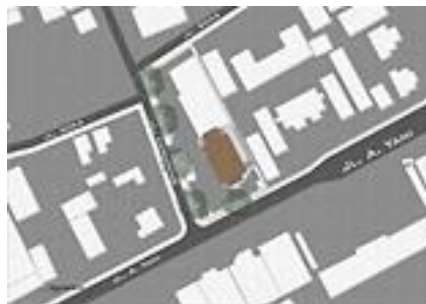
**Fig. 3.** The location of The Salib Suci Catholic Church

As seen in Figure 3, this Church is located on the side of the main road in the city, namely on Jenderal Ahmad Yani Street and is a corner building with two access roads from Jenderal Ahmad Yani Street and Kemuning Street. The heavy traffic on Jenderal Ahmad Yani Street caused this access to only be opened at certain times, while daily access was via Kemuning Street. To maintain security at the entrance from Kemuning Street, an additional building in the form of a guard post was added. Apart from that, a generator room was also established next to the guard post [10]. The change in the surrounding area into a commercial and office area has impacted the Salib Suci Catholic Church. A food kiosk can be set up on the side of the generator room. So, there are three additional buildings on the side of Jalan Kemuning: the guard post, generator room and food kiosk, as seen in Figure 4.

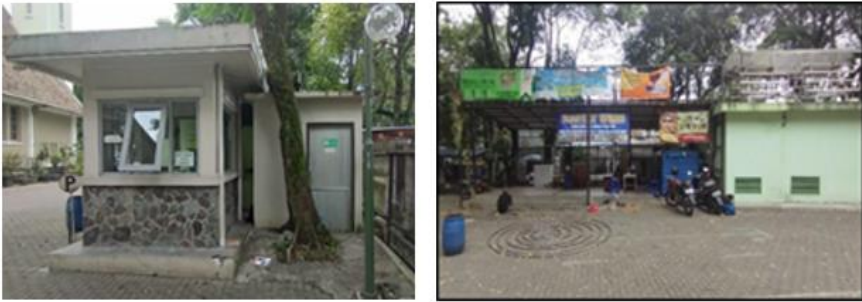
**Fig. 4.** The guard post, generator room, food kiosk

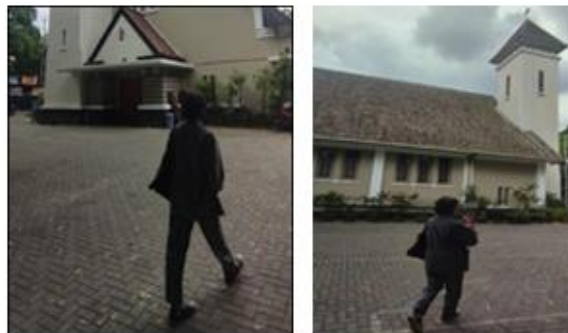
**Fig. 5.** The yard covered by paving block

Apart from that, due to limited parking space at the Government Office located in the surrounding area, the management provides parking permits for its employees in the Churchyard [6]. For this reason, the entire surface of the yard is covered with paving blocks, leaving a little space for plants, as seen in Figure 5.

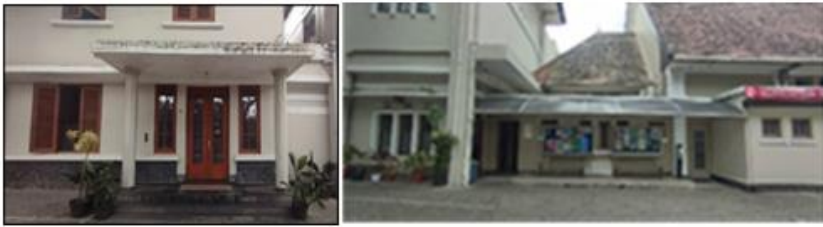
**Fig. 6.** The Rectory building at the back yard and the connecting between Rectory and Church

As for the encouragement from within, to support worship activities, a new building was built behind the Church, which functions as a Rectory, as seen in Figure 6. The

space between the Church and the Rectory functions as a connecting corridor which also functions as an access to the right side of the Church.

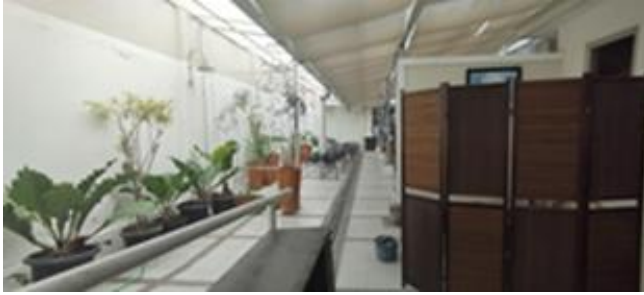
**Fig. 8.** Additional prayer space with transparent canopy for light protecting

maintain the authenticity of the shape and character of the building. Until now, the originality of the form and character has been maintained. Changes occurred on the right side of the building by changing the function of the side yard into an additional prayer room on the lower floor. A canopy with transparent material was added to protect the congregation seating from direct sunlight so that light could still enter, as seen in Figure 8. For security, on the right side of the building, a side entrance has been made, as seen in Figure 9.

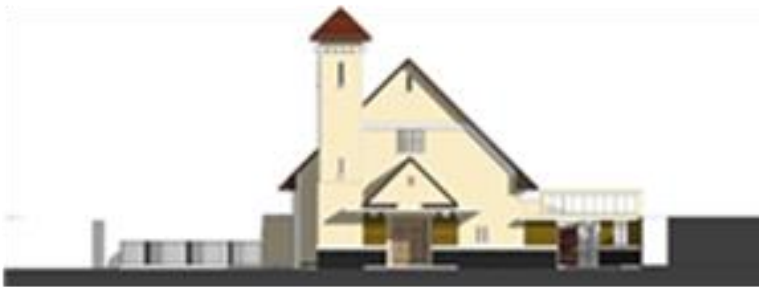
**Fig. 9.** Present time façade: with additional side entrance to prayer space at the right side

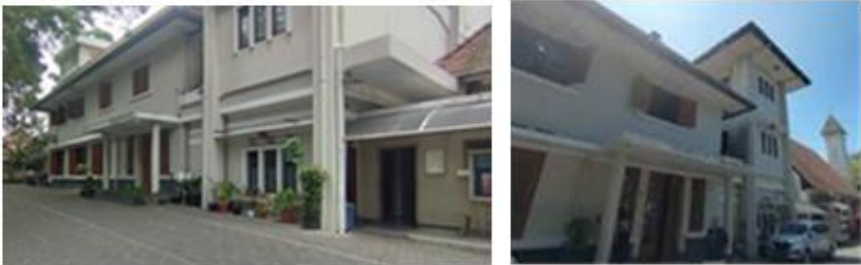
**Fig. 10.** The Rectory building at the back side use the same colour as the Church

The use of architecture style and colour of Rectory building as an additional building, consider match to the main building (Church) and can be said to be in harmony, as seen in Figure 10.
