# Optimization and Implementation of Key Technologies in Prefabricated Building Construction-A Case Study from Zhengzhou

## 2 Overview of the Zhengzhou Project

### 2.1 Basic Project Information

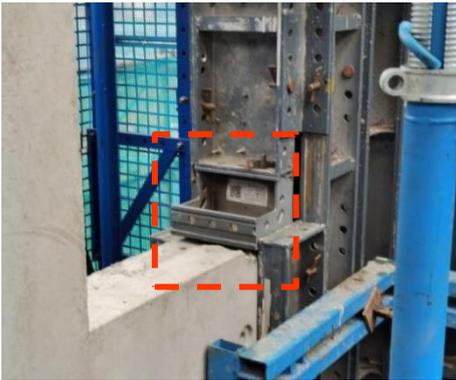
**Fig. 1.** A deviation between the reserved window of the PC component and the detailed design of the aluminum formwork.

Certain prefabricated composite slab truss reinforcements exhibit height deviations of up to  $\pm 2$  mm from the design specifications, necessitating on-site adjustments (Figure 1.). The positioning of reserved holes in prefabricated components deviates by 5 - 10 mm from the aluminum formwork backing ribs, augmenting the risk of concrete leakage (Figure 2.). On-site measurements reveal that the installation deviation of some components exceeds (Table 1)  $\pm 10$  mm, far exceeding the allowable design tolerance of  $\pm 5$  mm, severely impacting construction quality.

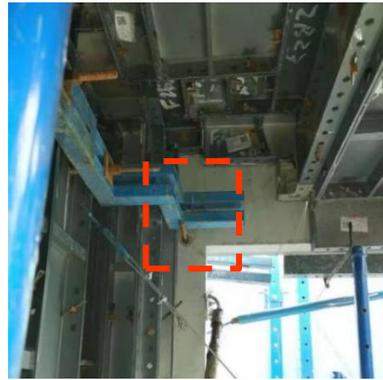
**Fig. 2.** The reserved holes are inconsistent with the aluminum formwork backing ribs.

The height deviation of the prefabricated composite slab truss reinforcement is substantial, with some parts deviating from the design requirements by  $\pm 2$  mm, leading to a significant amount of on-site labor and time consumption for secondary adjustments. The misalignment between the reserved holes in prefabricated components and the aluminum formwork backing on-site, with a deviation range of 5 - 10 mm, heightens the risk of concrete leakage during pouring and adversely affects the quality of component formation. Except for the top slab meeting the requirements, the verticality, flatness, and door and window opening compliance rates of other components still leave room for improvement.

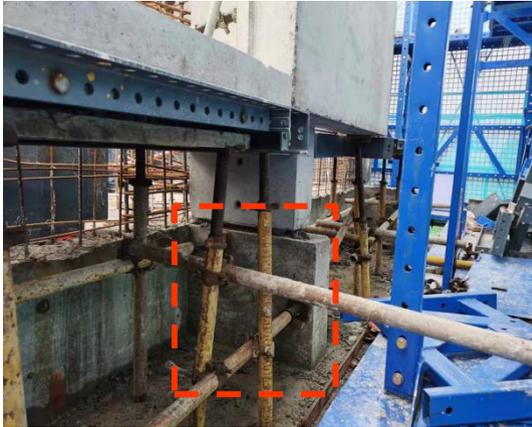
**Fig. 3.** Installation support problem of the first-floor PC components at the south-side bay window.

The design of the installation support for the first-floor precast concrete (PC) components of the bay window on the southern side is flawed(Figure 3.), resulting in insufficient bearing capacity of the node connections. During construction, conspicuous deformation occurs, endangering structural safety. Some node connections employ traditional rebar sleeve grouting techniques. However, due to construction errors and variations in grouting equipment performance, the quality of sleeve grouting is unstable, with issues such as insufficient grouting and voids, significantly degrading the mechanical performance of the nodes.

The installation support design for the first-floor PC components of the south-side bay window is inadequate, and the node connection bearing capacity cannot withstand the actual construction loads, resulting in obvious deformation during construction and posing a serious threat to structural safety. Some node connections utilize traditional rebar sleeve grouting methods. However, due to construction errors and differences in grouting equipment performance, the sleeve grouting quality is unstable, with defects such as insufficient grouting and voids, which greatly reduce the mechanical performance of the nodes.

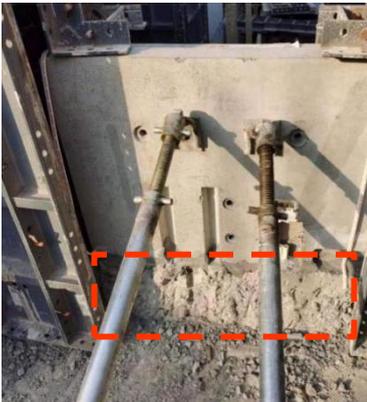
**Fig. 4.** The position deviation of the floor slab reverse edge.

The position of the floor slab reverse edge deviates by 5 - 10 mm(Figure 4.), clashing with the installation position of prefabricated components, making installation arduous and requiring a substantial number of on-site adjustments, severely affecting construction efficiency. There are also frequent conflicts between the suspended formwork of kitchen and bathroom partition walls and PC components(Figure 5.). In multi-trade concurrent operations, due to irrational construction planning and poor information communication, the process coordination is poor, and the rework rate is high.

The deviation of the floor slab reverse edge position is 5 - 10 mm, which conflicts with the installation position of prefabricated components, making installation difficult and requiring a large number of on-site adjustments, seriously affecting construction efficiency. There are frequent conflicts between the kitchen and bathroom partition wall suspended formwork and PC components. In multi-trade concurrent operations, due to unreasonable construction planning and poor information communication, the process coordination is poor, and the rework rate is high.

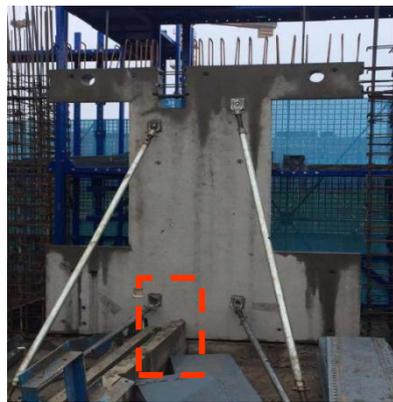
**Fig. 5.** The suspended formwork of kitchen and bathroom partition walls clashes with PC components in position.

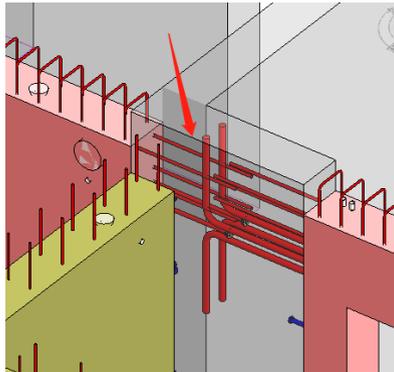
**Fig. 6.** A rebar collision when installing YWQ3 and YWQ1 components.

Employing BIM technology to simulate (Figure 6.) and analyze the construction process discloses that process conflicts mainly occur in the floor slab installation and pipeline layout stages[5]. The BIM model integrated the information from architecture,

structure, and electromechanical systems. By creating a virtual construction environment, we could identify potential clashes and inefficiencies in the construction process, especially in the floor slab installation and pipeline layout stages. The traditional construction management approach often suffered from information silos and lack of real-time coordination, leading to frequent rework and delays. BIM technology's visualization and data integration capabilities offered a solution to these problems. It enabled us to proactively detect and resolve conflicts, optimize the construction sequence, and improve overall construction efficiency. This was the main rationale for choosing BIM technology in this aspect of our study.
