Stability Analysis of Slopes with Weak Interlayers Considering Dynamic Construction Processes and Variable Dip Angles of Low-Angle Discontinuities

Abstract. Based on the engineering case of a gently inclined bedding rock slope containing weak interlayers, this study summarizes the engineering characteristics of weak interlayers and preliminarily determines that the slope failure mode is bedding slip-tensile cracking, with the weak interlayer being the primary factor affecting slope stability. Numerical analysis was conducted to evaluate the stability of both vertical-cut and slope-cut excavations with varying structural plane inclinations. The results indicate that unloading through excavation improves slope safety but disrupts the original stress equilibrium, reduces the beneficial self-weight load of the overlying soil, releases initial slope stress, and increases tangential displacement. The intersection zone between the excavated slope surface and the weak structural plane constitutes a post-excavation weak area. Compared to vertical excavation, slope cutting significantly enhances the stability factor across different inclination angles. The study reveals that the stability o

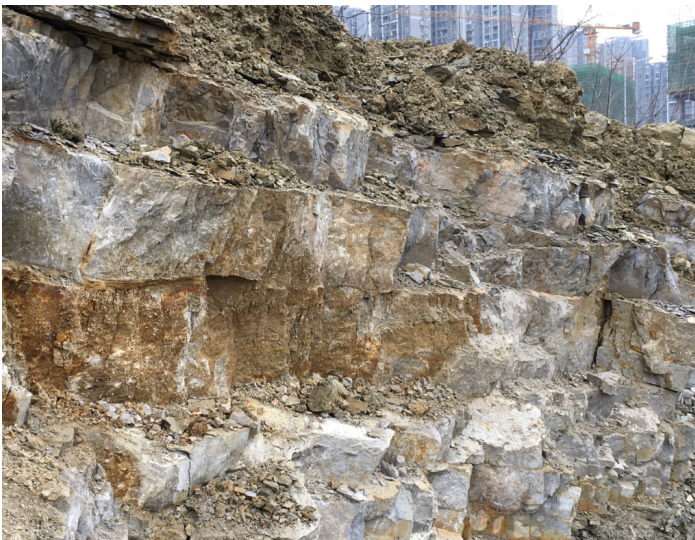
Fig. 1. Characteristics of Rock Mass and Discontinuities.

Based on the field characteristics and rock mass types of the slope, preliminary stability calculations and evaluations were conducted (Figure 1). The site plan of the slope

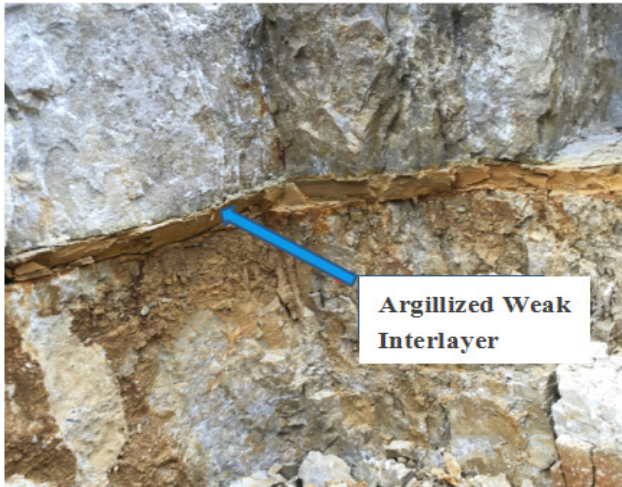
Fig. 2. Argillized Weak Interlayer.

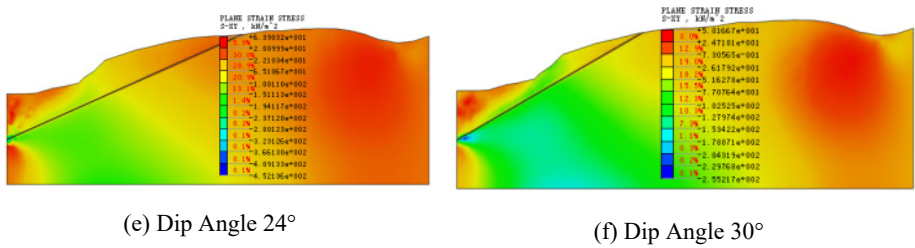
Fig. 8. Shear stress contour plots from numerical simulations of slopes with different dip angles after vertical excavation.

Based on the analysis of Table 3, Figure 8, and numerical calculation results of different dip angles in gently inclined weak structural planes after vertical excavation, the following patterns and conclusions are obtained:

- ④ Shear stress contours show that when dip angles increase from 19° to 30° , vertical stress distribution becomes pronounced along the slope rear, indicating tension crack development and sliding-tension failure mode, with more evident failure at higher angles.

- ⑤ Notably, the 9° dip angle exhibits more concentrated shear stress than 14° , particularly at frontal/rear structural plane intersections, suggesting greater overlying mass weight at 9° makes it less stable than 14° .

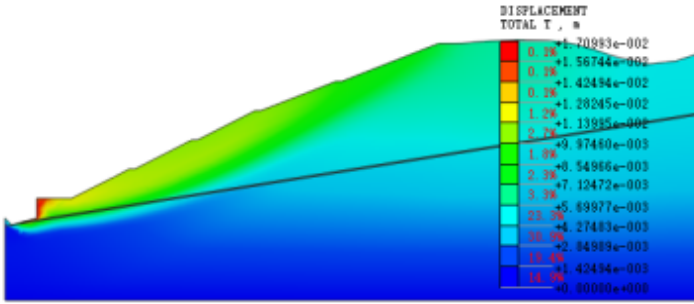
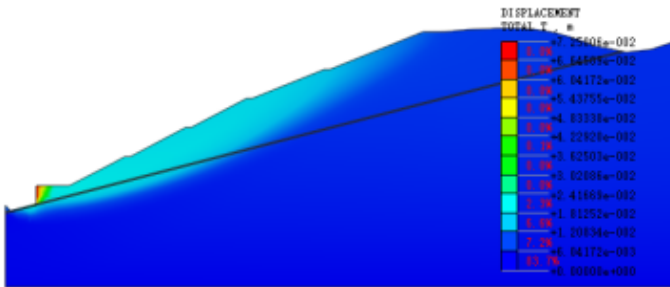
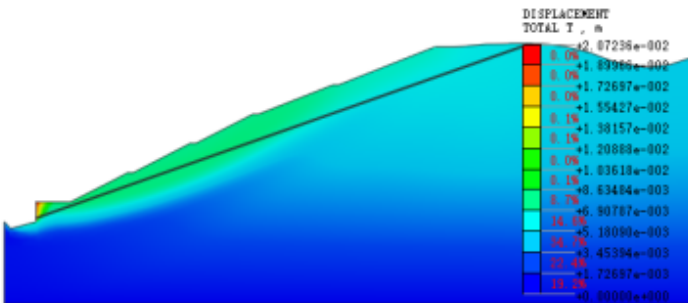
Fig. 9. Total displacement contour plots for different dip angles after slope cutting.

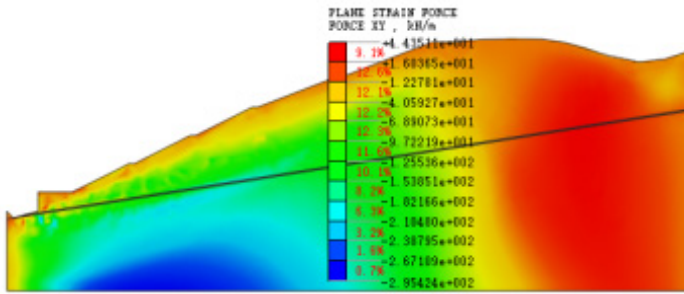
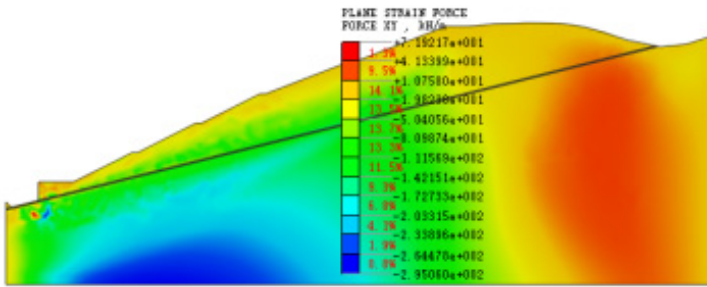
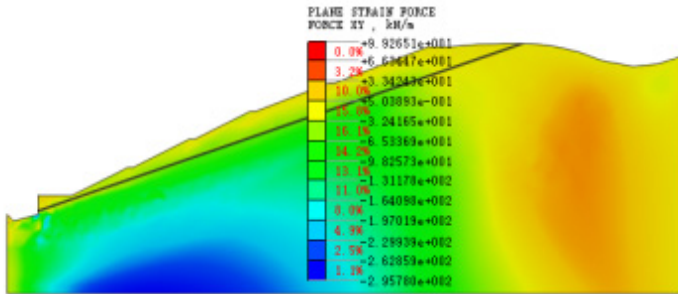
Fig. 10. Shear stress contour plots for different dip angles after slope cutting.

③ Comparing the shear stress contours of different dip angle models after cutting (Figure 10), it was found that as the dip angle increases, the shear stress distribution in all three working conditions shows a similar decreasing pattern, with stress mainly concentrated at the rear edge of the slope. This indicates that for this slope, the increase in dip angle after cutting does not significantly contribute to the shear stress at the rear edge, which is primarily influenced by the self-weight of the overlying sliding mass. The greater the self-weight of the overlying rock and soil mass, the more likely tension cracks will develop at the rear edge.
