# Effects of Loess sinkholes Development on Loess Slope Stability Under Rainfall Infiltration Conditions

**Abstract.** Loess sinkholes are one of the common diseases on loess slopes. To study the influence of loess sinkholes on the stability of loess slopes under rainfall conditions, indoor artificial rainfall simulation tests were carried out based on the rainfall similarity criterion. The corresponding laws of the influence of loess sinkholes on the rainfall infiltration of slopes and the impact on slope deformation were analyzed. The ABAQUS software was used to analyze the displacement development and stability of loess slopes with and without loess sinkholes under the same rainfall conditions.

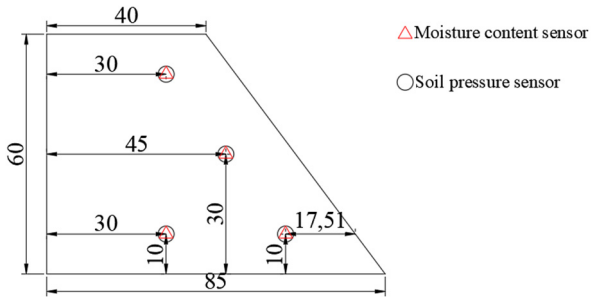
**Fig. 1.** (a) Side View of the Arrangement Position of the Sensors; (b) Top View of the Arrangement Position of the Sensors; (c) On-site Test Diagram

Designed according to the similarity ratio theory, the indoor model of the slope has a length of 0.85 m, a height of 0.6 m, a width of 0.5 cm, and a slope gradient of 53°. The prototype rainfall intensity is 20 mm/h, and after calculation, the simulated rainfall intensity is 90 mm/h. The similarity relationship between the prototype and the indoor model is shown in Table 2. A total of two groups of tests are designed. One group is the test of a normal slope, and the other group is the test of a slope with a sinkhole. Both the diameter and the depth of the sinkhole are 10 cm, and its position is 10 cm away from the slope surface at the top of the slope. When filling the model, in order to ensure the uniformity and compactness of the soil, the method of layered filling and controlling the dry density is adopted, and each layer is 10 cm thick for filling. The on-site test photos and the monitoring schematic diagram are shown in Figure 1, and the monitoring points are all placed at the layering positions.

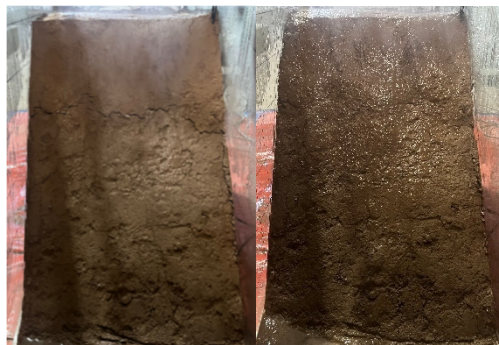
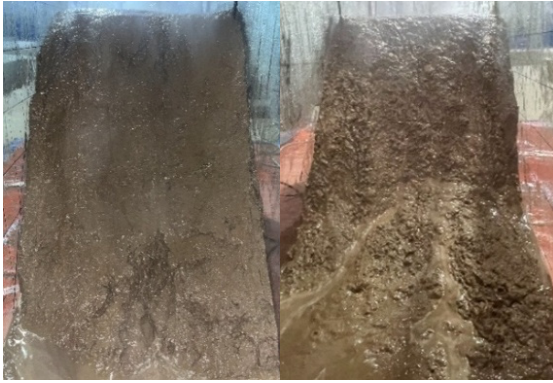
**Fig. 2.** (a) Process Diagram of the Simulation Test for the Normal Slope, (b) Process Diagram of the Simulation Test for the Slope with a Sinkhole

The failure of the normal loess slope is manifested as progressive overall instability. In the initial stage of rainfall, rainwater infiltrates downward along the vertical joints and large pores, causing the shallow soil of the slope body to become saturated. The self-weight of the soil increases, and its shear strength decreases due to the loss of matric suction, which easily induces local slippage at the toe of the slope. With continuous rainfall, the saturated area expands deeper, and the pore water pressure increases, forming a potential slip surface. Eventually, the slope shows overall collapse in the shape of an arc or steps. Its failure process is relatively slow. The slip surface usually runs through the middle of the slope body to the toe of the slope, and the scale of the collapsed body is large, with obvious progressive characteristics.

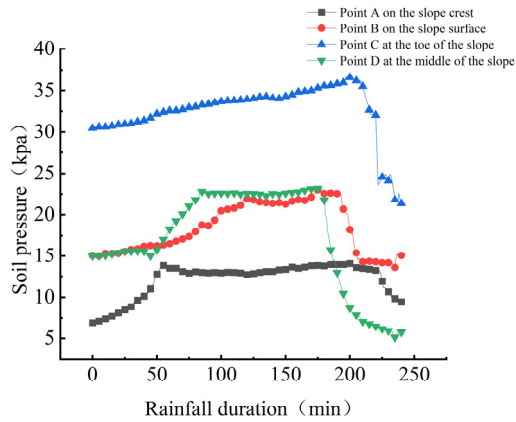
**Fig. 3.** (a) Soil Pressure Data Diagram of the Normal Slope, (b) Soil Pressure Data Diagram of the Slope with Loess sinkholes

As show in figure 3. In the normal slope, the soil pressure at the monitoring point A on the slope crest increased significantly at the beginning of rainfall, and tended to be stable at around 55 minutes. At about 220 minutes, due to the sliding and collapse of the soil on the slope crest, the soil pressure dropped sharply. The soil pressure at the monitoring point B in the middle of the slope surface was stable at the beginning of rainfall, began to increase obviously at around 50 minutes, tended to be stable at around 80 minutes, and decreased significantly at around 180 minutes due to the rapid sliding

of the soil on the slope surface. The soil pressure at the monitoring point C at the toe of the slope remained basically unchanged within 70 minutes, continued to increase from 70 to 120 minutes, and decreased rapidly at around 190 minutes due to the large-scale sliding of the soil at the toe of the slope. The soil pressure at the monitoring point D at the rear edge of the slope body increased slowly from the beginning of rainfall with a small variation range, and decreased rapidly after 210 minutes due to the large-scale collapse of the whole slope.

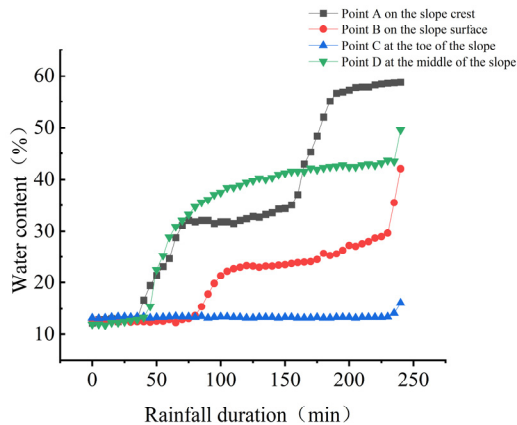
**Fig. 4.** (a) Water Content Data Diagram of the Normal Slope, (b) Water Content Data Diagram of the Slope with Loess sinkholes

As show in figure 4. In the initial state, the slope soil is unsaturated soil with a water content of about 12%. As the rainfall duration increases and the rainwater continuously infiltrates, the water content within the slope body will change significantly.

It can be seen from the figure that in the normal slope, the water content at the slope crest of measuring point A and the slope surface of measuring point B first began to increase rapidly at around 50 minutes. However, in the slope with loess sinkholes, the water content at the slope crest of measuring point A and the slope surface of measuring point B started to increase rapidly at around 30 minutes. This is because in the early stage of rainfall, rainwater accumulates in the loess sinkholes and infiltrates into the slope body.

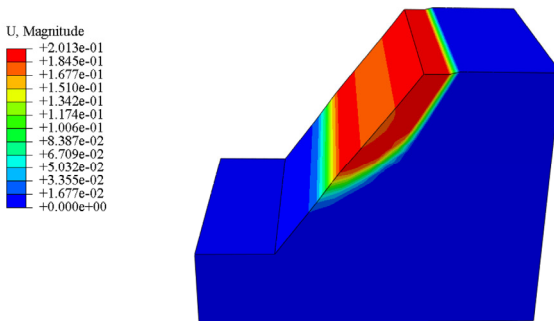
**Fig. 6.** Slope Displacement Nephogram of the Normal Slope When It Loses Stability after 255 Hours of Rainfall Duration

The ABAQUS numerical simulation software was used to calculate the slope displacements, plastic strains, and safety factors of the normal slope and the aforementioned slope with loess sinkholes under two working conditions, respectively. The slope displacement nephogram of the normal slope under the condition of continuous rainfall with a rainfall intensity of 20 mm/h is shown in Figure 5. As the rainfall duration increases continuously, the slope displacement keeps increasing. Until after 255 hours of rainfall, the maximum slope displacement reaches 20 cm. After that, the maximum slope displacement starts to increase rapidly, and at this time, the slope begins to lose stability.

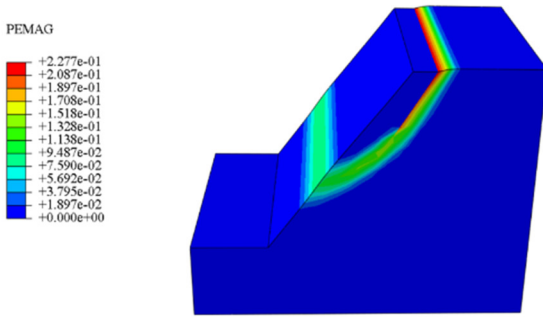
**Fig. 7.** Plastic Strain Nephogram of the Normal Slope When It Loses Stability after 255 Hours of Rainfall Duration

The plastic strain nephogram of the normal slope is shown in Figure 6. With the increase of the rainfall duration, the plastic zone first appears at the slope toe after the rainfall duration reaches 200 hours. After that, the area of the plastic zone at the slope toe keeps increasing as the rainfall duration progresses. When the rainfall duration reaches 250 hours, the plastic zone begins to increase rapidly, and the plastic strain keeps increasing. Until after the rainfall duration reaches 255 hours, a continuous plastic through zone is generated in the slope. According to the judgment basis of the plastic zone through, at this time, the loess slope begins to lose stability.

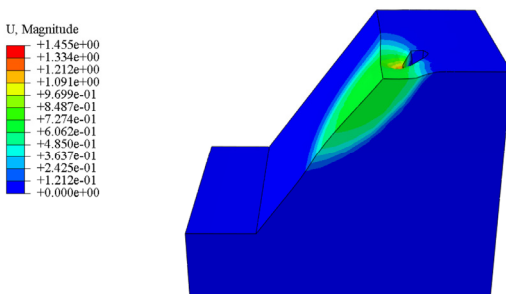
**Fig. 8.** (a) Displacement Nephogram of the Slope with Loess sinkholes after 250 Hours of Rainfall , (b) Displacement Nephogram of the Slope with Loess sinkholes When It Begins to Lose Stability after 252 Hours of Rainfall

The displacement nephogram of the slope with loess sinkholes under the rainfall condition of 20 mm/h is shown in Figure 7. Before the rainfall duration reaches 250 hours, the maximum displacement of the slope mainly occurs on the slope surface, and the pattern is basically consistent with that of the slope without loess sinkholes. However, the displacements are all larger than those of the normal slope during the same period. When observing the slope with loess sinkholes, there are obvious differences in displacements at different positions, and the maximum displacement on the slope surface is more biased towards the side with loess sinkholes.

After the rainfall duration exceeds 250 hours, relatively large displacements first occur in the soil around the loess sinkholes. This is because the loess sinkholes have changed the original structure of the soil, causing stress concentration in the soil around the holes, which makes it a weak point in the slope stability. The loess sinkholes have damaged the integrity of the soil and weakened the mutual restraint and supporting capacity among the soil particles, making the soil more prone to deformation and movement.

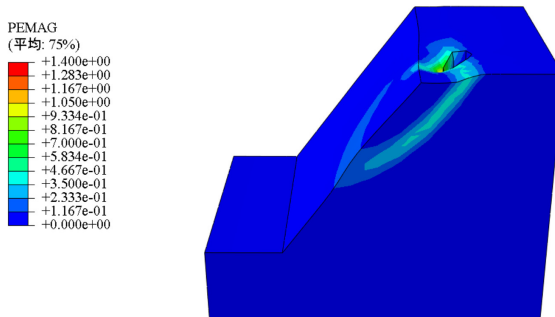
**Fig. 9.** (a) Plastic Strain Nephogram of the Slope with Loess sinkholes after 250 Hours of Rainfall, (b) Plastic Strain Nephogram of the Slope with Loess sinkholes When It Begins to Lose Stability after 252 Hours of Rainfall

The plastic strain nephogram of the slope with loess sinkholes is shown in Figure 8. After the rainfall duration reaches 248 hours under the condition of a rainfall intensity of 20 mm/h, plastic strains with relatively high strain values appear around the loess sinkholes. This is because the presence of the loess sinkholes has changed the stress state of the surrounding soil, and the stress distribution of the soil near the hole walls has become uneven, resulting in local stress concentration, which causes the soil to enter the plastic deformation stage in advance.

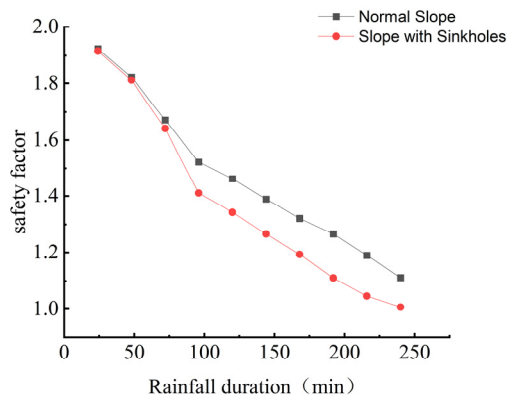
**Fig. 10.** Curve Diagram of Safety Factor

Using the strength reduction method in the ABAQUS finite element software, the broken line diagrams of the safety factors with a rainfall time interval of 24 hours for the normal loess slope and the loess slope with loess sinkholes were obtained, as shown in Figure 9.

As can be seen from the above figure 10, under the condition that the rainfall intensity is both 20 mm/h, with the increase of rainfall time, the safety factor of the slope shows a continuously decreasing trend. At the beginning, the safety factor decreases significantly with the continuation of rainfall, and then the decreasing rate gradually slows down. The safety factor of the slope with loess sinkholes starts to decrease significantly compared with that of the normal slope after 72 hours of rainfall

duration. The safety factor of the slope with loess sinkholes decreases at a faster rate, and the slope of the curve decline is steeper, indicating that the presence of loess sinkholes makes the slope more prone to instability under the influence of rainfall.
