# The Interplay of Cathodic Protection Failure and Hydro-Abrasive Wear in Offshore Electrical Submersible Pumps: A Disassembly-Based Analysis

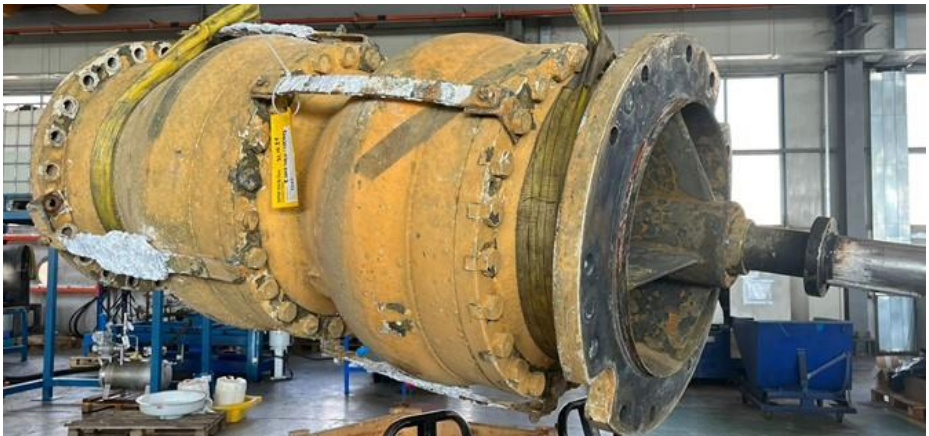
The study adopts a Disassembly-Based Analysis (DBA) methodology which includes Retrieval and Strip-Down: Units were retrieved due to reported low performance. Sacrificial anode condition (wear, deterioration) was visually inspected and qualitatively described 70% worn out or completely failed(see Fig.1).

**Fig. 1.** Severely Consumed Sacrificial Anode from Electrical submersible Pump

In the high-wear SWLP units, the cause of failure was directly linked to anodes found in destroyed condition signifying a complete loss of CP for an extended period. The effect on surface coatings was immediate and severe. The mentioned report noted that the protective coating of the chambers was completely erased as a result of the material being thoroughly exposed to the unprotected environment. The gravimetric analysis provides the most compelling quantitative evidence of the accelerated degradation.

The inspection findings revealed a critical failure in the primary corrosion defense mechanism. This premature consumption of the anodes is the direct enabler of the accelerated erosion-corrosion. To quantify this inefficiency and validate the recommendation to increase the anode mass, a back-calculation of the actual current demand and a forward-calculation for the required new mass were performed.

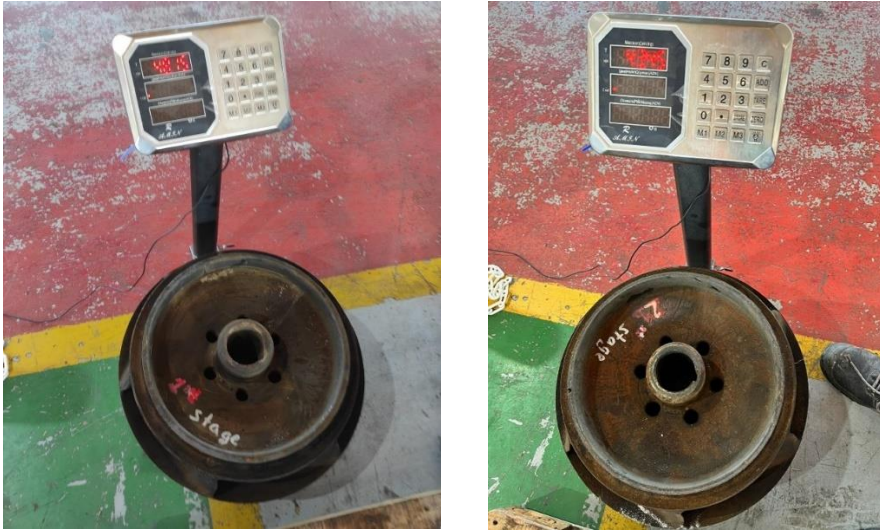
When it comes to Gravimetric Analysis, impeller weight was measured and compared between stages (or against OEM specifications) to calculate material loss in kilograms (e.g., 48.15 kg vs. 43.45 kg).(See Fig.2)

Fig. 2. Comparison of Stage-to-Stage Impeller Weight

The consistent and significant weight loss, particularly the variation between stages (highlighted by the 4.7 kg and 6.95 kg differences), indicates the differential wear profile that occurs when a combination of corrosive environment and solid particle impact is present. The upper stage impellers often experience a higher mass loss, which is characteristic of the flow-accelerated degradation regime.

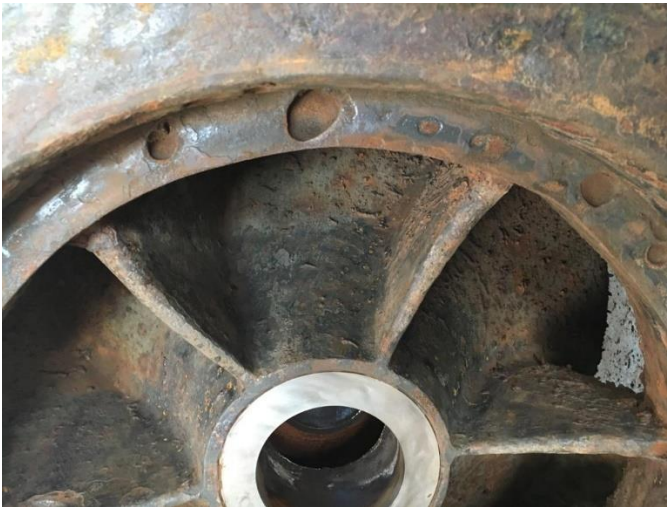
In dimensional assessment critical non-contact components (intermediate bowls, chambers, bellmouths) were inspected for erosion, scoring, and protective coating integrity.

Fig. 3. Severe Erosion-Corrosion on Pump Components
